## Safety recommendation issued due to a threat of an accident during investigation L2019-05

### Occurrence

An accident happened at Tampere-Pirkkala airport on 31 July 2019, where a student pilot on a solo flight lost control of an Evektor-Aerotechnik EV97 Eurostar ultralight airplane during take-off. The student pilot died in the accident.

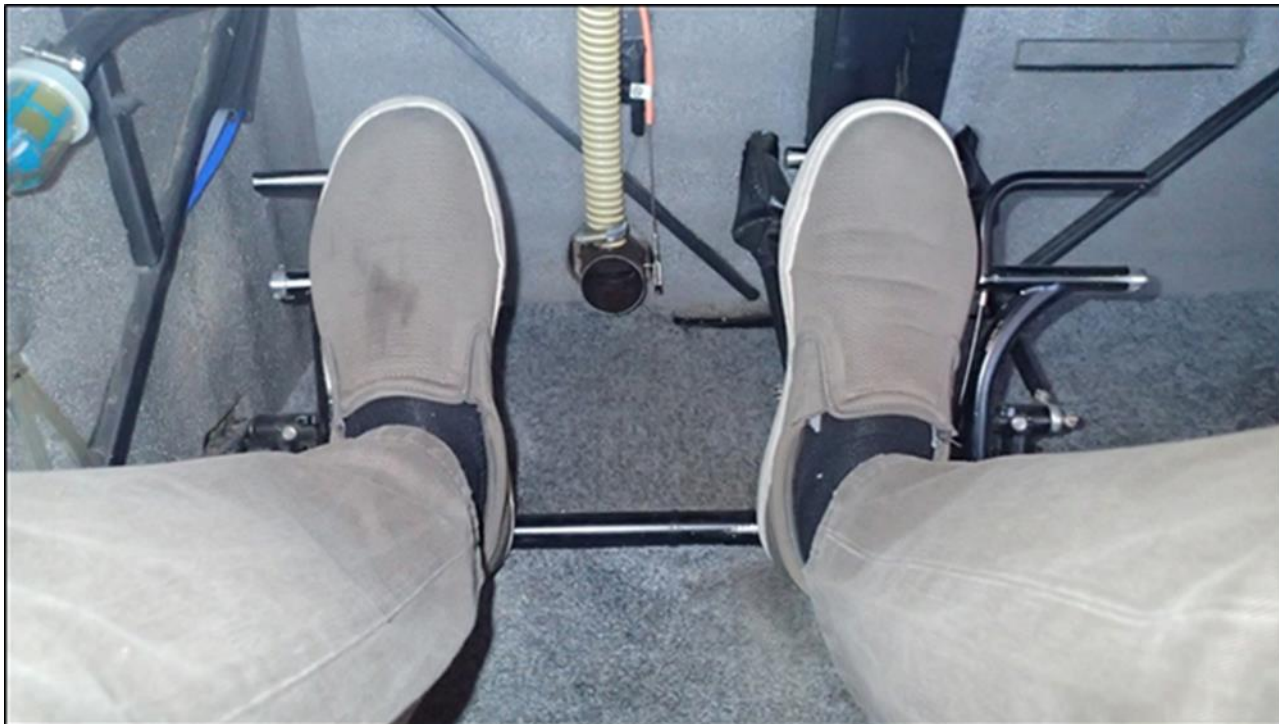
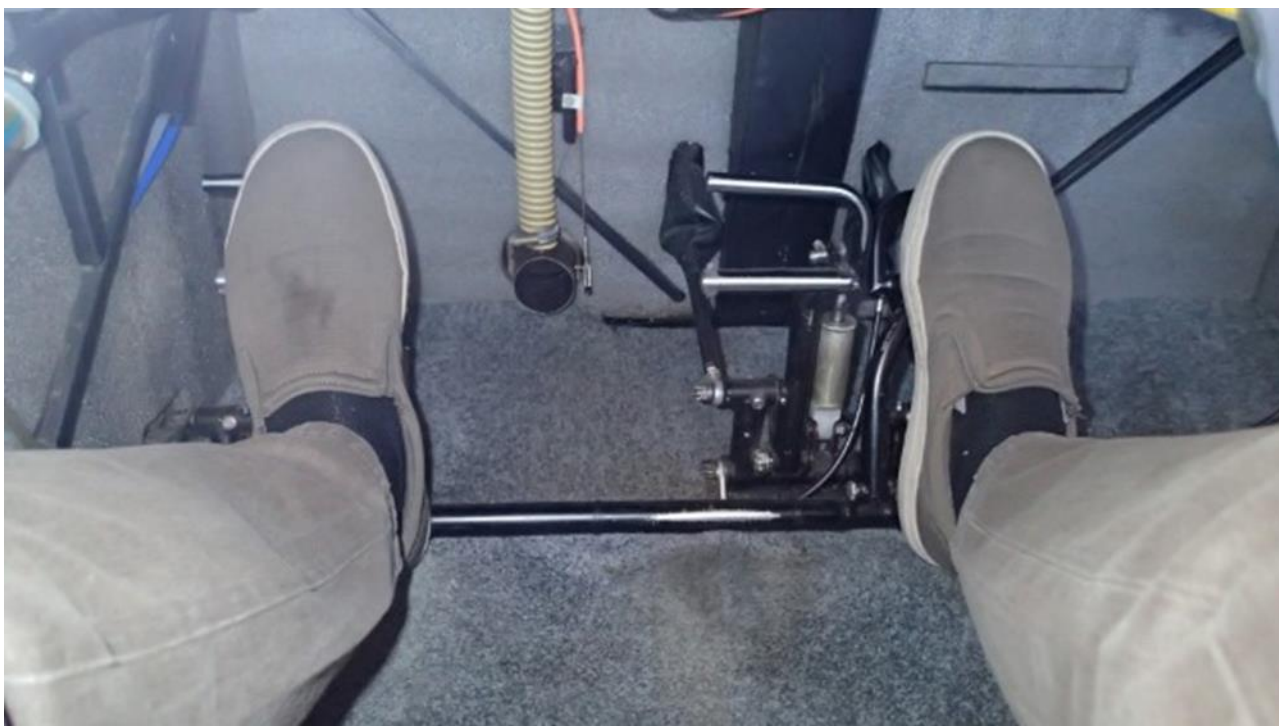
The technical investigation of the airplane that was destroyed in the accident at Tampere-Pirkkala airport on 31 July 2019 is now complete. The investigation found no evidence of a technical fault with the airplane. The airplane type EV-97 is fitted with two pairs of adjacent pedals situated very close to each other. It is possible that the pilot sitting on the left (pilot) seat inadvertently pressed the co-pilot side's left rudder pedal with his/her right foot – with the intention to press the right pedal of the pilot's (left) seat.

The Light Aircraft Association of the Czech Republic (LAA CR) prepare a mandatory service bulletin for a modification on Evektor-Aerotechnik EV97 Eurostar airplanes to prevent the pilots from unintentionally depressing the adjacent rudder pedals.
