Airliner Veering Off the Runway During Landing Roll at Savonlinna Airport on 7 January 2019

L2019-01

SYNOPSIS

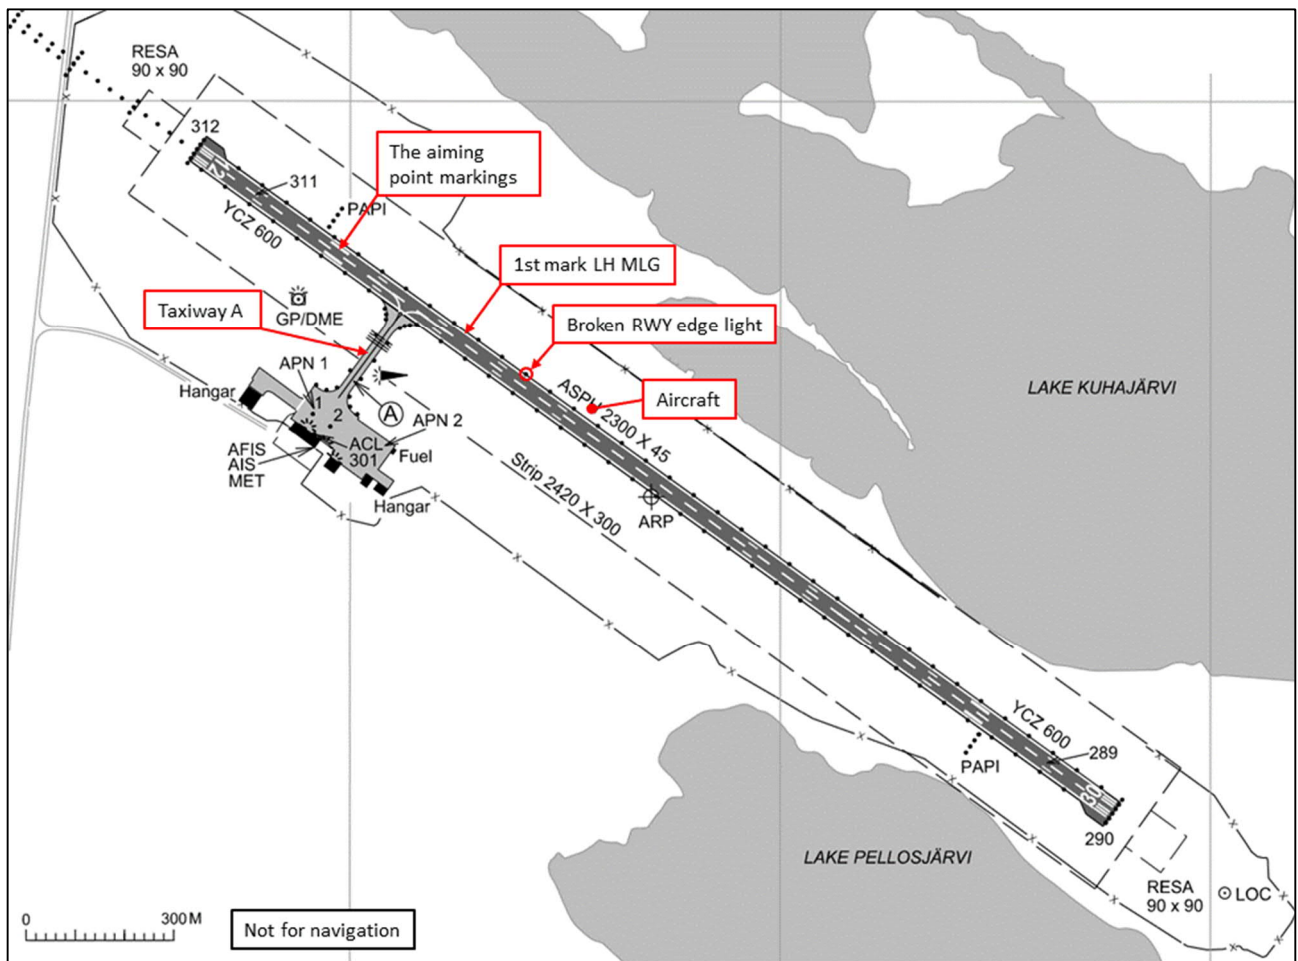
Judging by the marks on the snow the left main landing gear hit the left snowbank on the uncleared area. The nose gear touched the runway, following which the left main gear became airborne for a moment and the right main gear touched the ground. The left main gear touched down again. After having travelled approximately 100 metres from the first touchdown point the aircraft's nose gear and the right main landing gear moved outside the cleared runway area. The aircraft was tracking towards the left, away from the direction of the runway. The pilots tried to turn the aircraft back towards the runway centreline. According to the markings the aircraft began to turn and started to skid sideways outside the cleared area of the runway. When the left main gear hit a high snowbank outside the runway, the aircraft began to turn more sharply to the left. The left engine stalled when snow entered its air intake. The pilots did not deploy reverse thrust. The right main gear knocked one runway edge light over. The aircraft stopped in half-metre deep snow outside the runway, at a 110 degree angle in relation to runway 12.

Figure 1. Stages of the landing on the runway. (Base map: ©ANS Finland Oy; markings and positioning: SIAF)

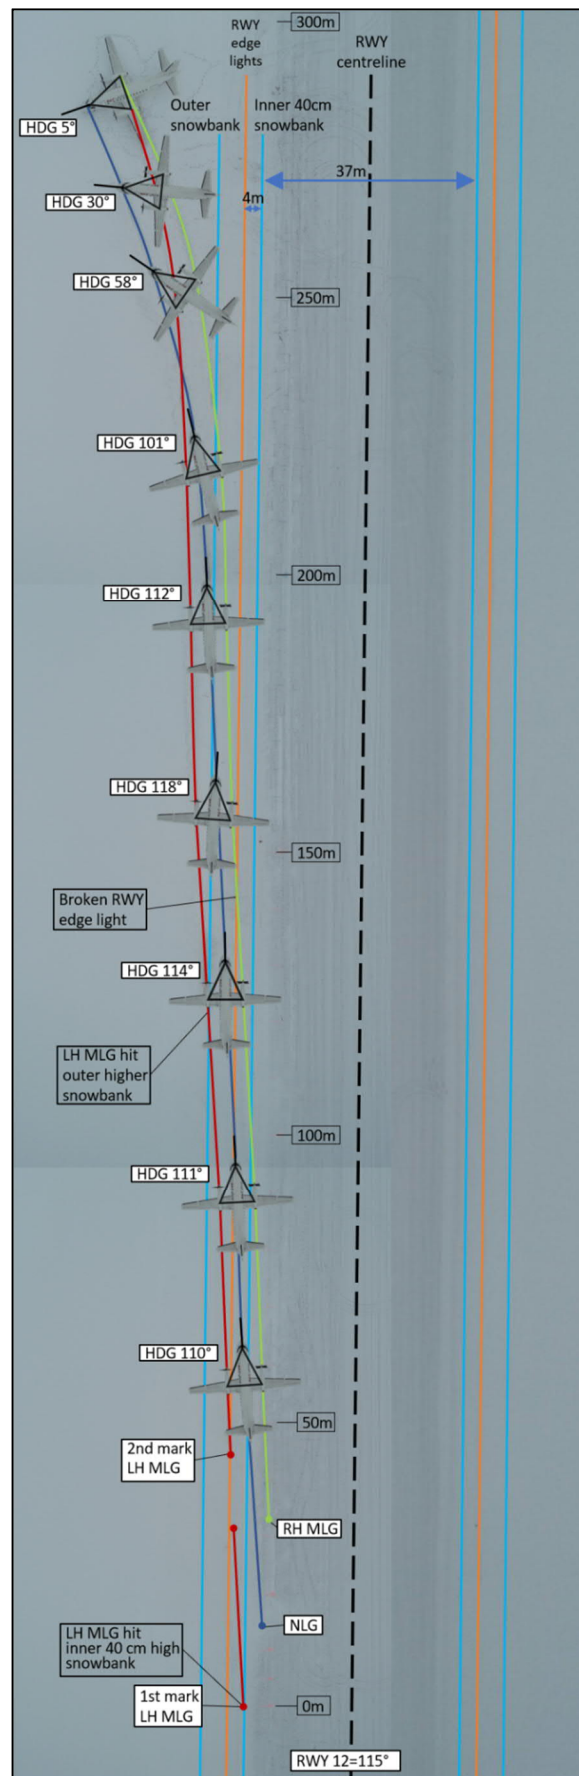
Figure 2. The heading of the aircraft during the landing roll according to the markings left by the tyres. (Base images: Police of Finland; drawings and markings: SIAF)

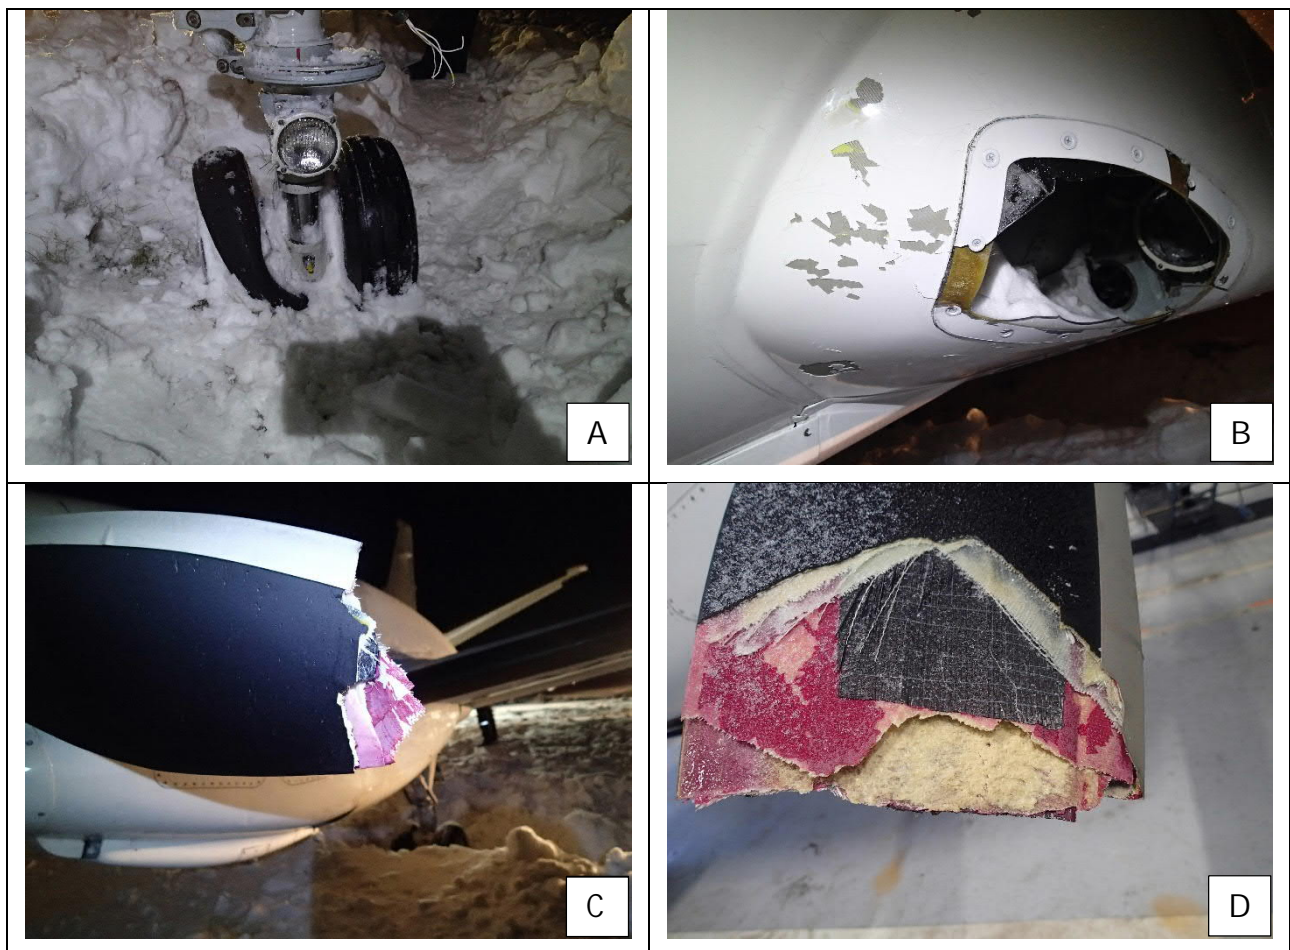
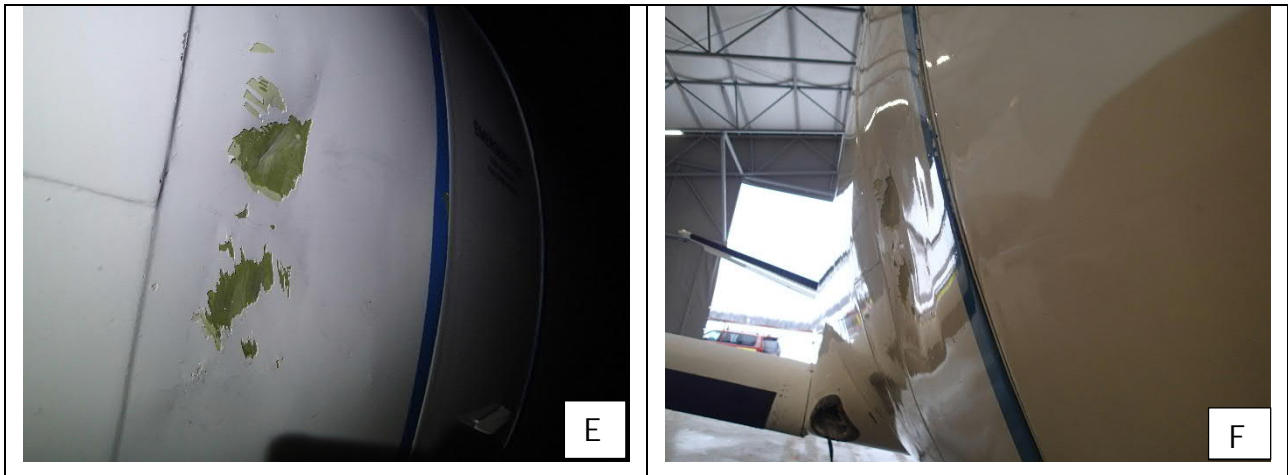
The accident caused considerable damage to the aircraft. Both of the aircraft's propellers were damaged: among other things, the damage included fractures, delamination, and some broken-off propeller tips. The nose wheel's right tyre came off its rim. The nose wheel's landing light wiring and control wiring sheared off. The landing light casings situated on both wing roots were broken and the landing lights were damaged from ingesting the snow. There was a 60 cm x 45 cm x 2.5 cm dent on the right front fuselage skin panel. Additionally, dents, cracks and paint damage were found around the fuselage, on skin panels and parts. Much of the damage was caused when the aircraft ran into the packed snowbank, which the propellers also hit. The propellers flung snow and ice clumps onto the fuselage. The right main landing gear's left tyre tread was damaged when it hit the runway edge light. Snow was packed inside the left engine intake and stalled the engine. The cabin was undamaged.

Figure 3. A Nose landing gear, B Damage to the landing lights at the wing root, C-D Damage to propeller blades, and E-F Damage to the right side of the aircraft. (Photos: SIAF)

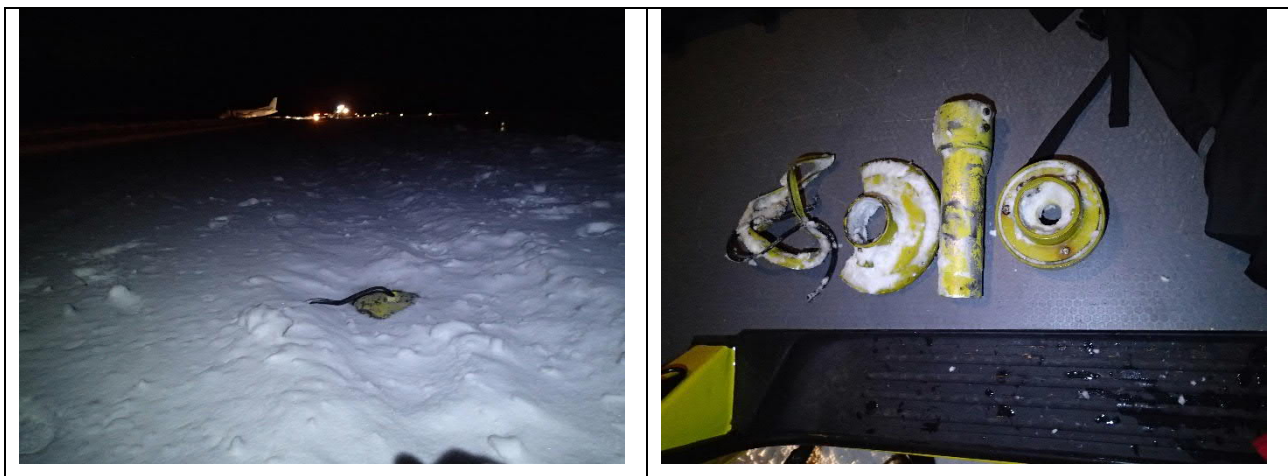
The right main landing gear broke one runway edge light on the left side of the runway. Airport maintenance replaced the light fixture.

Figure 4. The broken runway edge light. (Photos: SIAF)

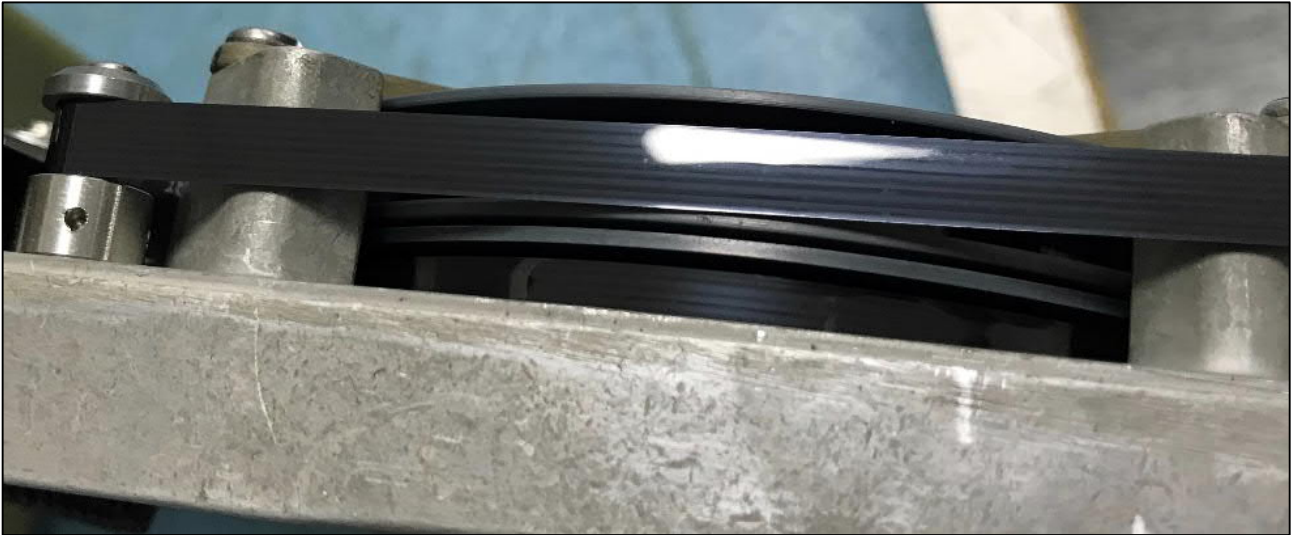
Figure 7 The longitudinal stripes visible in the photo are telltale signs of wear. Tapes that are in good condition do not show stripes. (Photo: AAIB)

The FDR data was first downloaded at the laboratory of the UK Air Accidents Investigation Branch (AAIB). While the device had recorded the data, the recording was of poor quality and parts of the recording were missing. In all, several hours' worth of data were missing from the tape, considering its total capacity. The recorder was further examined at the laboratory of Muirhead Avionics under the supervision of the AAIB. It became evident that the magnetic tape used for the recording was in very poor condition and worn. The tape was removed from the FDR and the AAIB continued its examination in their own laboratory. The further examination retrieved more information to the data, but the electronic signal still contained a lot of noise.

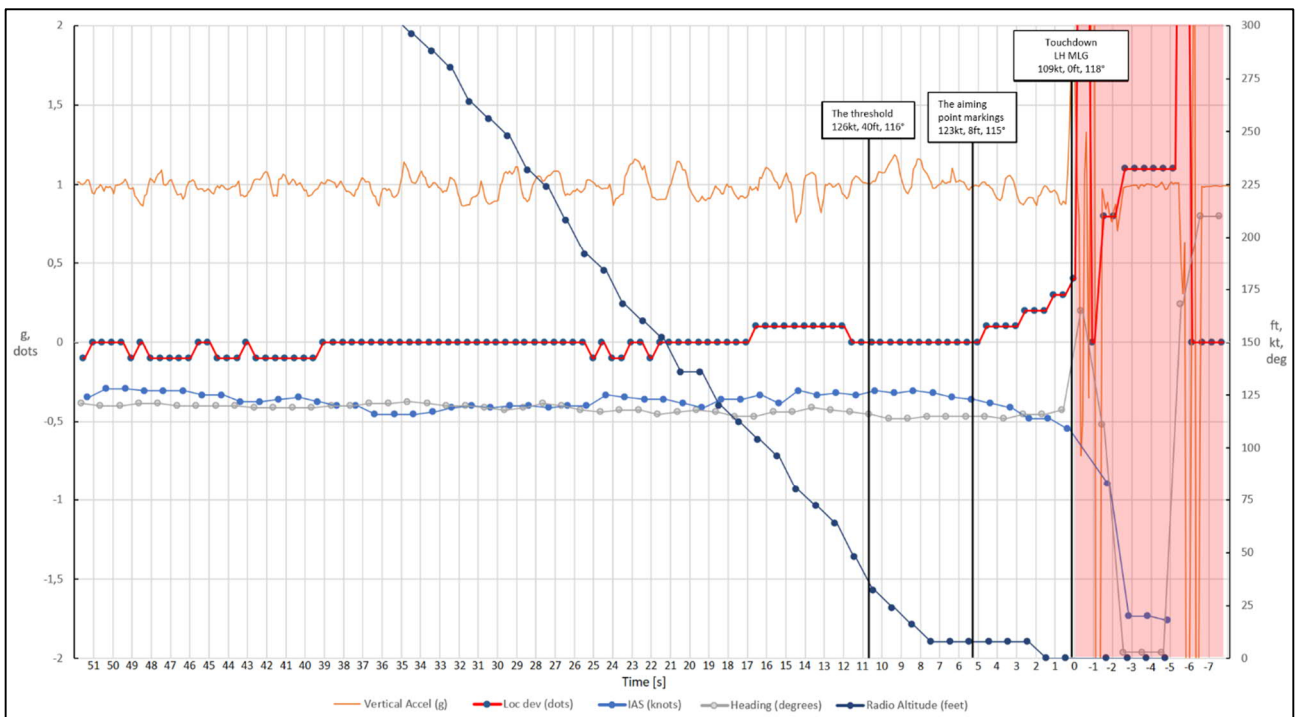
Figure 8. Graphs of the basic parameters during the final phases of the flight, drawn on the basis of FDR data. Owing to defects and noise in the recording, the values in the red zone are not representative. (Image: SIAF)

According to the FDR recording the approach was normal and the aircraft was established on the ILS localiser and glide slope. The recording reveals that airspeed (IAS) on the short final was 10–17 knots higher than the one recommended (110 kt) by the aeroplane operating manual. Over the threshold the airspeed was 126 knots and 123 knots at the touchdown markings, respectively. The aircraft touched down at the airspeed of 109 knots.
