## **Aircraft Incident Report**

B 11/1996 L

# **Aircraft incident at Kajaani airport, Finland 1. October 1996**

DC-9-83 (MD-83)

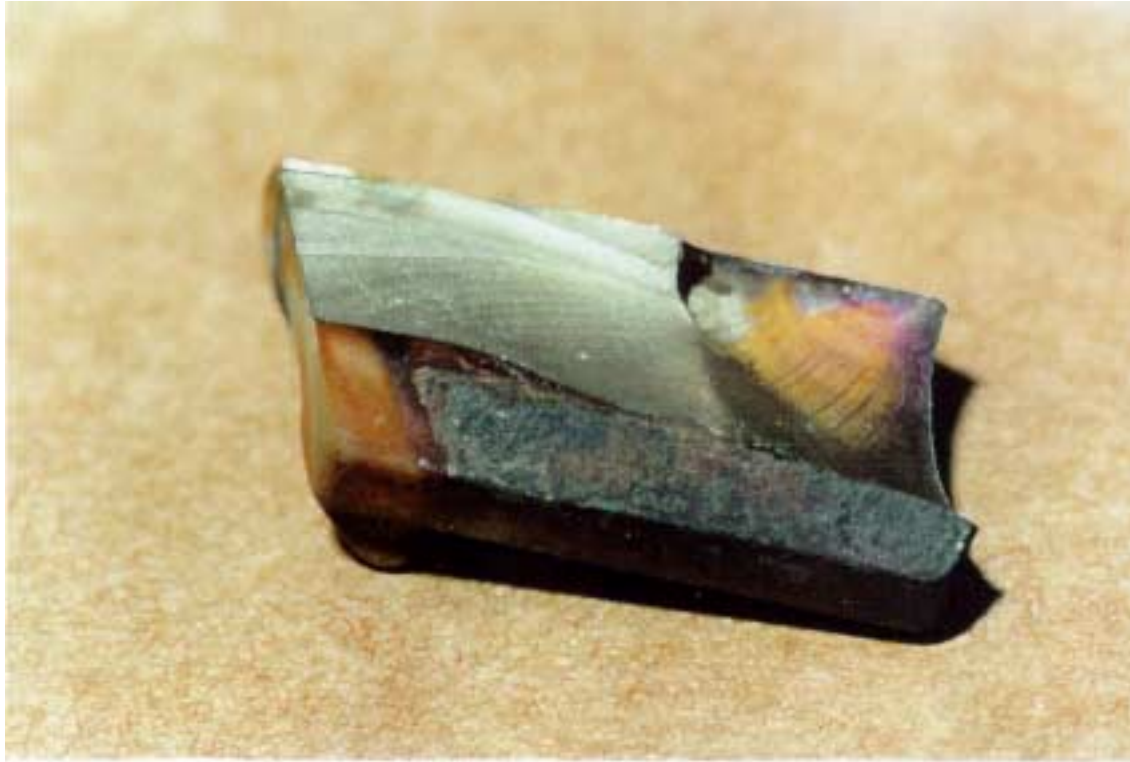
One 8th stage compressor rotor blade (p/n 802 808) had fractured from the root and only the root piece was remaining in the disc. The liberated blade part had caused the compressor damage. The rotor blades were severely damaged in the leading and trailing edges. The blade tips had tom and pieces were missing. Several blade roots had rough surface which looked like corrosion (ref galling). All the 8th stage rotor blades were scrapped (58 pieces).

Figure 1. The failed 8th stage compressor rotor blade root

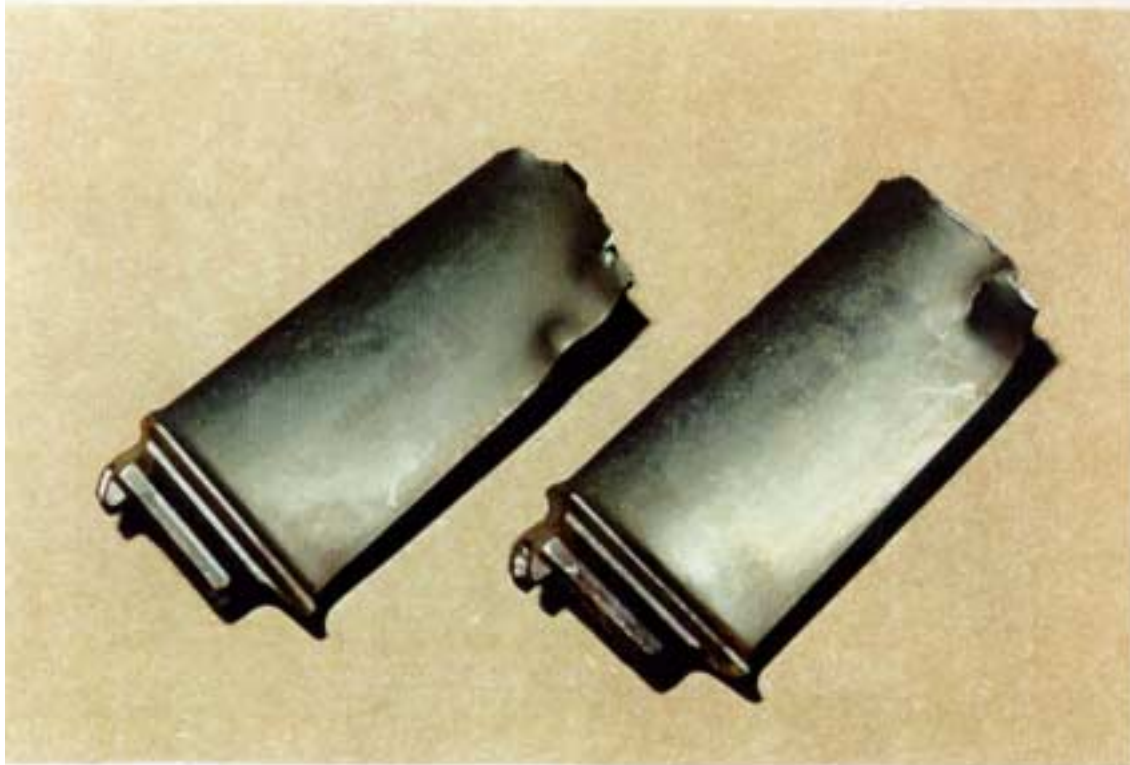
Figure 2. Two of the damaged 8th stage compressor rotor blades

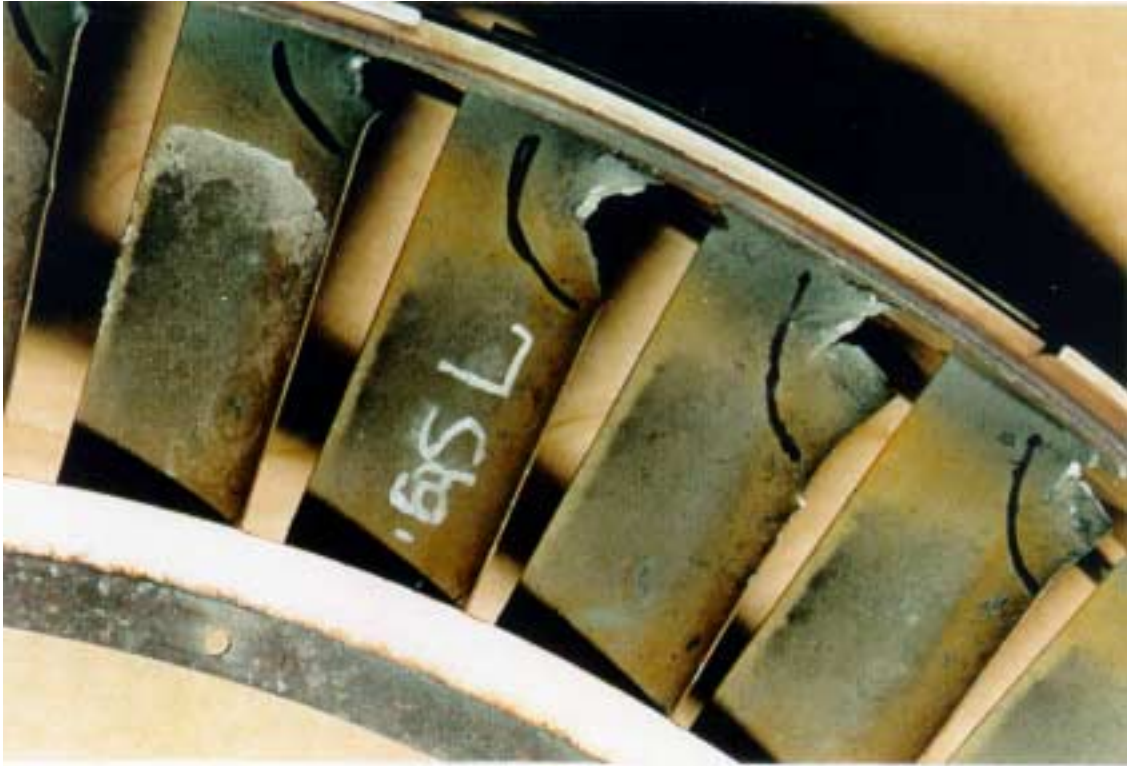
The 7th stage compressor rotor blades were in good condition. Trailing edges of all stator vanes had severely tom in the tip area. Pieces of the vanes had separated but leading edges were in good condition.

Figure 3. Some of the compressor 7th stage stator trailing edge damages

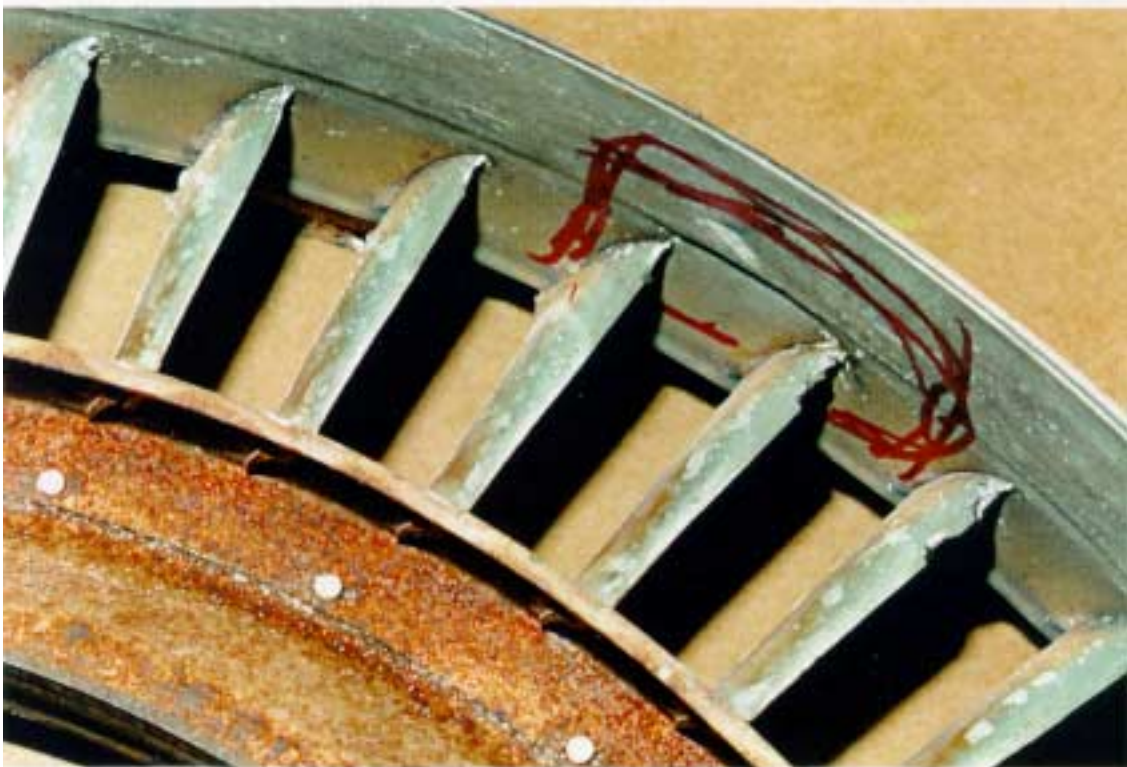
The 8th stage stator vane leading and trailing edges had strikes, nicks, deformations and fractures. Some vane material had separated. The damage was most severe at blade tips. The stator outer shroud had one deep dent, which was also visible on the outer skin of the outer shroud.

Figure 4. Some of the 8th stage stator leading edge damages

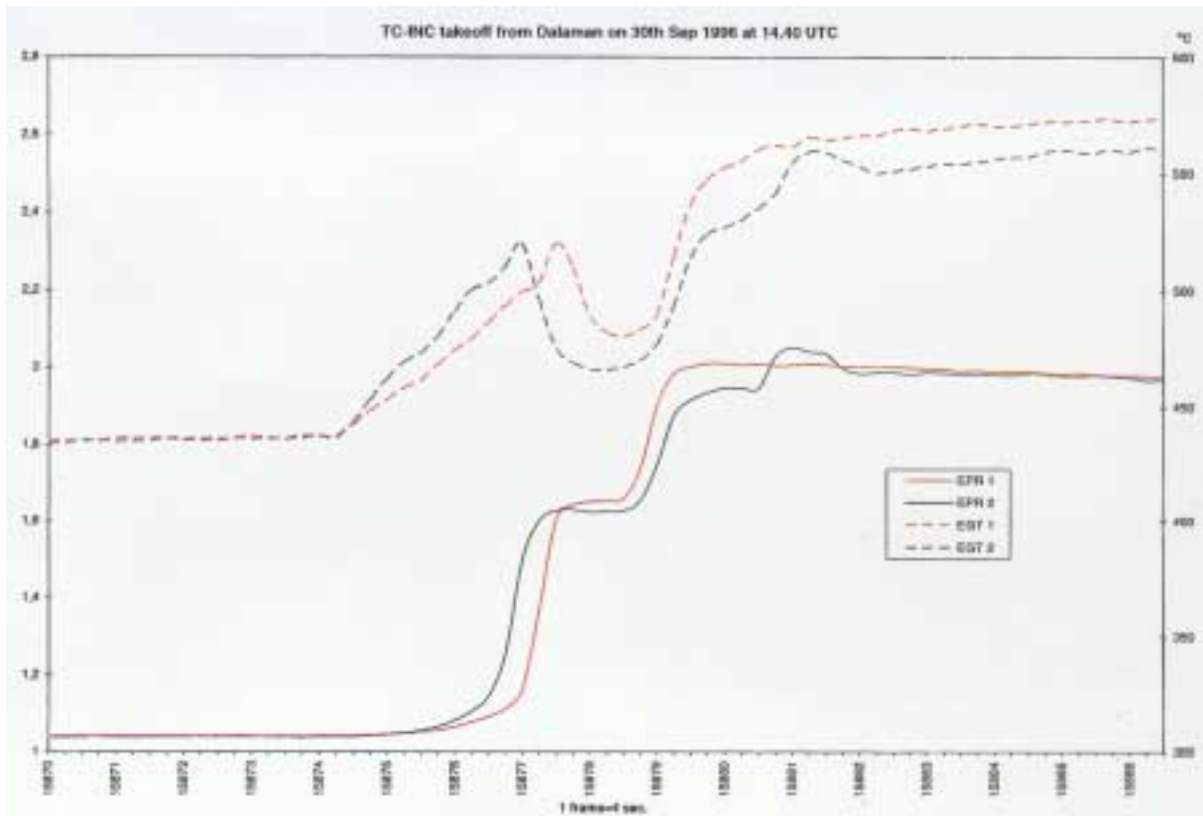
Figure 5. EPR and EGT during the takeoff in Dalaman

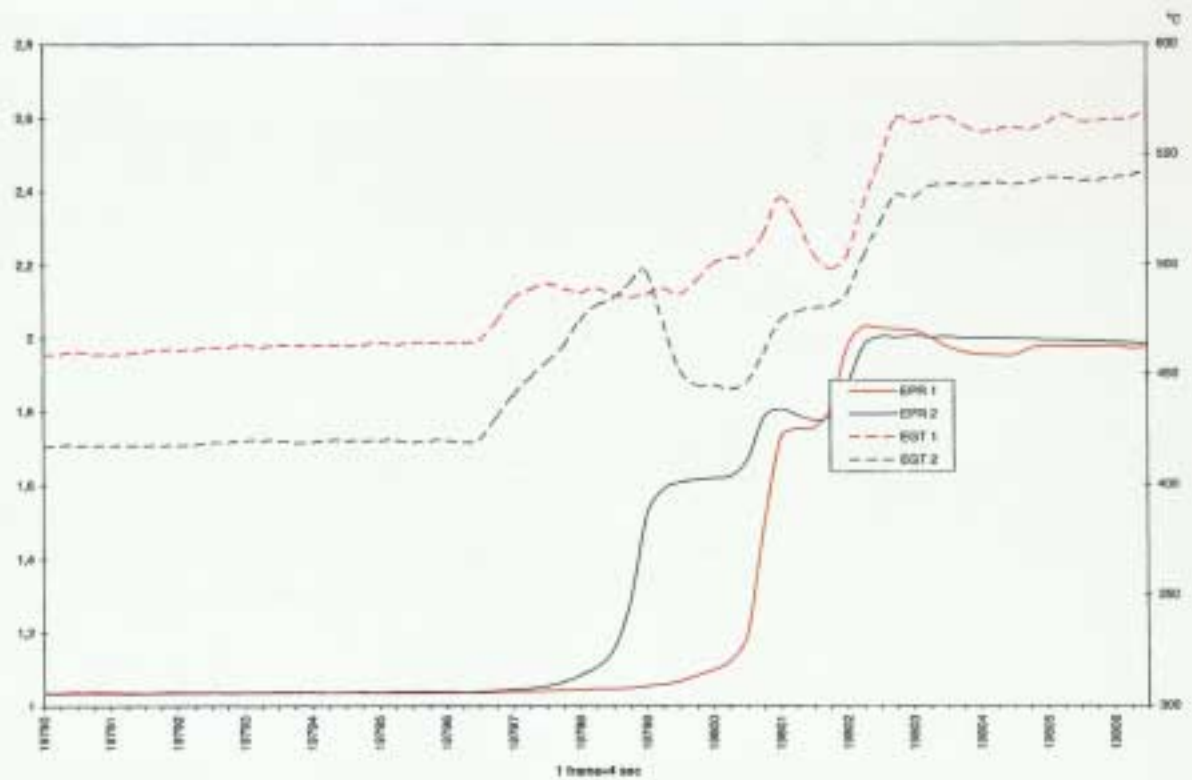
Figure 6. EPR and EGT during the takeoff in Cologne/Bonn

18. It was found out from the UFDR data that when throttles were manually advanced for spool-up in the beginning of the takeoff in Cologne/Bonn, the right engine accelerated normally to 1,6 EPR but the left engine responded slowly. When the throttles were further advanced, both engines accelerated to 1,75 EPR which after the autothrottle was engaged. The left engine accelerated from idle to 1,4 EPR approximately 8 s slower than the right. In Dalaman this difference had been only 2 s. According to the written statement of captain A no abnormalities in the left engine instrument indications were observed during the takeoff, departure and climb from Cologne/Bonn. During the interview in Kajaani the cockpit crew stated that the engine acceleration had been normal during the takeoff in Cologne/Bonn. A difference of 8 s between engine acceleration rates is easily recognizable.

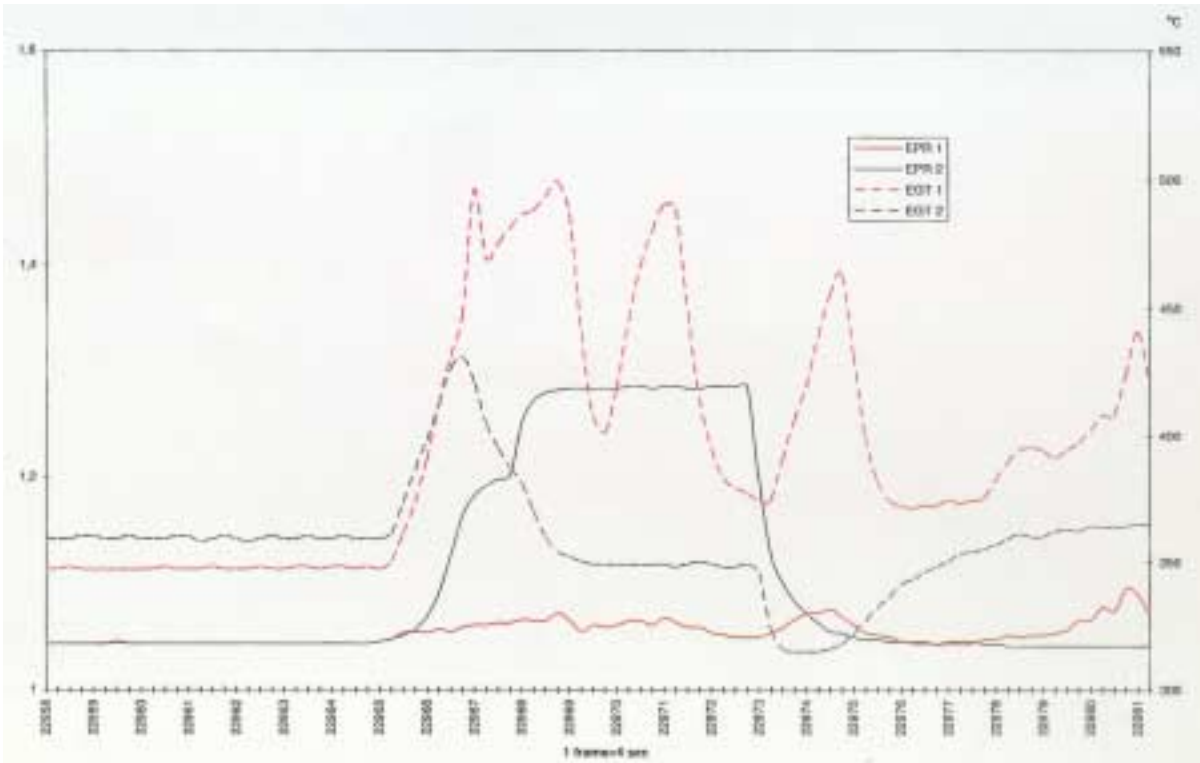
Figure 7. EPR and EGT during the attempted takeoff in Kajaani

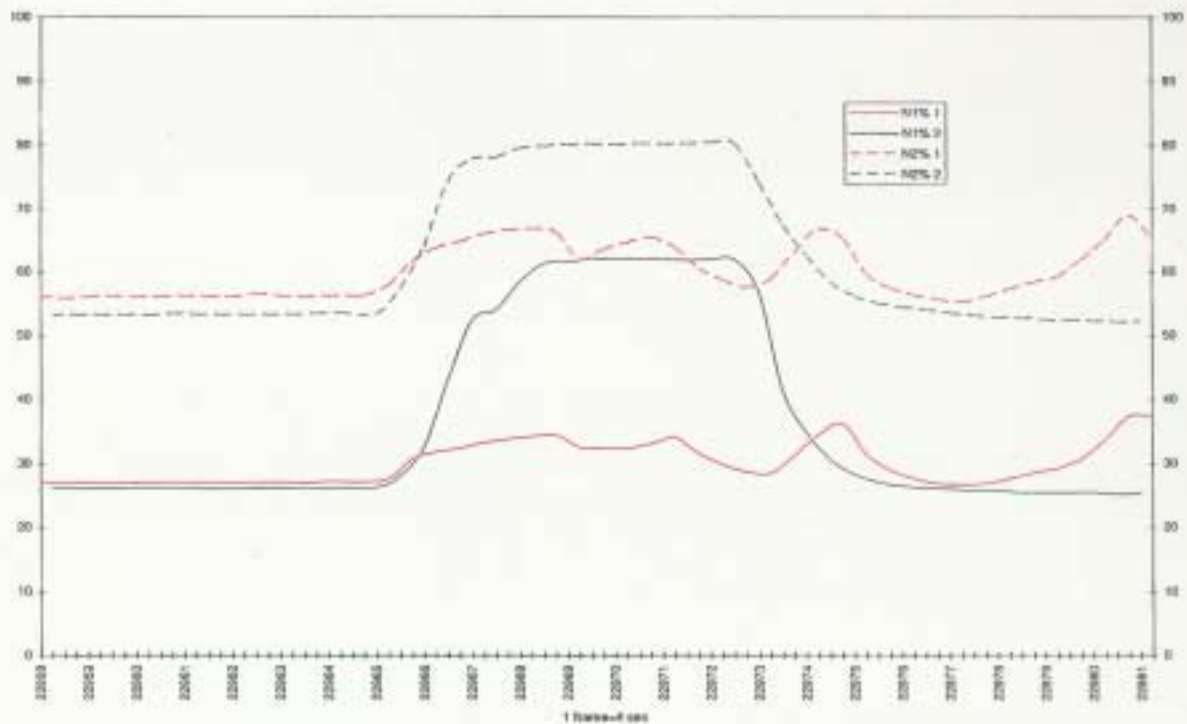
Figure 8. N1 and N2 during the attempted takeoff in Kajaani
