Incident Investigation Report

B 5/1997 L

Aircraft Incident at Joensuu airport, Finland on 11 April 1997

**TC-INC
DC-9-83 (MD-83)**

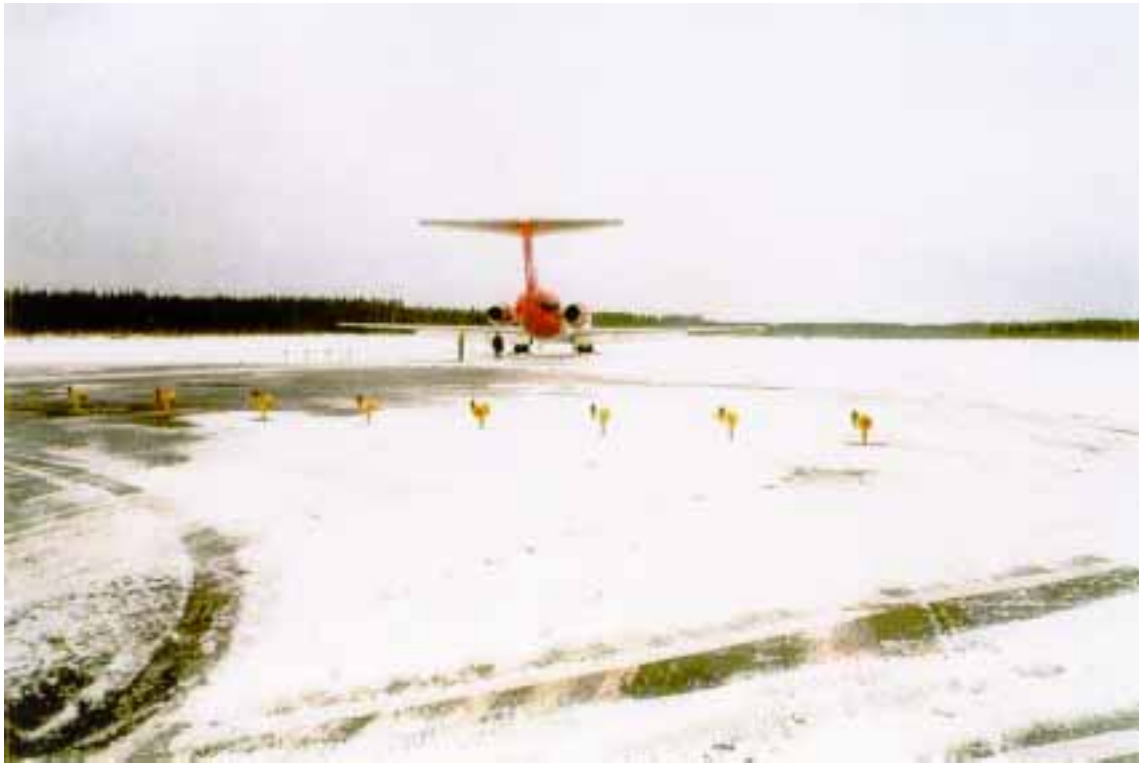
Figure 1. TC-INC 50 m beyond the end of the runway.

The aircraft stopped at 40 m after the end of the runway and the reverser buckets were stowed in 5 s. About 20 s later the captain attempted to taxi the aircraft and increased the engine thrust to nearly take-off thrust settings three times. The aircraft moved three times almost straight ahead for 20 m and came to a final stop at 60 m beyond the end of the runway on a gravel surface covered by 15-20 cm of hard snow, right of the second approach light row for runway 28 on a heading of 094°. The direction of runway 10 is 102°. The attempt to turn and taxi back to the runway was unsuccessful due to skidding of the nose wheel. Flight SWW 1022 had landed at 01.54.

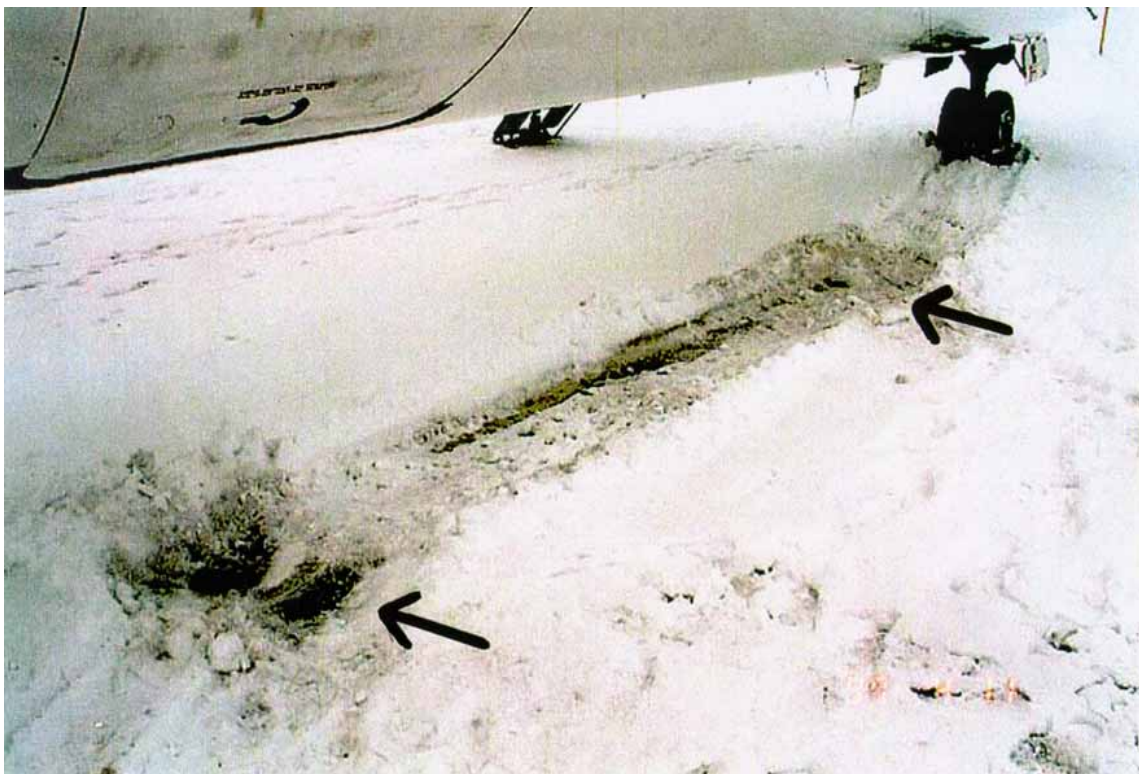
Figure 2. Stopping points on nosewheel track outside the runway.

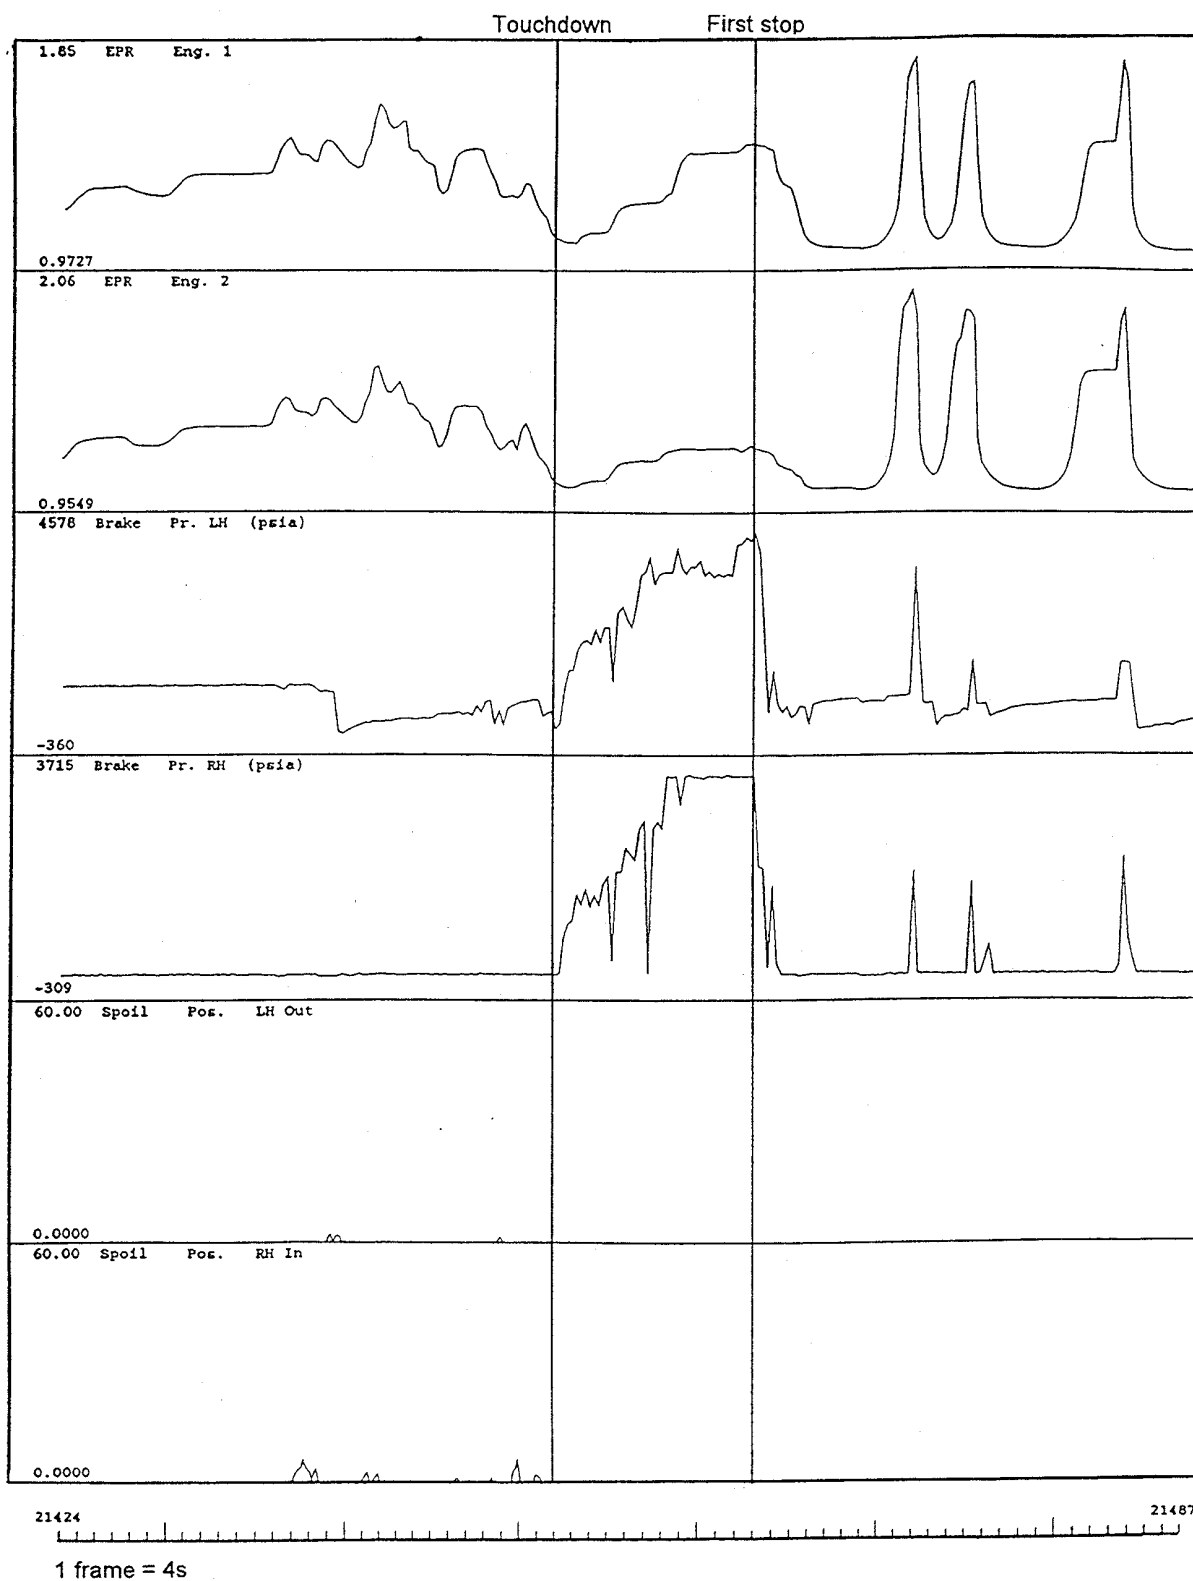
A graph of the most relevant parameters in the final phase of the flight (engine EPRs, wheel brake pressures and spoiler panel angles) are shown in figure 4. Factors contributing to the incident can be found in the graph.

The pilots claimed in the hearings after the incident that the spoiler/speedbrake lever had moved fully back as it normally does as the ground spoilers deploy at touchdown. According to the UFDR data and a passenger observation the spoilers did not deploy at touchdown. The spoilers had worked normally as flight spoilers until touchdown (figure 4) and also as ground spoilers on the previous landing in Jyväskylä. The aircraft manufacturer does not know of any case in the history of DC-9/MD-80 when the spoiler/speedbrake lever would have moved back to EXT position without ground spoiler deployment.

Figure 4. EPR, Brake pressure and spoiler panel position during landing in Joensuu

According to the UFDR data the engine reverse thrust settings during the landing roll were 1.10-1.25 EPR in the left and 1.10-1.22 EPR in the right engine until a speed of 65 kt, which after the settings were 1.24-1.41 EPR and 1.22-1.23 EPR. According to the FCOM reverse thrust of 1.3 EPR should be used on a wet runway. Under emergency conditions, maximum reverse thrust may be used to a complete stop. The captain told the commission and also in his report to the DGCA, Turkey that he applied a reverse thrust of 1.5 EPR after touchdown, increased it to 2.0 EPR and finally used the maximum reverse thrust setting. UFDR data and the captain's statement disagree.
