## Aircraft Incident Report

B 8/1997 L

### ATC incidents near Vihti VOR radio beacon on 25.10.1997 and 20.8.1997, Finland

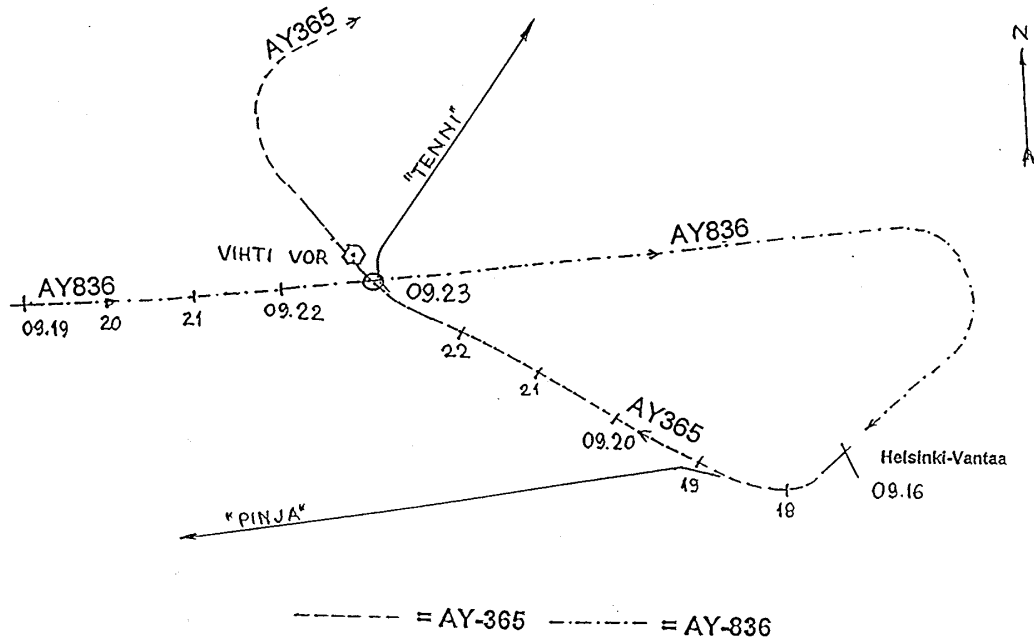
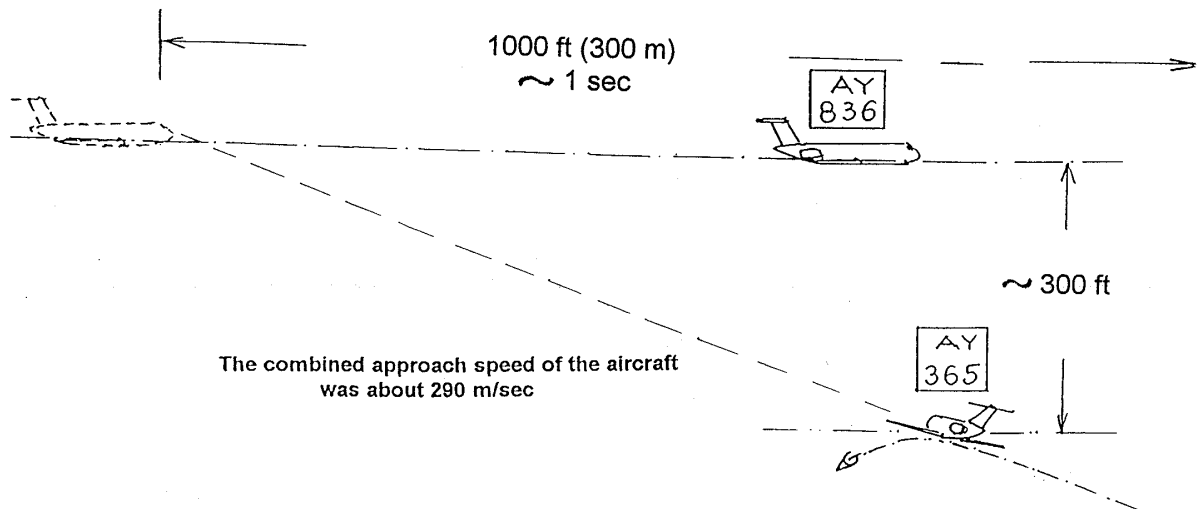
THE INCIDENT BETWEEN AY365 AND AY836 ON OCT 25, 1997  
AT 09.23 UTC

The probable cause of the incident was the partially wrong traffic image of the radar controller, when she thought that AY365 was flying southwest. In reality the aircraft flew northwest following the standard departure route TENNI 1 E via Vihti to Oulu. The controller had the correct traffic information on her radar display and on the strips, but she did not realize the disagreement between the image in her mind and the real information. Neither did she give a clear order to open the ARR control position as she wanted, although it should have been done because of the traffic situation and according to valid instructions.

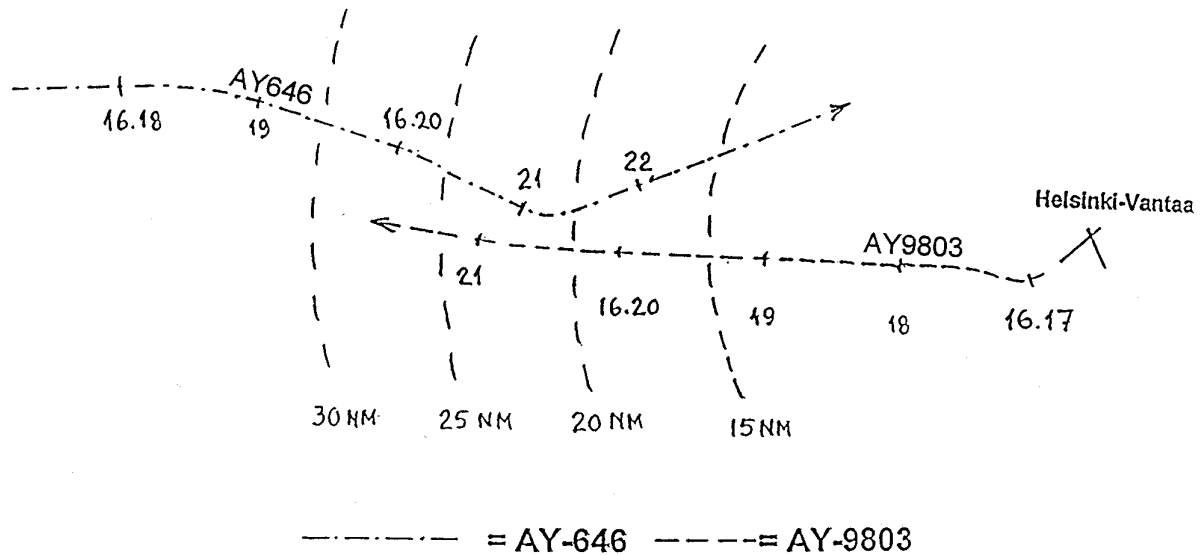
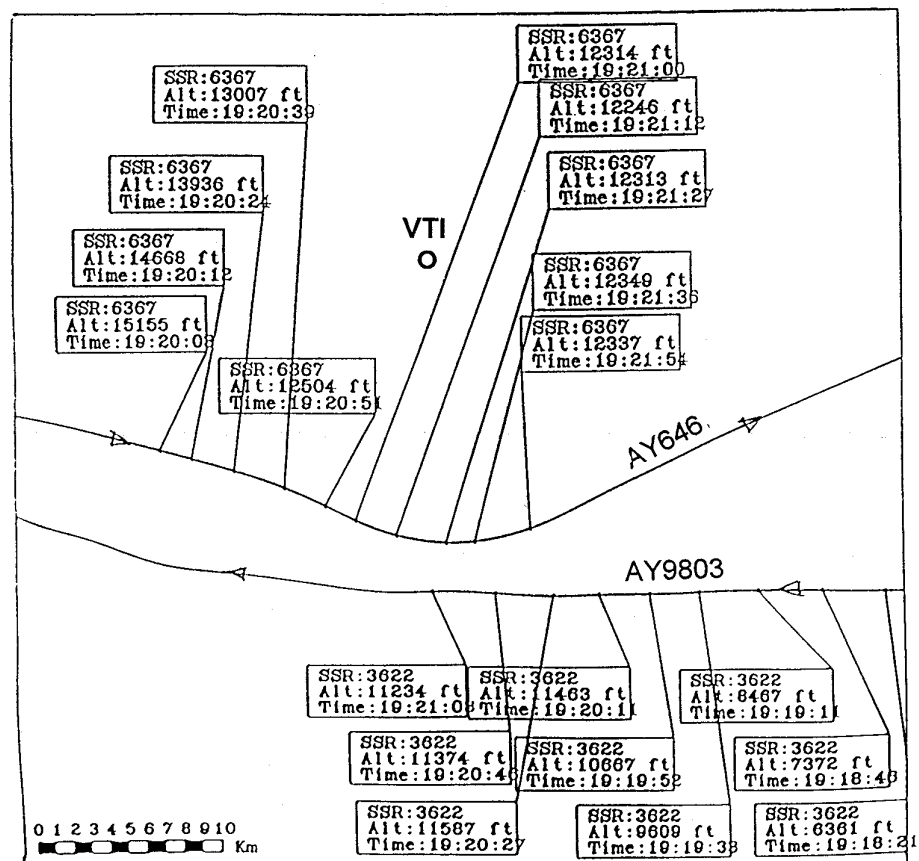
# THE INCIDENT BETWEEN AY646 AND AY9803 ON AUG 20, 1997 AT 16.20-16.21 UTC

The probable cause of the incident was the working practice of the controller in a traffic situation that was difficult to anticipate. A contributing factor was the heading change of AY646, which was greater than requested and approved. In addition, the controller closed the ARR position contrary to current instructions, and then she had to manage alone all air traffic, which was rather heavy and further complicated by the CB front.
