Aircraft incident Report

B 9/1997 L

Aircraft incident at Turku airport, Finland on 30.12.1997

DC-9-41

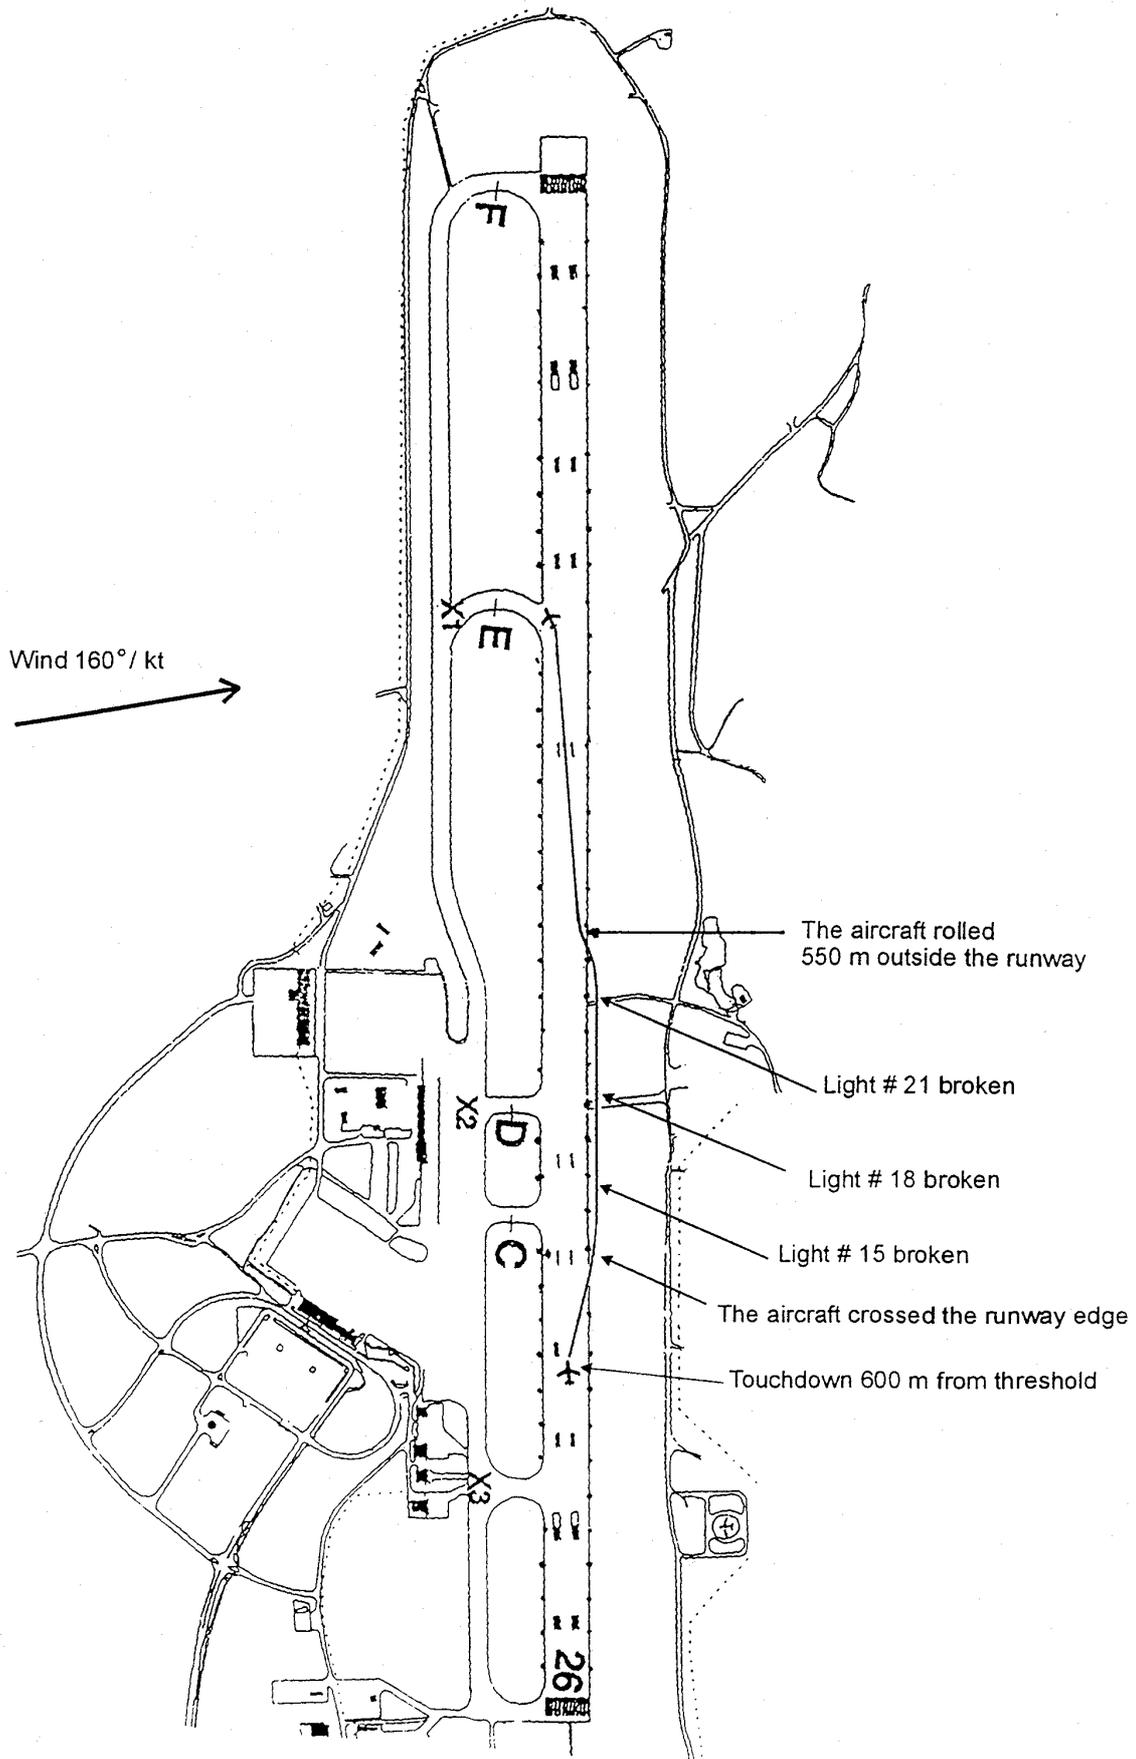
SK-720 TRACKS AT TURKU AIRPORT ON 30.12.1997

The aircraft touched down 600 m after the threshold. The right main landing gear wheels were 12 m inside the right runway edge line and the left gear wheels 13 m right of the centerline. The spoilers extended normally decreasing the lift of the wings. The aircraft touched down with a slight right bank and ran off the right edge of the runway 200 m after touchdown. The tracks of the main wheels could be seen on the snow covered runway and strip. No side slipping could be noticed. The nose wheel track began outside the runway edge.

The captain told that he first selected engine reverse thrust. When he realized that the aircraft had run out of runway he decreased the thrust to idle or possibly selected forward idle. He tried to get the aircraft back to the runway by using rudder control, but his feeling was that the rudder did not respond. He tried to use left wheel brake but even it had no effect, which after the captain selected reverse thrust again. When the speed decreased he was able to get the aircraft back to the runway by using nose wheel steering. The aircraft ran outside the runway for 550 m.

A drawing of the aircraft's track during landing roll can be seen in figure 1.

The left main wheels and nose wheels ran on asphalt all the time but the right main wheels ran partly on grass. The aircraft stopped on the runway 1800 m after the threshold, at taxiway E intersection. The strip outside the runway was covered by 10-20 cm of wet snow and slush. The slush spray damaged the aircraft slightly.
