Investigation report

C 24/1998 L

Risk of collision between two airliners southwest of Vihti VOR, Finland on 9 October 1998

OO-DHW, B727-223F

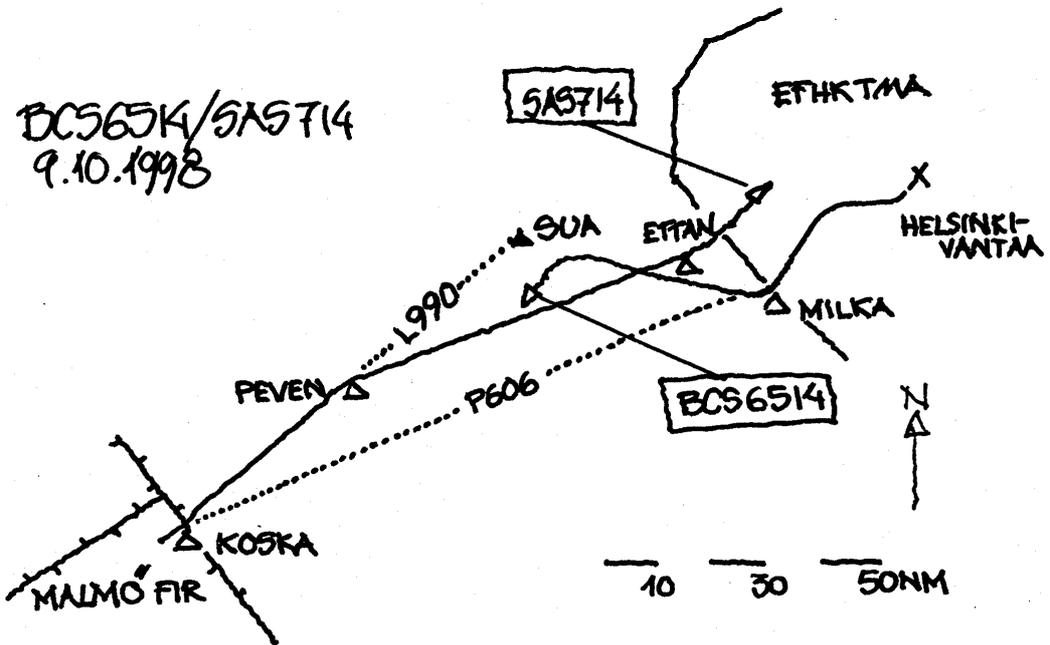
The aircraft passed each other on intersecting flight paths, by a horizontal distance of about 1 km and a vertical distance of 400 ft, so that the required minimum separation was lost. The incident occurred 50 NM west of Helsinki at an altitude of 6250 m.

Figure 1. The flight paths and flight altitudes of the aircraft intersected at the same point on airway T6.

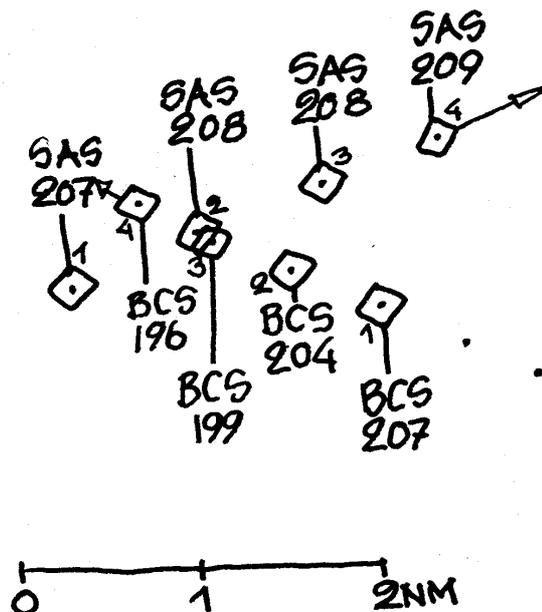
TUTKAN KORKEUSTIETO KOHTAUSTILANTEESTA
(PIIRRETTY VIDEOTALLENTTEESTA)

Figure 2. Radar altitude information at the time of intersection.
