Aircraft incident report

B 3/1999 L

Aircraft incident at Vaasa airport, Finland on 16 August 1999

SE-LIN, FOKKER 50

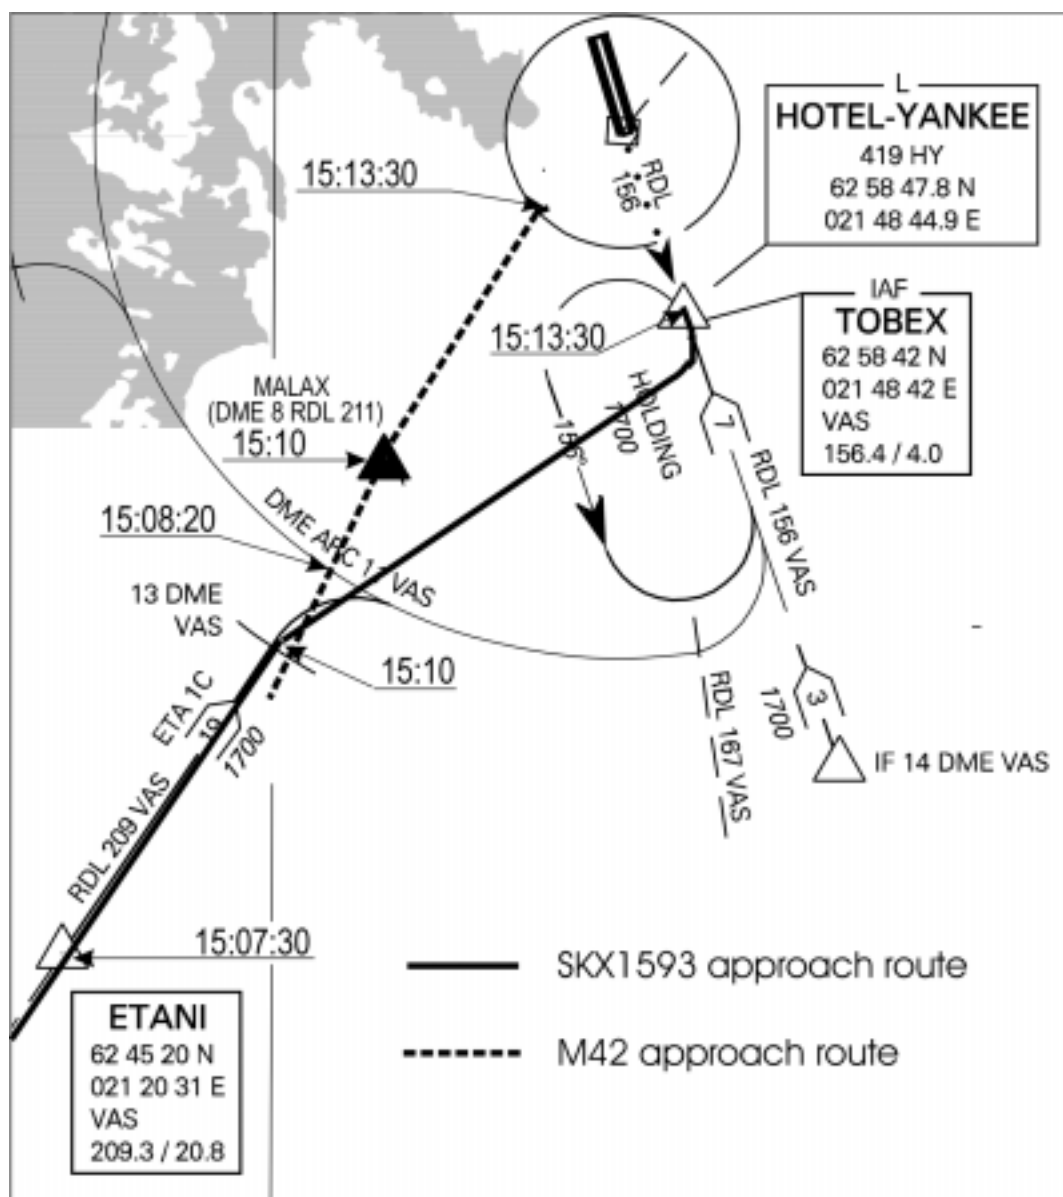
Picture 1 The approach routes of the aircraft

The approach routes of the aircraft are shown in picture 1.

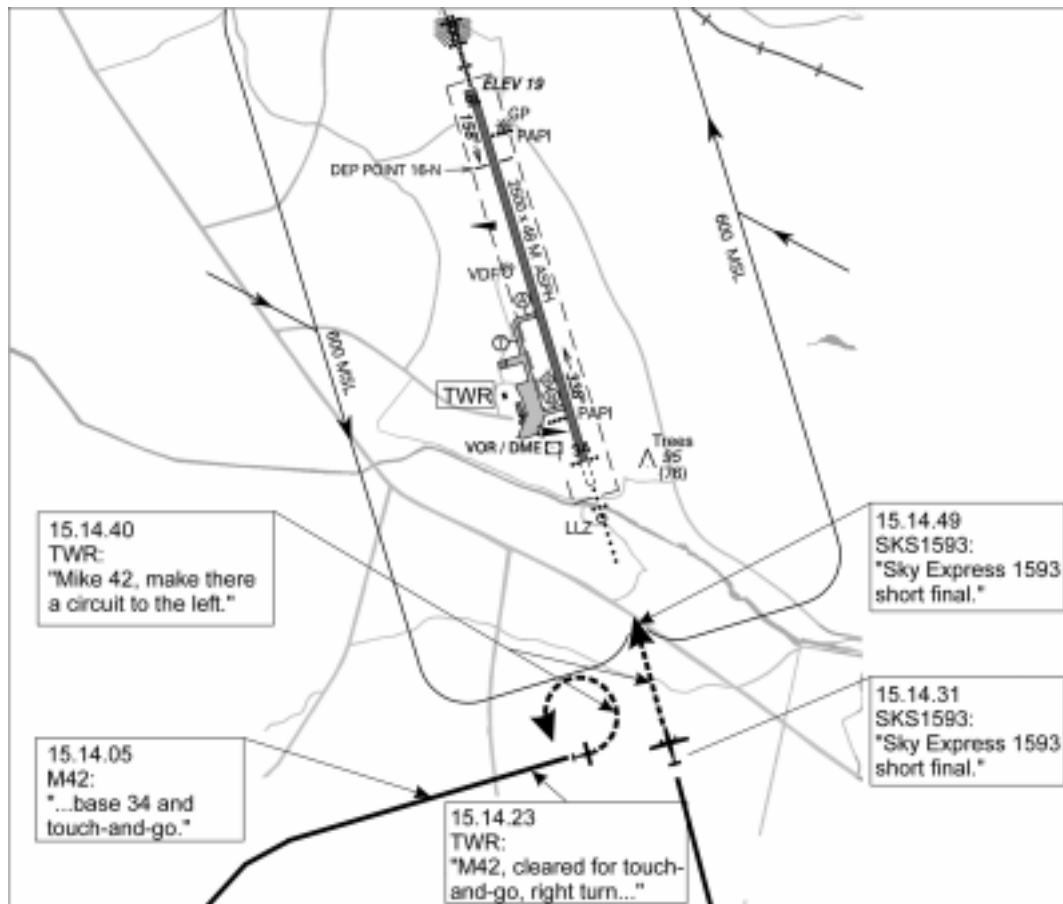
Picture 2 Flight paths of the aircraft on final to runway 34

After receiving the touch-and-go clearance the M 42 pilot concentrated on turning to final approach leg. As he was not informed about the other traffic, he could not particularly look out for the airliner approaching from the right. After starting the left turn he saw the other aircraft flashing by below the nose of his aircraft as a dark figure, which he instinctively avoided by pulling the control stick. The aircraft turn steepened and the altitude increased. As the trainee pilot had rather little flight experience, the commission considers it possible that the actual technique of flying required quite a lot of his capacity. For this reason he may not have paid sufficient attention to the lookout and radio traffic not directly concerning his own flight. M 42 made two orbits to the left as ordered by the controller, but the pilot did not acknowledge the clearances. This had no effect on the course of events, but forgetting to acknowledge the clearances may indicate that the pilot was totally concentrated on controlling the aircraft.

The flight paths of the aircraft are shown in picture 2.
