Investigation report

B 4/1999 L

Landing gear malfunction of a HS 125-700B aircraft and landing at Helsinki-Vantaa airport on 3 September 1999

OH-JET

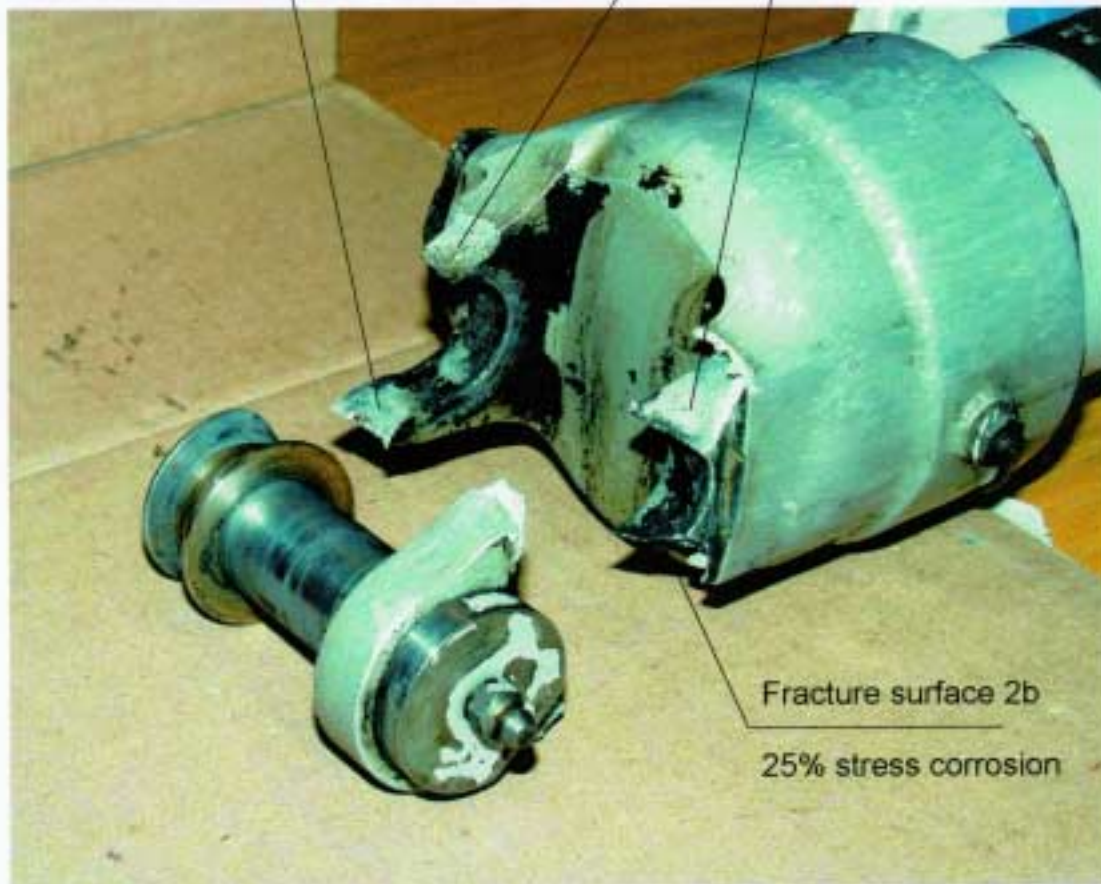
The first fracture had occurred on surface 1b of lug No. 1 (90% of stress corrosion cracking and 10% of ductile fracture caused by metal overloading). Surface 1b may have fractured entirely during the previous flight already. The fracture surface is not easily detected when the hydraulic cylinder is in place.

When the crew tried to extend the landing gear on the incident flight, the load needed to open the gear up-lock caused lug No. 1 to break. As the other lug was also deteriorated (25% of stress corrosion cracking on both fracture surfaces), it did not bear the unequal torsional load, but broke before the gear up-lock opened. Thereafter the cylinder head moved freely, and the gear up-lock could not be opened with the normal or alternative system.

Fracture surface 1b

90% stress corros.
10% ductile fracture

Fracture surface 1a

50% stress corros.

Fracture surface 2a

25% stress corrosion

Fracture surface 2b

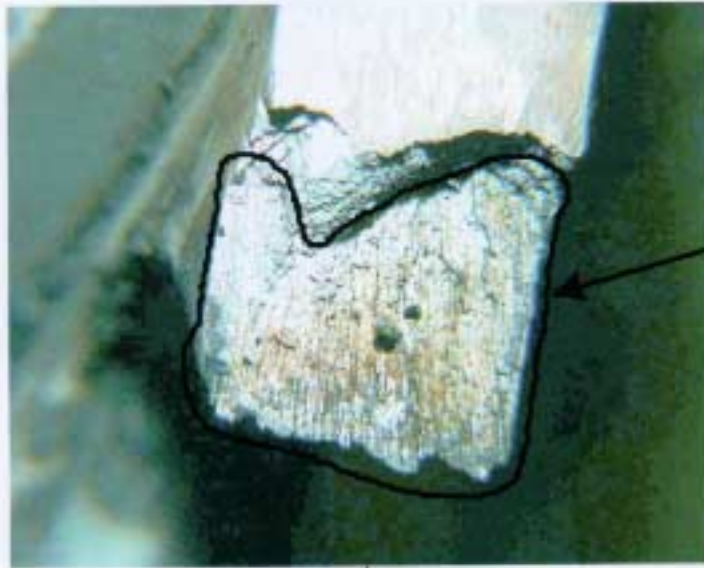
Fracture surface 1a.
50% of the fracture is
caused by stress corrosion.

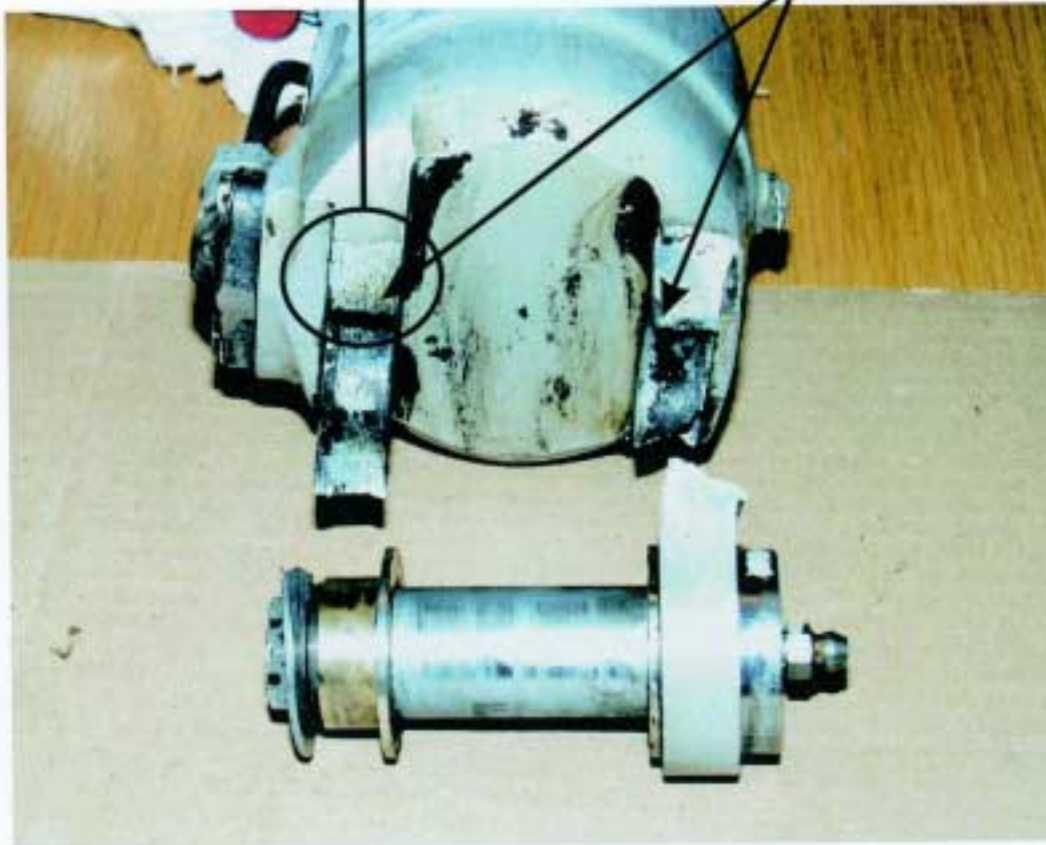
Examination of the fracture surfaces with a scanning electron microscope showed that the fibrous area (the area adjacent to the hole) was mainly grain boundary fracture caused by stress corrosion, while the uneven area bordered to the outer surface had an appearance typical of a ductile fracture, resulting from overloading. When a 10-fold magnification was used, corrosion pits and numerous cracks could be seen on the inner surface of the lug hole. The grain boundary fractures caused by stress corrosion had originated at the inner surface of the lug, gradually reducing the undamaged cross-section of the lug. Stress corrosion is accelerated by moisture in the air and chlorides (e.g. marine climate). However, when the lug was inspected from outside, no indication of deformation or crack could be found. The age of cracks caused by stress corrosion could not be determined, but they have probably originated for a long time past, even years ago.

The landing gear malfunction was caused by fractures in hydraulic cylinder lugs, which had originated on the inner surface of the lugs. The fractures resulted from stress corrosion.

The stress corrosion cracks
emerge from the inner side of
the lugs and move outward.

The investigation commission is of the opinion that the hydraulic cylinder should be taken out and the bearing bushing removed in the inspection, which would allow any corrosion pits and cracks on the inner surface to be detected using e.g. 10-fold magnification.
