Aircraft incident report

C 16/1999 L

Aircraft Incident at Lappeenranta TMA, Finland on 29 July 1999

OH-FAF, Saab 340B

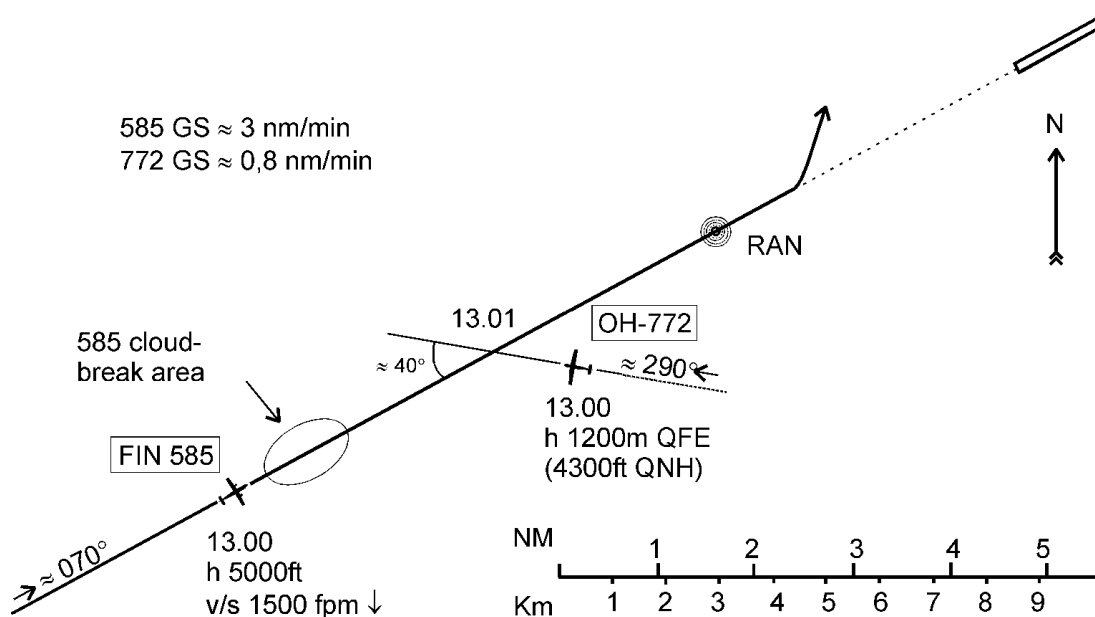
In the figure below are described the probable sequence of events and the reciprocal positions of the aircraft.

The incident took place approximately 11 km south-west from Lappeenranta airport on the extended centreline of runway 06 at an altitude of 4000 feet (1200 m).

Finnair 585 was approaching locator RAN in accordance with the clearance and was preparing for a right hand circuit and visual approach to runway 24, when the pilots observed a glider. It was on their fore right side at a distance of 200 metres and almost at the same altitude of 4000 feet. The glider was on intersecting flight path, heading west-

north-west. To avoid collision, the captain of Finnair 585 disconnected the autopilot and made an immediate evasive action by pulling the aircraft to climb. The distance between the aircraft at the moment of passing was about 100 metres according to what they reported. Finnair 585 immediately reported the incident to ATC. In spite of having received misleading traffic information, the crew of Finnair 585 maintained a sharp lookout and could thus avoid the risk of collision.
