Investigation report

C 22/1999 L

Aircraft incident during approach to Lappeenranta, Finland on 29 November 1999

SAAB 340A

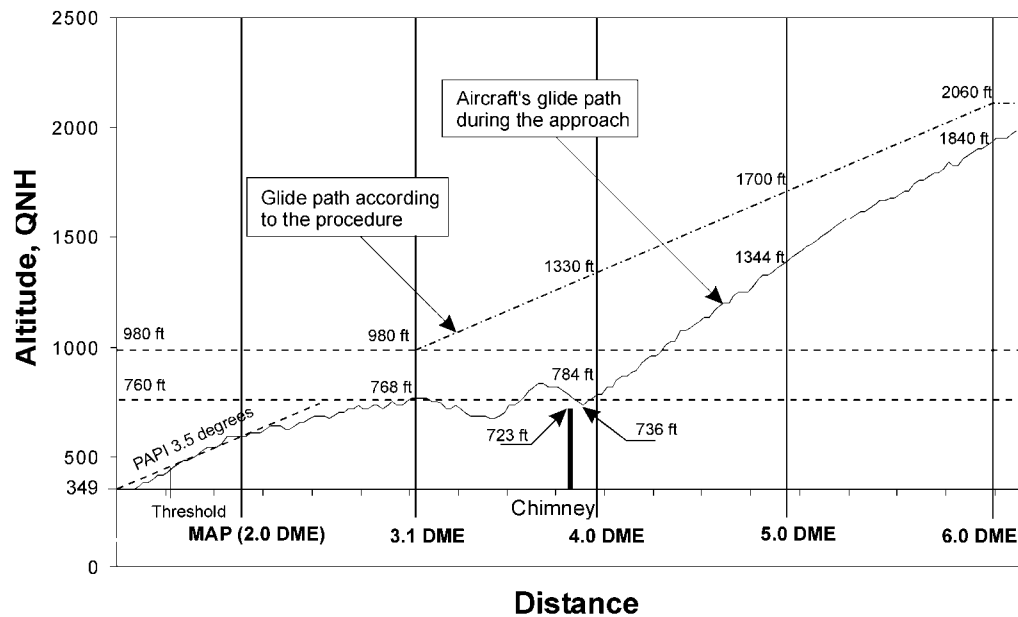
Picture 1. Altitude of the aircraft during the approach compared to the distance. The altitude information is from the FDR.

onds. At the lowest point the aircraft's altitude was 736 feet and during the avoiding manoeuvre the aircraft climbed to 832 feet. The chimney, which the aircraft avoided, reaches to 723 feet.

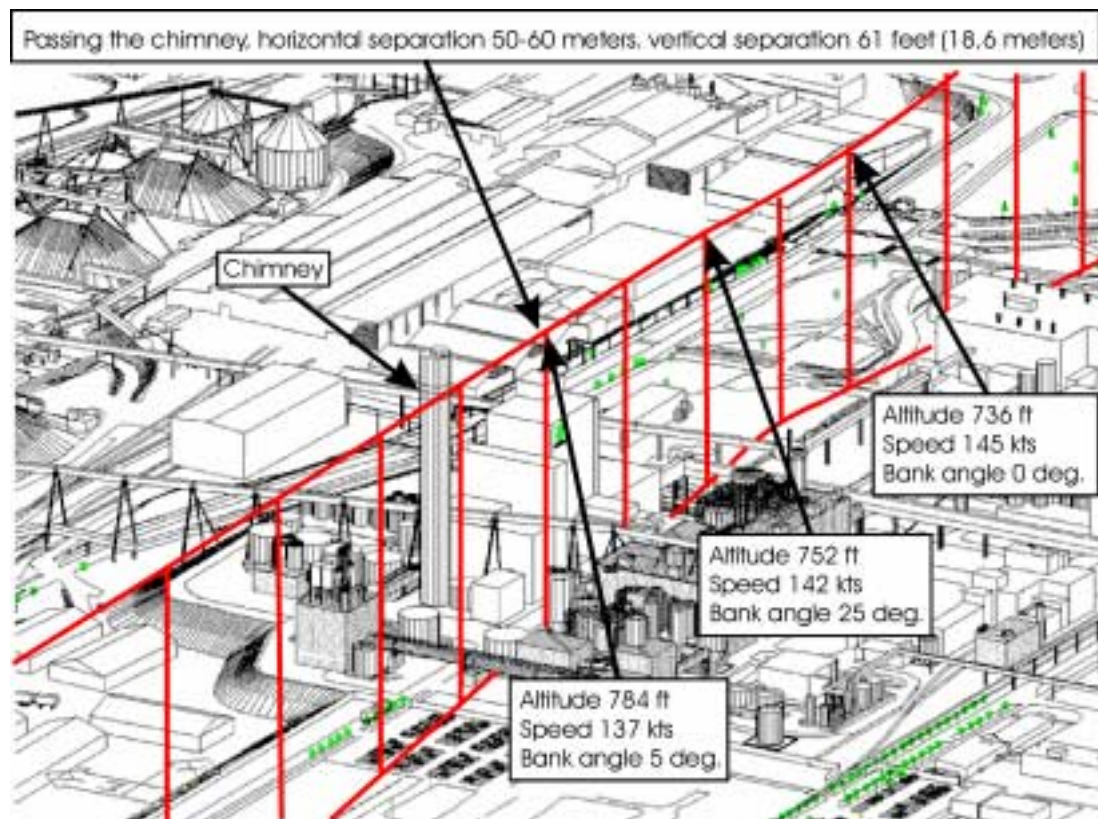
Picture 2. Picture of the flight path of the aircraft near the chimney (the aircraft is flying from right to left). The minimum altitude in the picture area is 980 feet.

16. The co-pilot told that according to his judgement they were clearly above the chimney when he saw the hazard lights.
17. During the avoiding manoeuvre the lowest altitude was 736 feet. The chimney reaches to 723 feet.

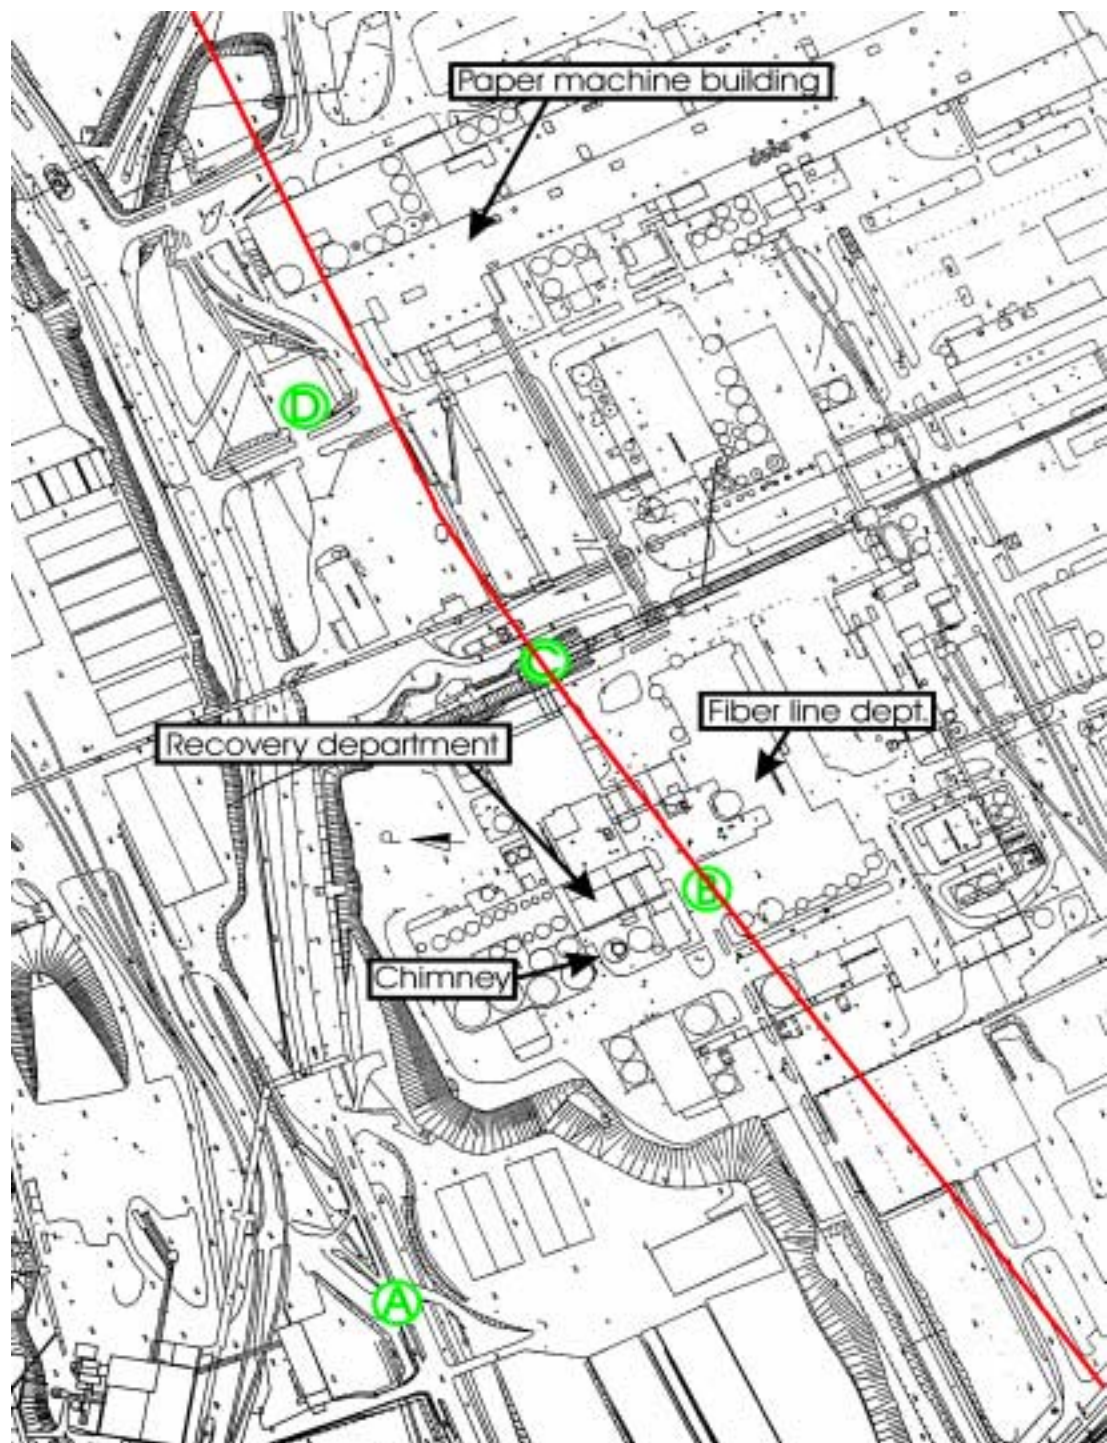
Picture 3. The locations of the eyewitnesses and the flight path of the aircraft over the paper mill area.

Eyewitness A was sitting in his car near the western gate to the Kaukas paper mill area when he observed a low flying aircraft in north-easterly direction. He stopped the car and saw an aircraft passing south of the chimney. In his opinion the aircraft was approximately 20 meters below the top of the chimney. The distance between the chimney and the eyewitness was approximately 400 meters. According to him the aircraft turned to the left to avoid collision with the chimney and the maximum bank angle was approximately 40 degrees. The aircraft levelled off and continued level flight towards the aerodrome after passing the chimney. After examining the sight angles it can be concluded that if the aircraft was flying approximately 60 meters behind the chimney, from the eyewitness' point of view it would appear to be below the top of the chimney although it actually was about 15 meters above.

Eyewitness B was standing on the road between the recovery department and the fiber line department. The aircraft had passed straight over her at a low altitude. She saw the aircraft banked to the left and estimated that the aircraft turned approximately 30 degrees to the left. She also saw light from the cabin windows. According to this statement,

the aircraft cannot have passed south of the eyewitness. She could not estimate the altitude of the aircraft.

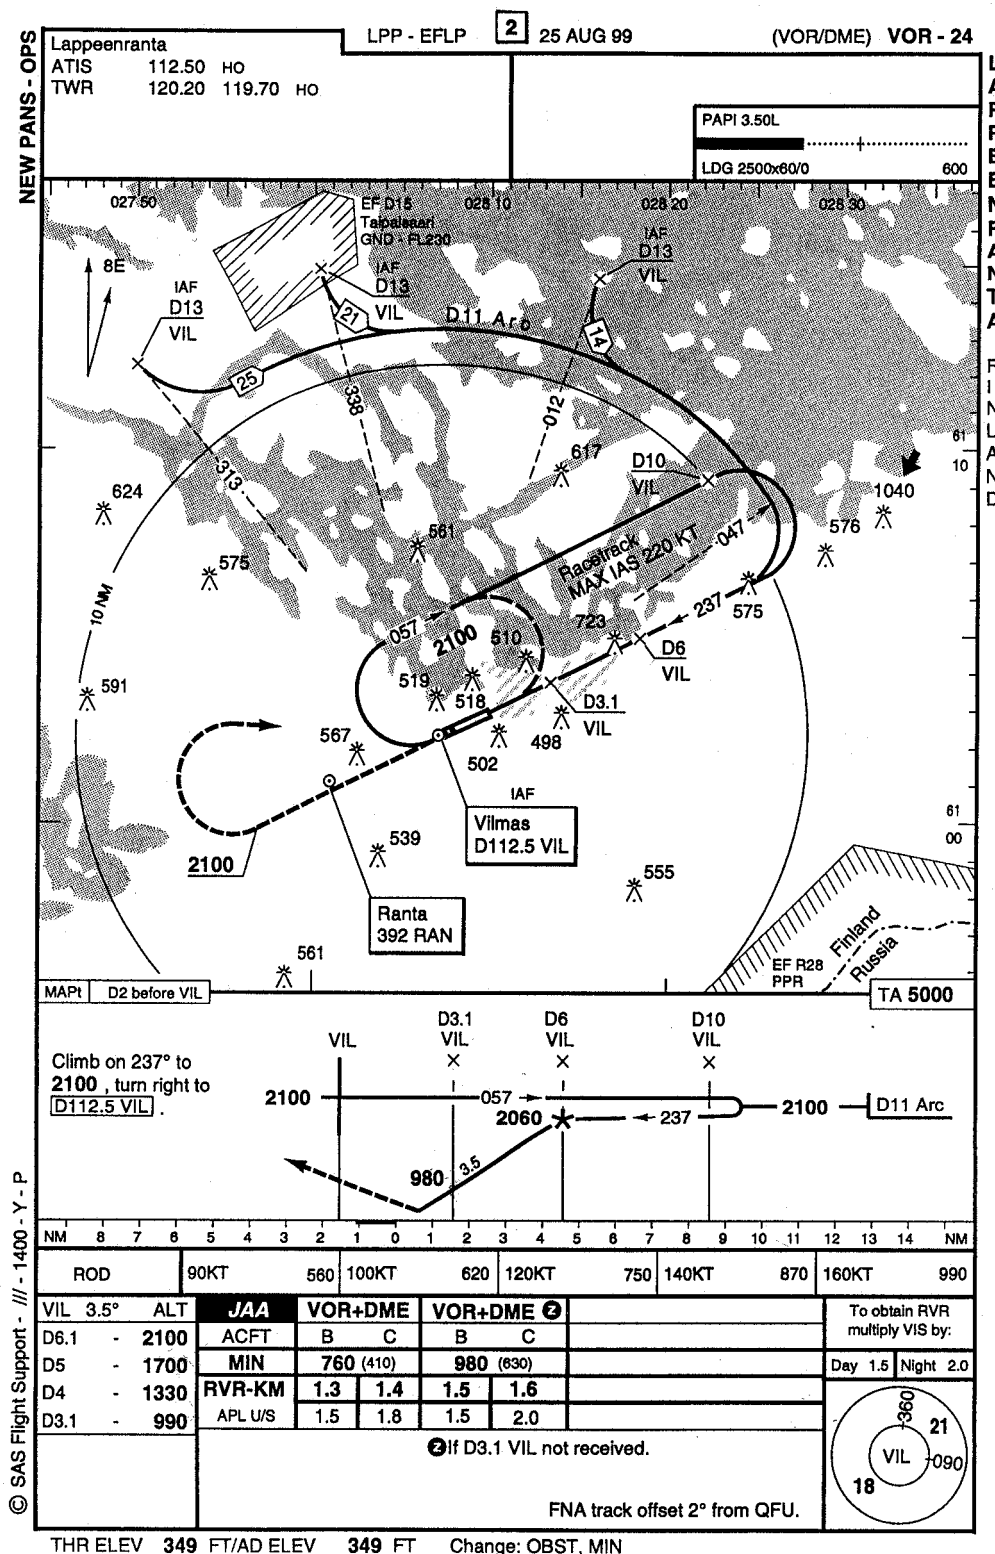
Picture 4. Lappeenranta VOR/DME 24 instrument approach chart published by SAS Flight Support AB. Reproduced with premission of SAS.

In the instrument approach chart (IAC) used by GA the chimney is located in the approach sector at approximately 5,3 DME. The correct location of the chimney as shown on the obstacle chart published by the CAA Finland is approximately 3,9 DME. The exact coordinates for the chimney, according to a database of the CAA Finland, are 61° 03' 56,42" N ja 28° 14' 33,5" E. Thus in the IAC published by SAS Flight Support AB the chimney is located approximately 2600 meters (1,4 nautical miles) further away from the runway threshold than in the obstacle chart published by the CAA Finland.

In charts published by SAS Flight Support AB all symbols for obstacle lights are alike, as in ICAO Annex 4. In the equivalent chart published by Jeppesen the high intensity obstacle lights are marked with an arrow and a text "Hazard beacon". In charts published in the AIP, Finland high and low intensity obstacle lights have different symbols.

4. SAS Flight Support AB should react more quickly to faulty information on their charts. The investigators also recommend that SAS Flight Support AB should consider marking the existing white flashing obstacle lights on their instrument approach charts in accordance with the Finnish AIP.

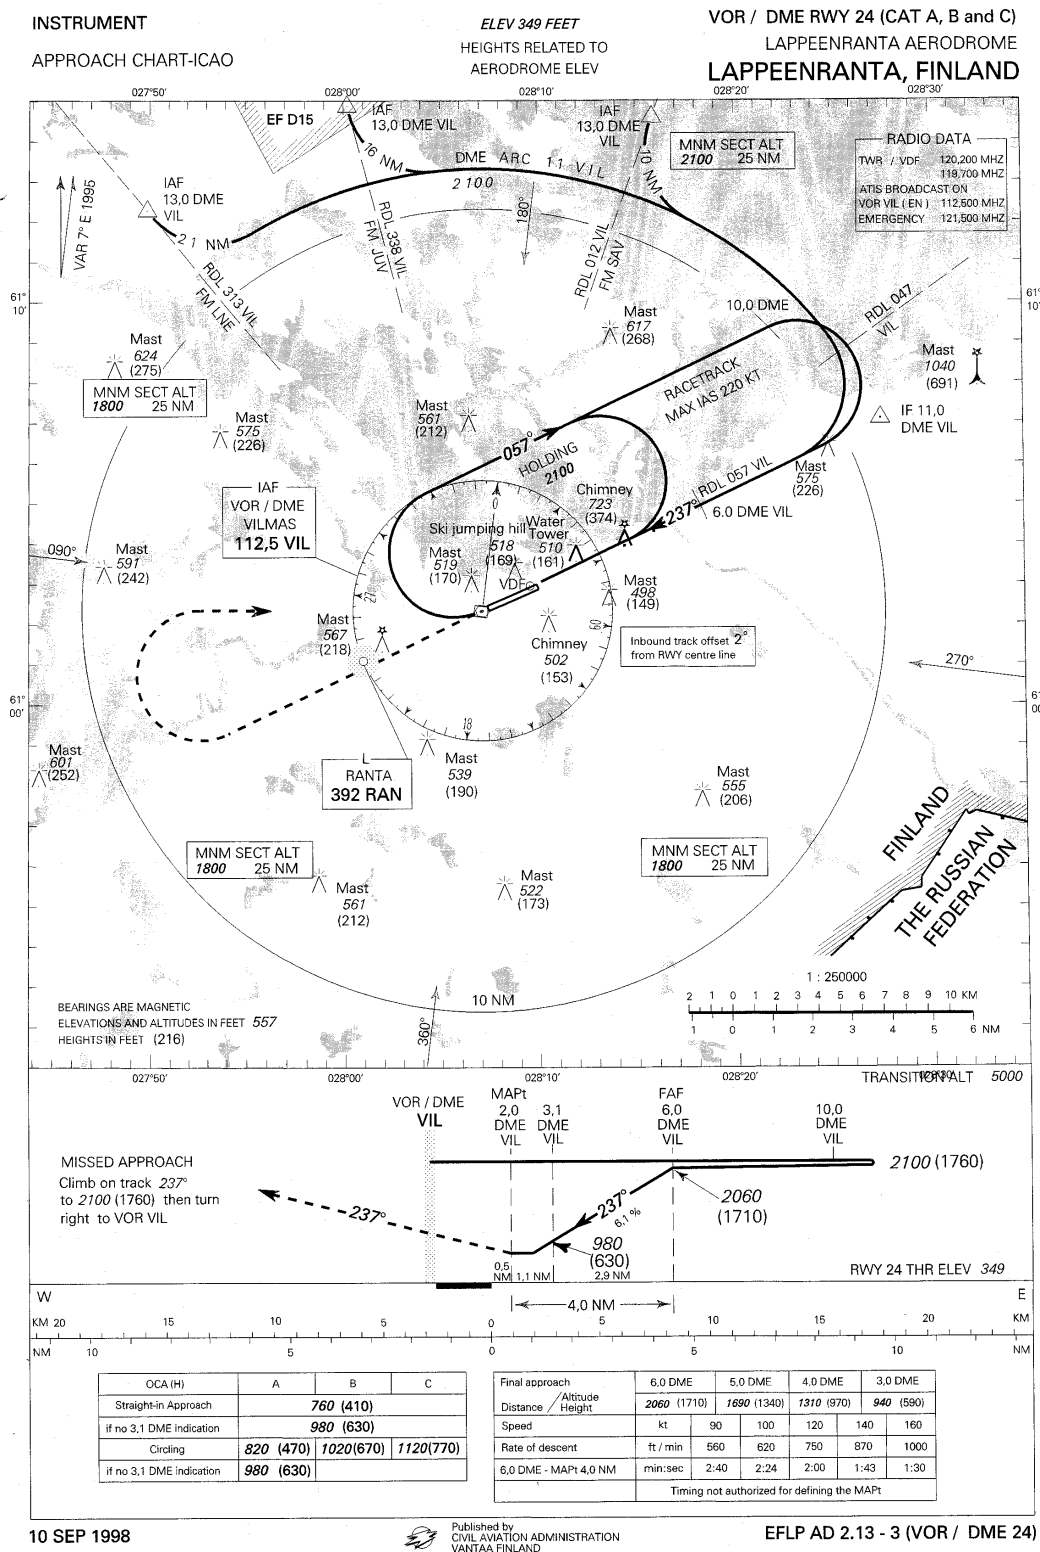
Picture 6. Lappeenranta VOR/DME 24 instrument approach chart published by CAA Finland. Reproduced with permission of CAA Finland

The inbound track for the VOR/DME approach to runway 24 is 237 degrees (radial 237 degrees). The descent starts at 2060 feet after reaching 6,0 DME. Minimum descent altitude (MDA) is 760 feet. In addition, there is an altitude restriction of 980 feet before reaching 3,1 DME. The missed approach point (MAPt) is at 2,0 DME. If 3,1 DME indication is not received then the MDA is 980 feet. See pictures 4, 5 and 6.
