## **Incident report**

B 3/2000 L

# **Engine damage at Helsinki-Vantaa Airport on 17th October, 2000**

OO-SSH  
Airbus A319

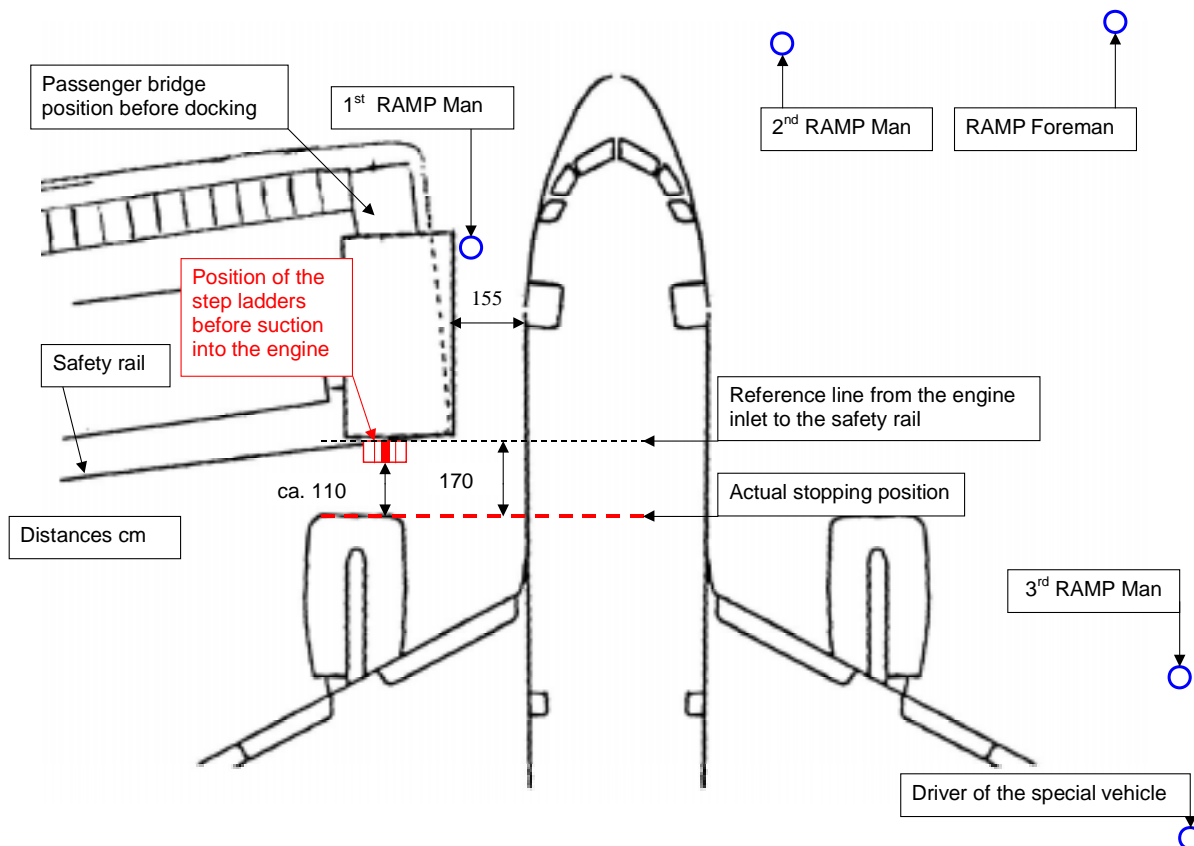
First Ramp man in the group preparing for attaching external power unit positioned on the left hand side of aircraft arriving to the stand had approximately 1 minute in order to make observations of arrangements at the apron area. He observed wrongly positioned maintenance stepladder just before aircraft had come to a complete stop at the stand. Aircraft stand is equipped with an emergency stop switch in connection with the APIS system operated at apron, however first RAMP man had at that time no realistic possibility to prevent the engine damage to occur. He had not been instructed to operate the emergency stop switch.

Also second RAMP man positioned on the right hand side of aircraft preparing to install the wheel chocks observed the maintenance stepladder next to safety rail, but too late. He observed them in an upright position in front of left engine and could see the upper part leaning towards the engine and get sucked into it. Parts of the stepladder flew from the front part of the engine and sparkles and smoke appeared from the rear end.

Picture 2. The parking of OO-SSH and the positions of RAMP group member's prior the maintenance stepladder is sucked into left engine of the aircraft

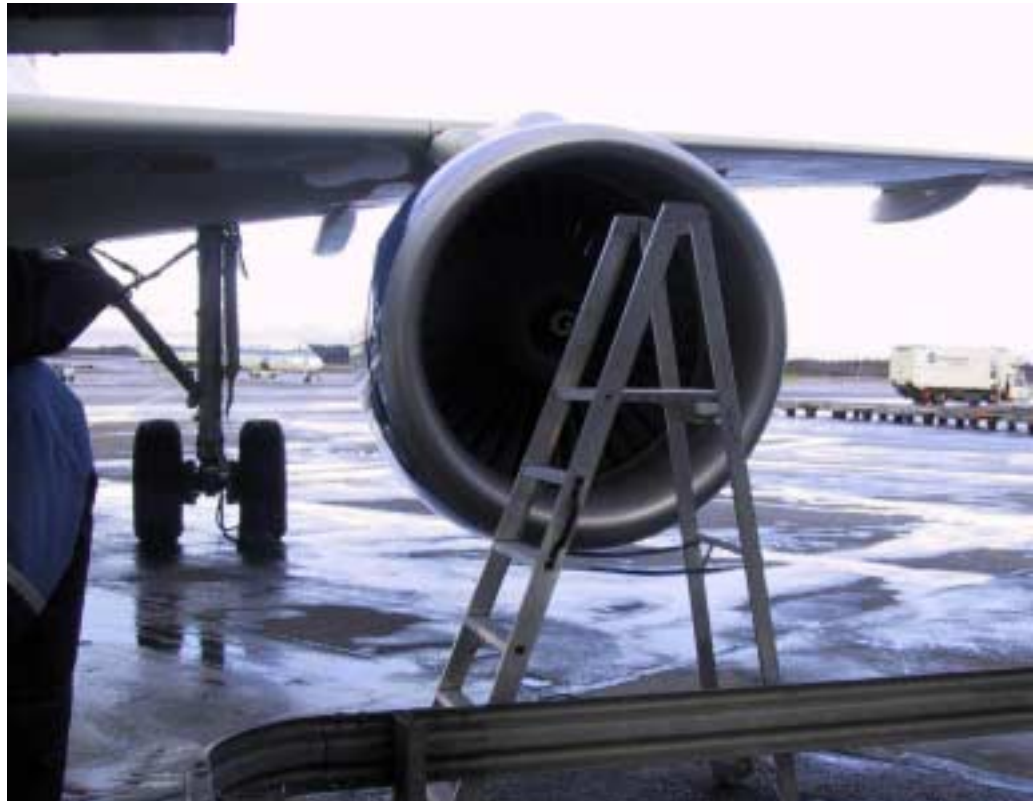
Picture 3. Simulated situation of the position of maintenance stepladder prior to damage

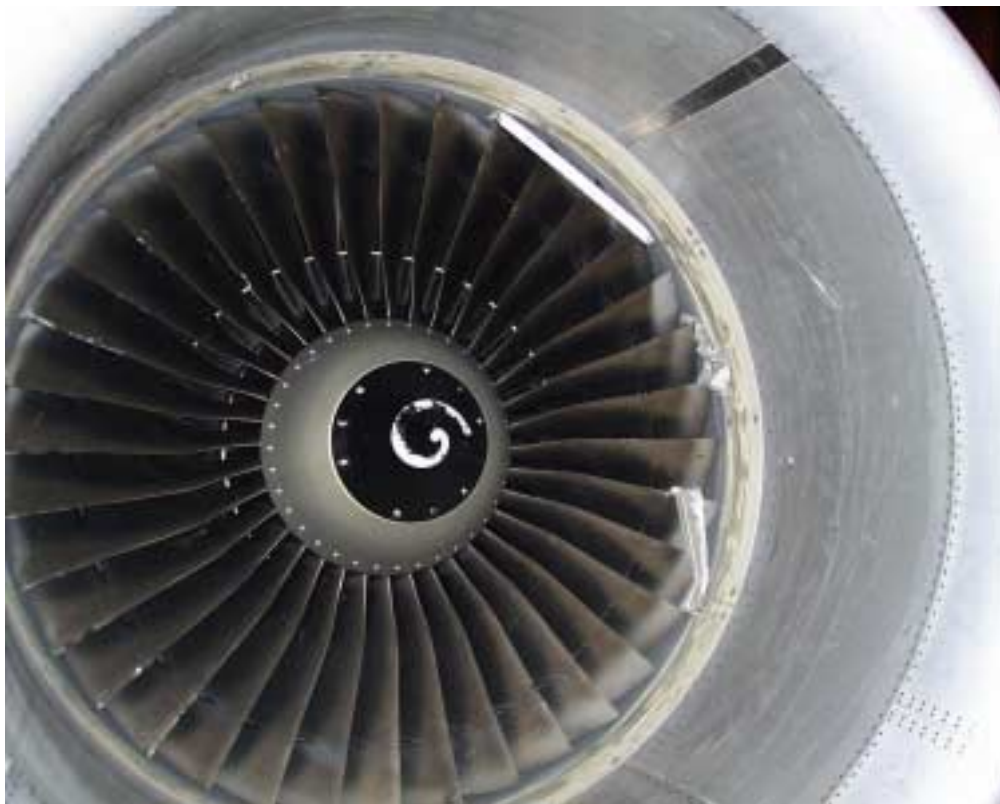
Ram air inlet case of the engine was damaged in various areas and sensor located in the ram air inlet which measures the temperature of air flow into the engine was destroyed. Fan blades and guide vanes of the bypass chamber had plenty of dents.

Sealing material by the compressor blades was damaged in several places, and the fan rotor did not rotate due to parts of the stepladder being in between blades and sealing material.

Picture 4. A general photo of the damaged engines air inlet and the parts of the maintenance stepladder in it

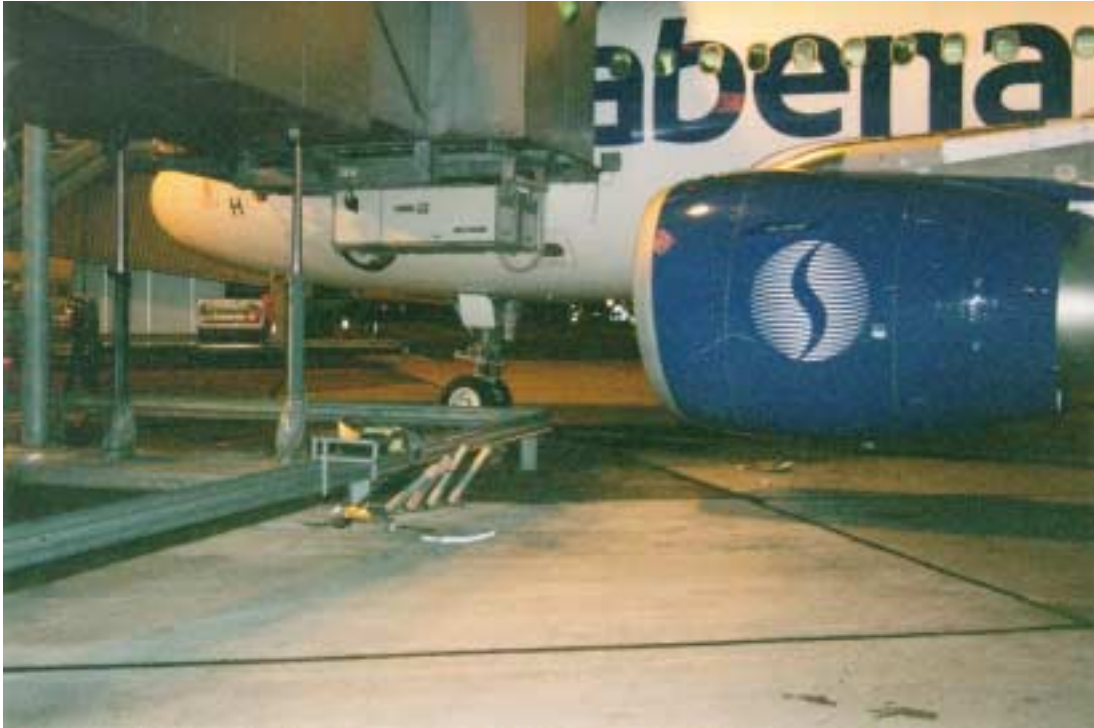
The stepladder causing the engine damage was destroyed and unusable.

Picture 5. The destroyed stepladder in front of the damaged engine (the stepladder has been removed away from its original position where the damage occurred)

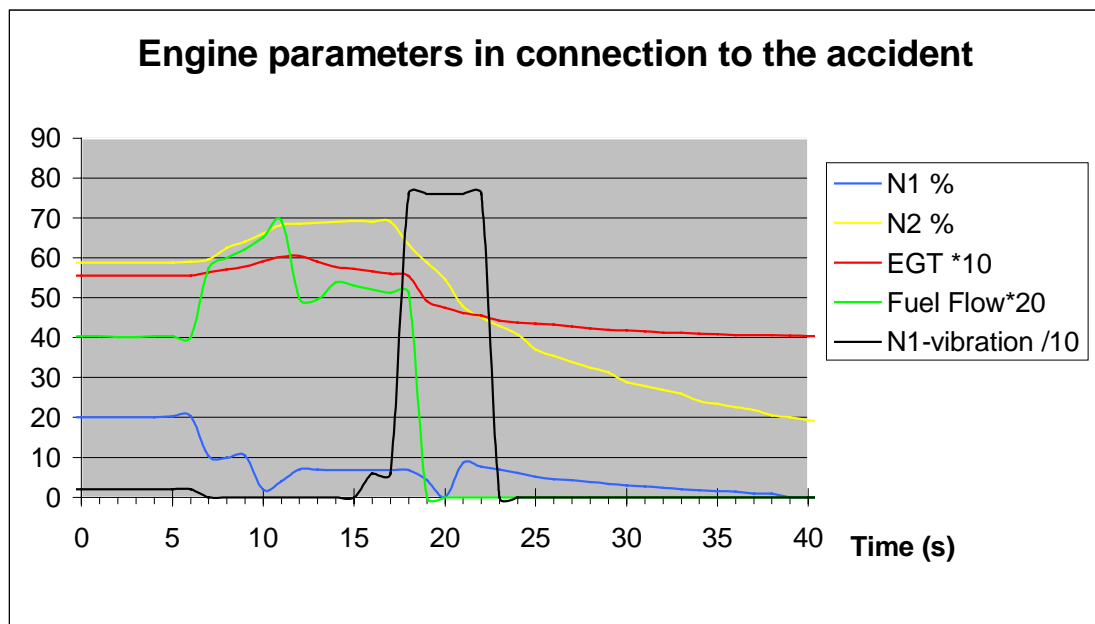
The diagram enclosed contains relevant engine parameters recorded into the DFDR starting from final portion of the taxiing approximately five seconds prior initiation of the damage. The power setting of engines was at minimum ground idle. When the step ladder was sucked against fan blades mechanical friction reduced  $N_1$  revolutions (blue graph), where at the engine's automatic power governor increased fuel flow (green graph) to maintain selected  $N_1$  power setting. Simultaneously  $N_2$  revolutions (yellow graph) and the exhaust gas temperature (EGT, red graph) increased.

The thrust of engine is created mainly by the fan. Therefore the power increased in the engine core did probably not add the forward directed thrust. There is no definite explanation to the high vibration value of  $N_1$  rotor presented in diagram (black dotted graph).

Picture 6. The flight recorder data of relevant engine parameters at time of occurrence

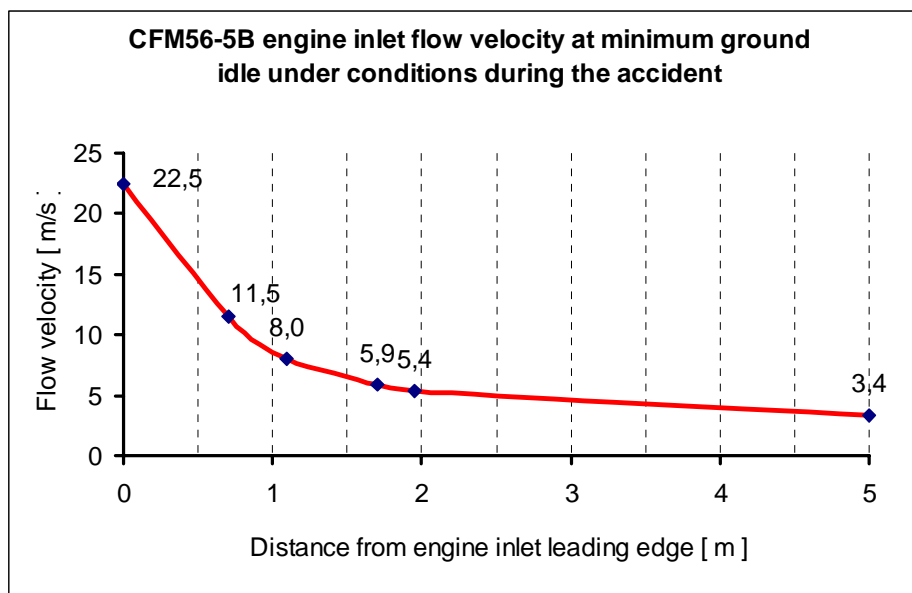
CFMI has defined a semicircular area in front of engine as a inlet danger area at ground idle. The diameter is 2.2 m.

The speed of airflow accelerates in this area significantly when distance reduces. The speed of airflow just in front of the leading edge of inlet opening is approximately 22.5 m/s (81 km/h) and at the edges of the area at a distance of 2.2 m approximately 5 m/s (18km/h).

Picture 7. The speed of air flow of engine CFM56-5B

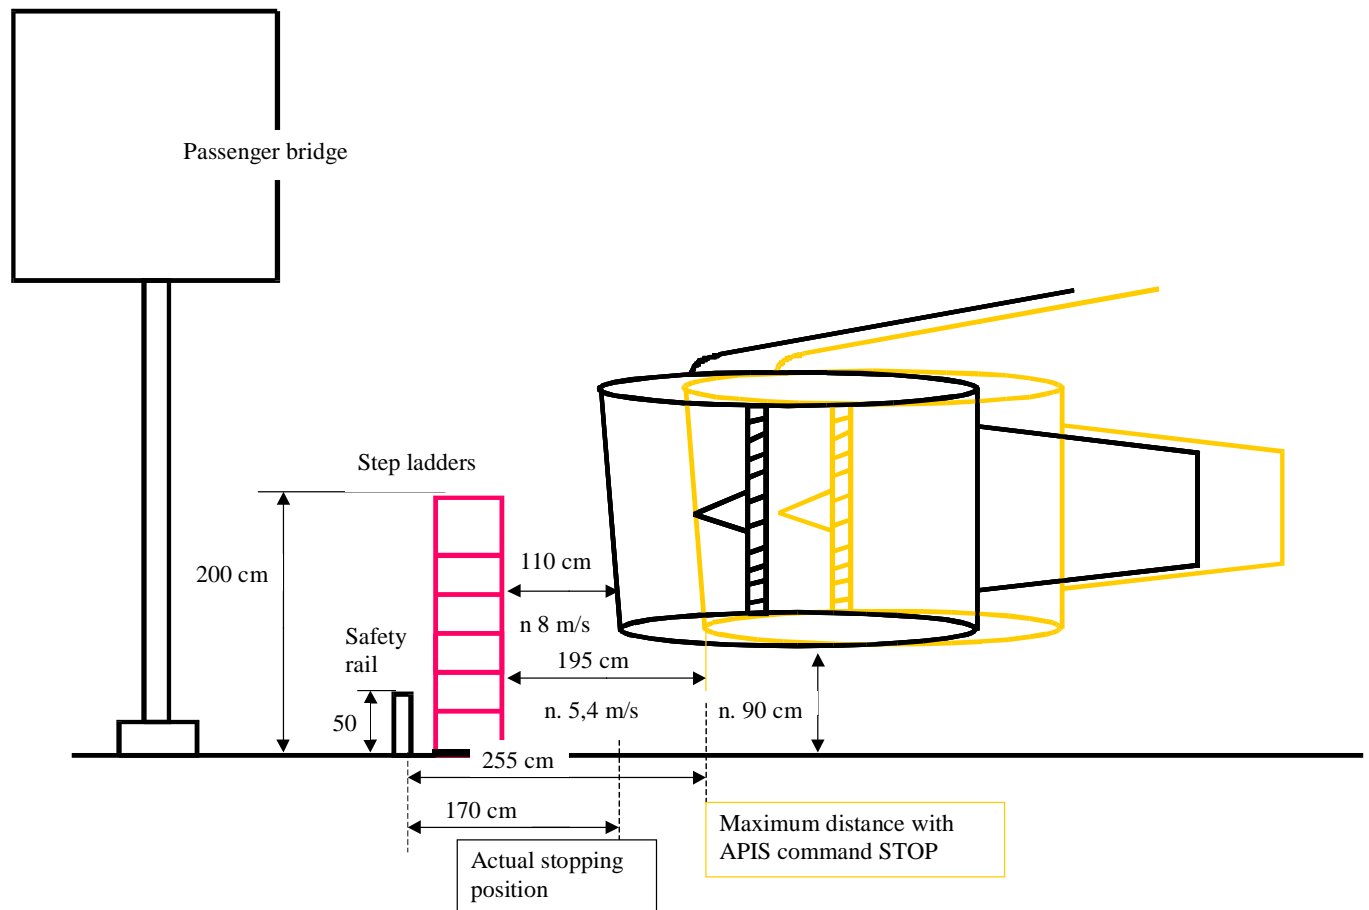
ble, that 205cm high stepladder could have hit the outer edge of the inlet opening when falling and slipped from there outside without ending up into the engine. Even though the speed of engines airflow changes significantly in relation to distance, suction of the engine would not likely have been able to lift on the ground located, 14.5 kg weighing stepladder into the engine. Velocity of the air flow by the leading edge of the engine is approximately 22.5 m/s, at a distance of 1.1 m approximately 8,0 m/s and at a distance of 1,95 m approximately 5,4 m/s.

The enclosed picture illustrates the position of the engine and the stepladder as well as the distances between them and the structures at the damage occurrence. The black drawing of the engine presents actual parking position of aircraft and yellow lineation the distance of the situation, if the aircraft would have stopped immediately after the STOP command indicated by the APIS system. In addition velocity of the inlet flow into engine is presented in the picture indicating the distances significant from the damage occurrence point of view.

Picture 10. Drawing presenting changes of the inlet airflow into the engine at damage occurrence

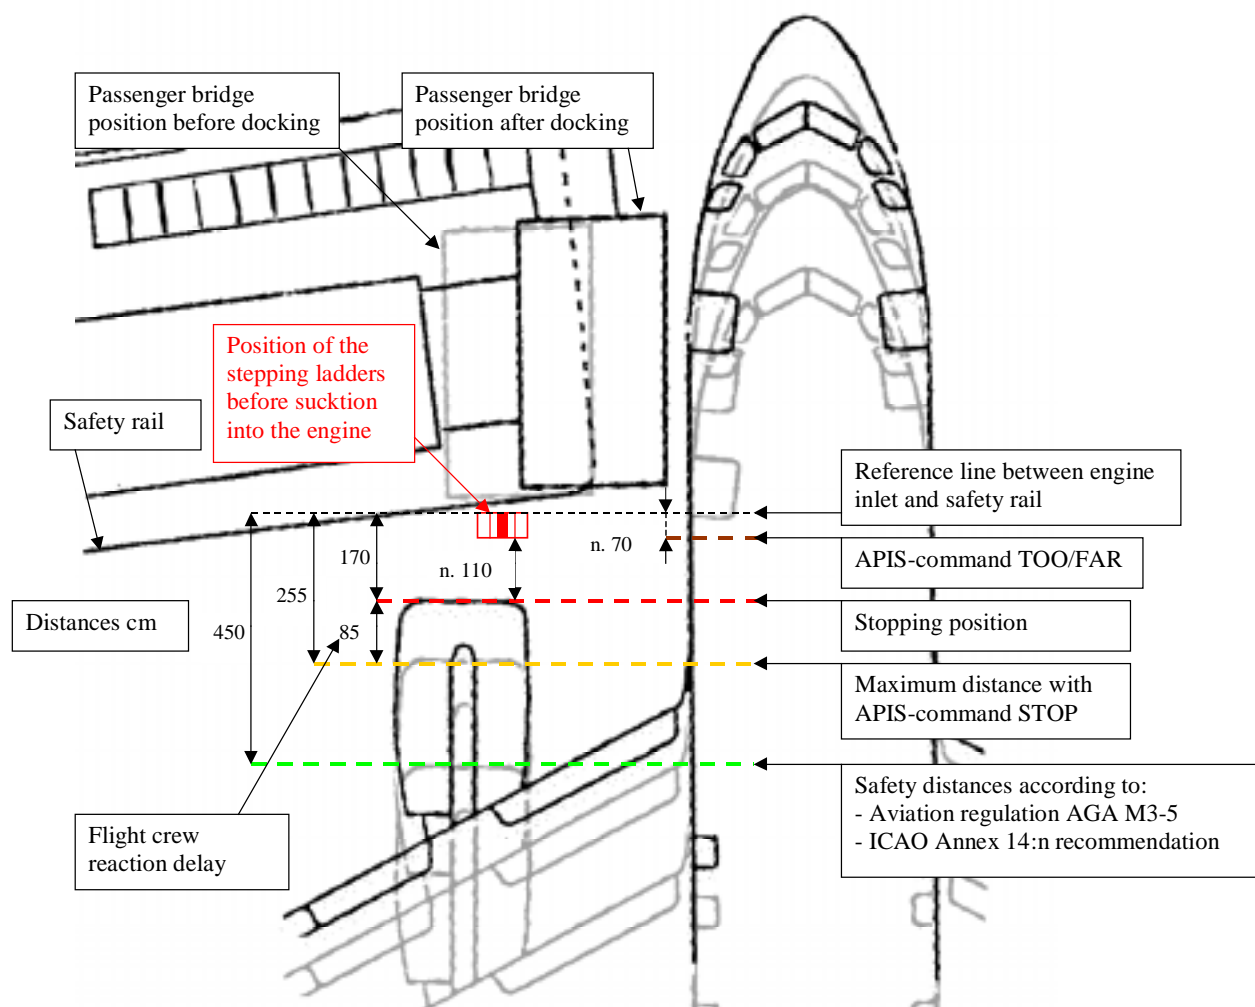
clearly fulfilled at aircraft stand number 25, though investigation commission finds the clearance in question relatively short on apron slipped by moisture or snow and ice.

Yellow dotted line indicates the APIS-systems STOP-command for the greatest safety distance of 255 cm from the passenger bridge and its safety rail, when aircraft is stopped immediately when STOP-command is lightened at parking stand number 25.

Picture 11. Safety distances according to instructions and regulations and the damage occurrences situational-distances at the Helsinki-Vantaa Airport aircraft stand number 25
