Tutkintaselostus

C 15/2000 L

Aircraft incident at Helsinki-Vantaa airport on 12.10.2000

OH-LMU DC-9-83

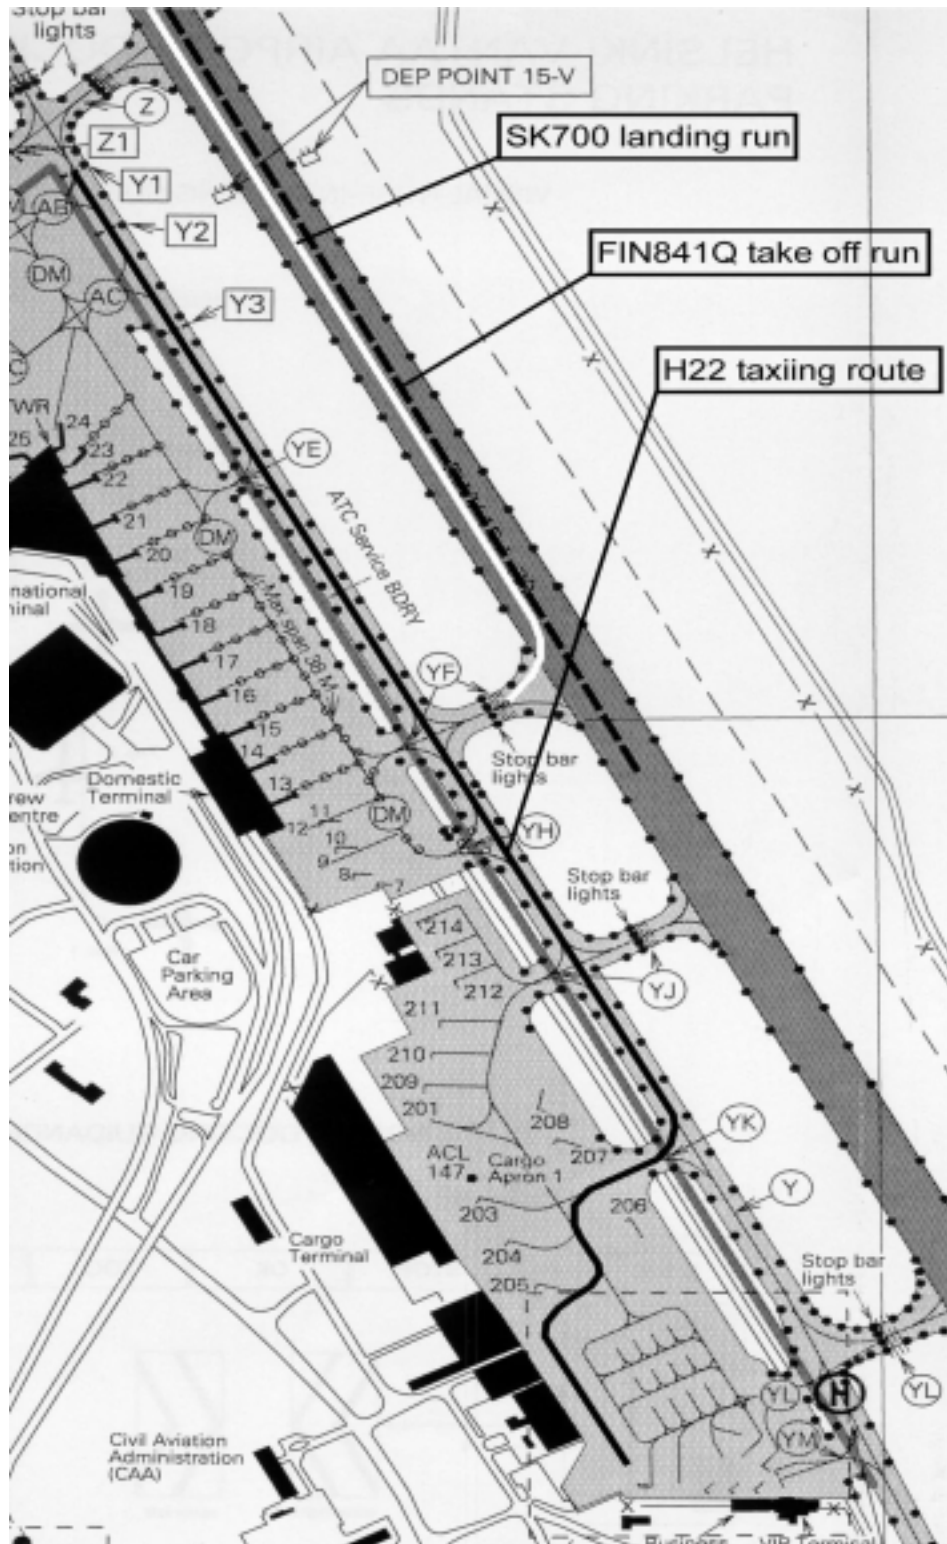
Picture 1. Taxiing routes of the aircraft

When SK700 had contacted Helsinki ground, the controller issued taxi clearance: *"Scandinavian 700, behind Fokker from left to right, taxi via Yankee and Alfa Charlie to stand 26"*. SK700 acknowledged this clearance at 08.50.30. The Fokker mentioned in the clearance was F27 using Air Force call sign H22. It was taxiing on taxiway Y from the Business Flight Center to Y1. Compared to SK700 H22 was taxiing from left to right and was passing YH at a distance of about 150 m, when the arriving SK700 was turning off the runway. The H22 crew observed SK700 taxiing from right and slowed down their speed. According to the statement of H22 first officer SK700 was so far enough that there was no need for continuous look at the right wingtip of H22. During FIN841Q take-off SK700 was waiting for the passing H22 on YF.

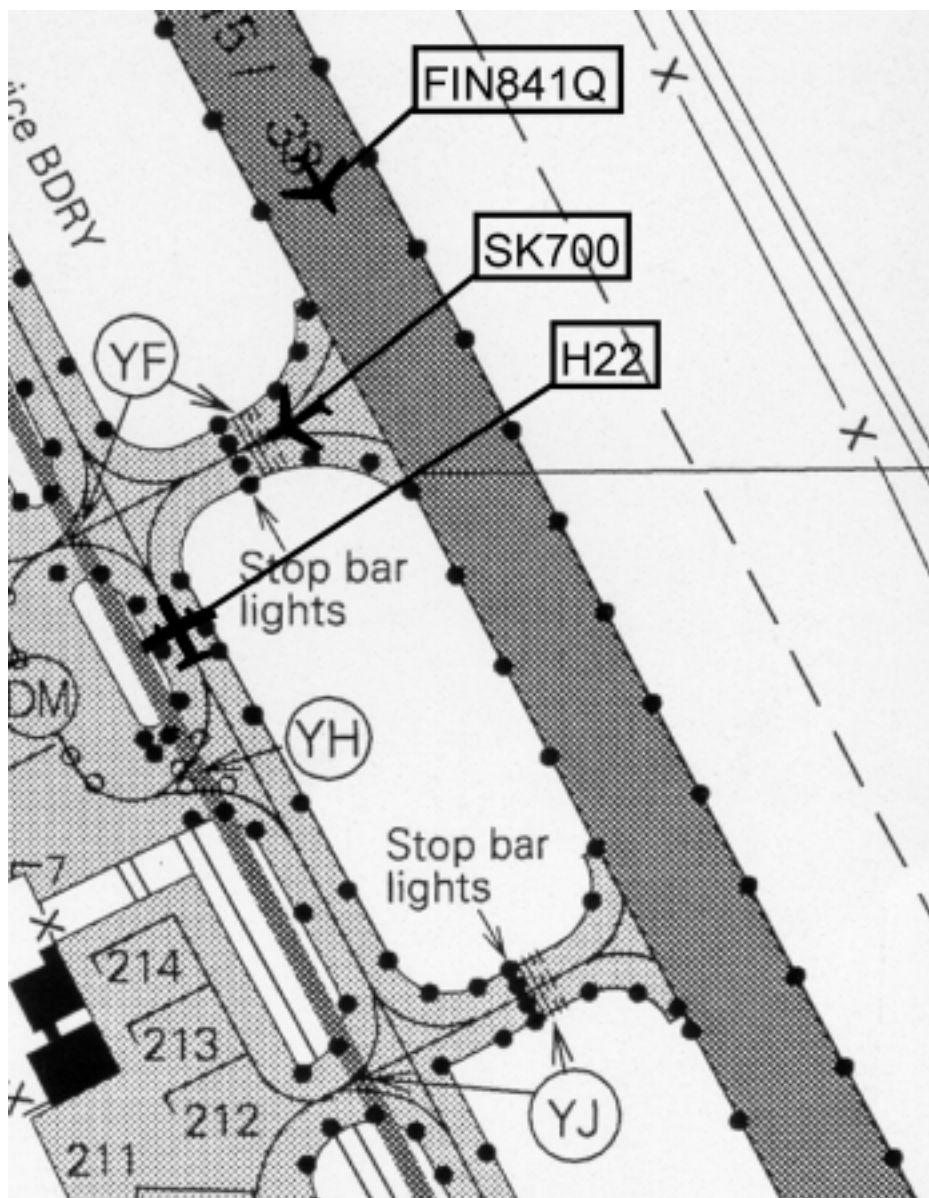
Picture 2: Position of the aircraft while FIN841Q was taking off

At 08.48.10 the ground controller had cleared Air Force Fokker 27 with call sign H22 for taxiing from Business Flight Center parking position to Y1. At 08.50.30, when turning off from the runway, SK700 contacted Helsinki Ground: *"Good morning, Scandinavian 700 vacated 15"*. When reporting this SK700 apparently expected to continue taxiing without stopping. The tower controller had cleared FIN841Q for takeoff five seconds earlier. When SK700 contacted the Ground H22 was at YH about 150 meters from YF, to which SK700 had turned. The ground controller estimated that H22 was taxiing so fast that it would have time to pass YF before SK700. When SK700 contacted the Ground the controller replied: *"Good morning Scandinavian 700, behind Fokker from left to right, taxi via Y and AC, stand 26"*. At the same time H22 pilots had noticed SK700 coming on their right hand side and had slowed their taxiing speed. The ground controller did not say anything to H22 and the aircraft continued taxiing, but with slower speed. SK700 had to wait for H22 to taxi from left and for this reason it stopped at runway area.

The pilots of FIN841Q had concentrated on their own takeoff and did not observe SK700 until in the short distance. They found out that they had space enough to pass SK700 without an evasive action. The commander of FIN841Q had no possibility to abort take-

According to the co-operation letter of Helsinki-Vantaa airport the ground controller gets the strip of the landed aircraft from the tower controller when the aircraft has vacated the runway. When planning the control of taxiing traffic the ground controller have to follow landing traffic visually and from the radar display. This is the way the controller told he had acted also in this case. He did not however succeed in determining the taxiing order of his traffic correctly, because the landed SK700 had to stop on connecting taxiway YF to wait for taxiing of departing H22. Due to the short distance of runway 15/33 and taxiway Y SK700 stopped at the runway area.
