Aircraft Incident Report

C 19/2000 L

Loss of separation over Espoo on 15.12.2000 Disappearance of aircraft from ATC radar

RA 86532 IL62M
OH-LMG DC-9-83

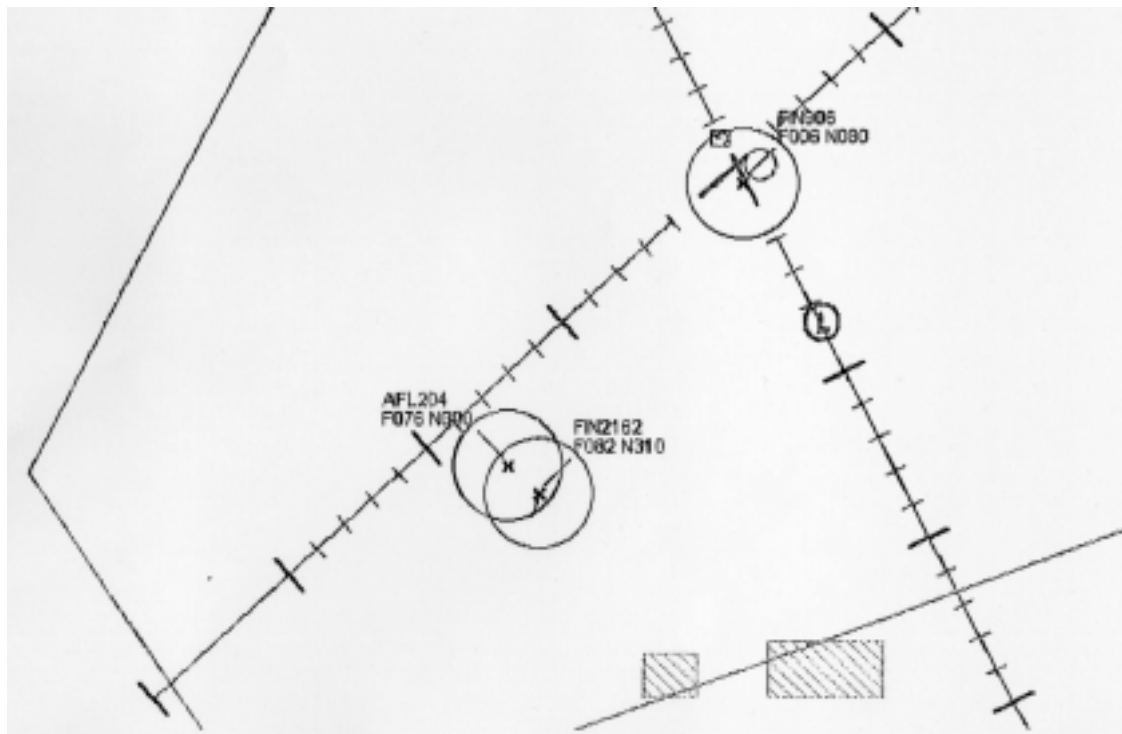
Figure 2. First radar observation of AFL204 at Helsinki ATC.

AFL204 became visible on Helsinki ATC radar screens at 16.45.56. It was then in front of FIN2162 about half a nautical mile on its front left side. The radar showed that AFL204 was flying at FL76. The tracks of FIN2162 and AFL204 intersected at an angle of almost 90°.

DEP did not inform AFL204 of their incorrect flight level. At that time, the radar showed FIN2162 to be at FL82. FIN2162 received a TCAS resolution advisory about traffic in

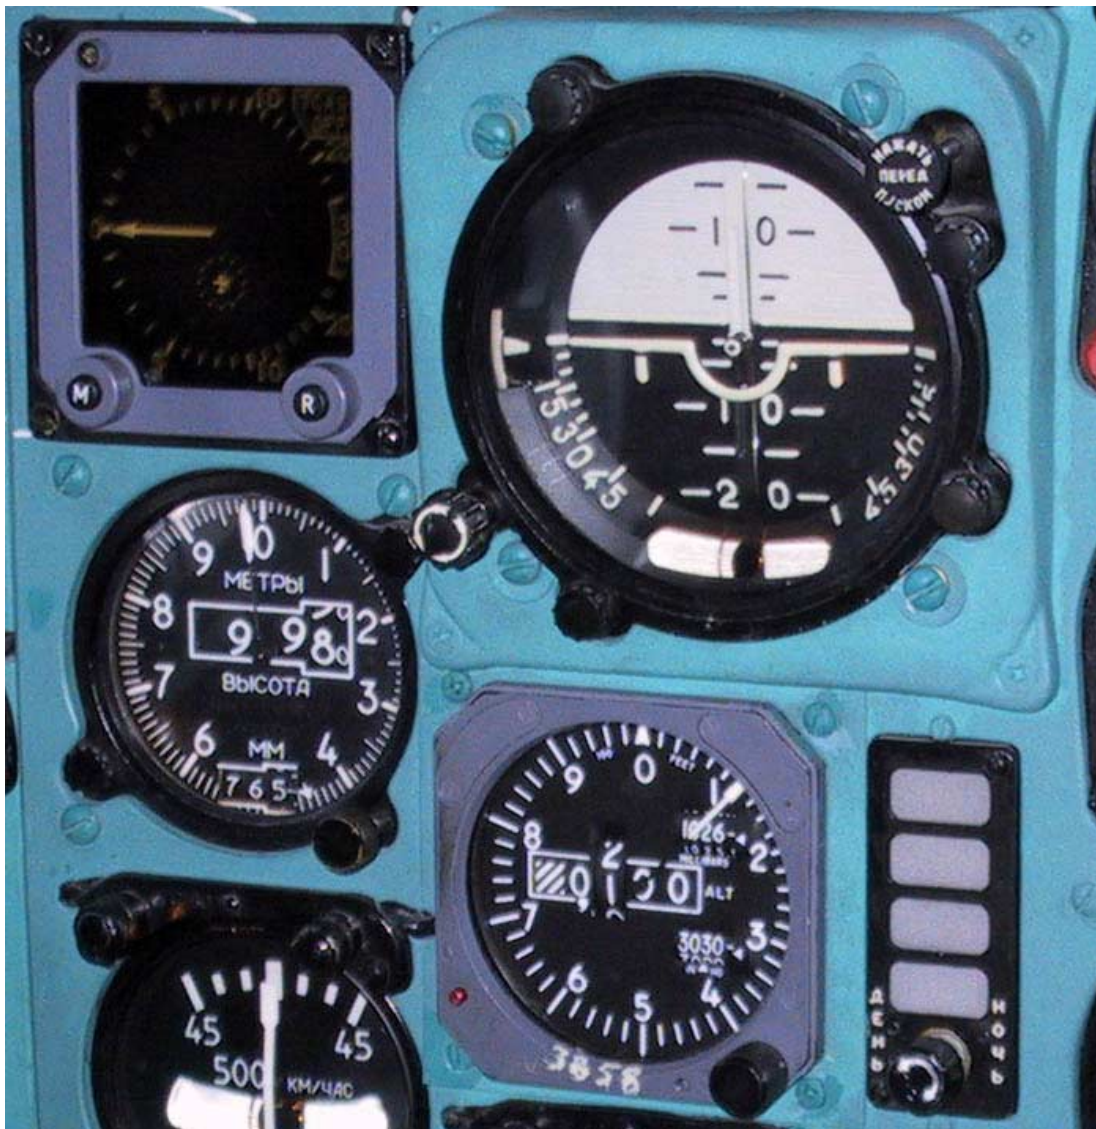
Figure 4. Altimeters available to the IL62M captain and TCAS display.

mean sea level. At the time of the incident, the difference between the actual barometric pressure QNH 994 hPa (mbar) and the standard pressure used above the transition altitude (1013.2 hPa) was about 520 ft. This means that FL50 was at 4480 ft, and the AFL204 should have changed altimeter setting before reaching this altitude since the crew reported passing through FL50. In his statement, the pilot-in-command of AFL204 told that the altimeter setting was changed at the *transition level*, though it should have been changed at the transition altitude, which is 5000 ft in all Finnish airspace. The adjustment of pressure setting in the metric altimeter is shown in the FDR recording provided by Aeroflot, but that of the altimeter showing feet is not recorded.

The loss of separation was caused by an incorrect altimeter setting of AFL204. A contributing factor was that AFL204 transponder was not in operation until a few seconds before the aircraft passed each other, for which reason AFL204 was not visible on Helsinki-Vantaa ATC radar.

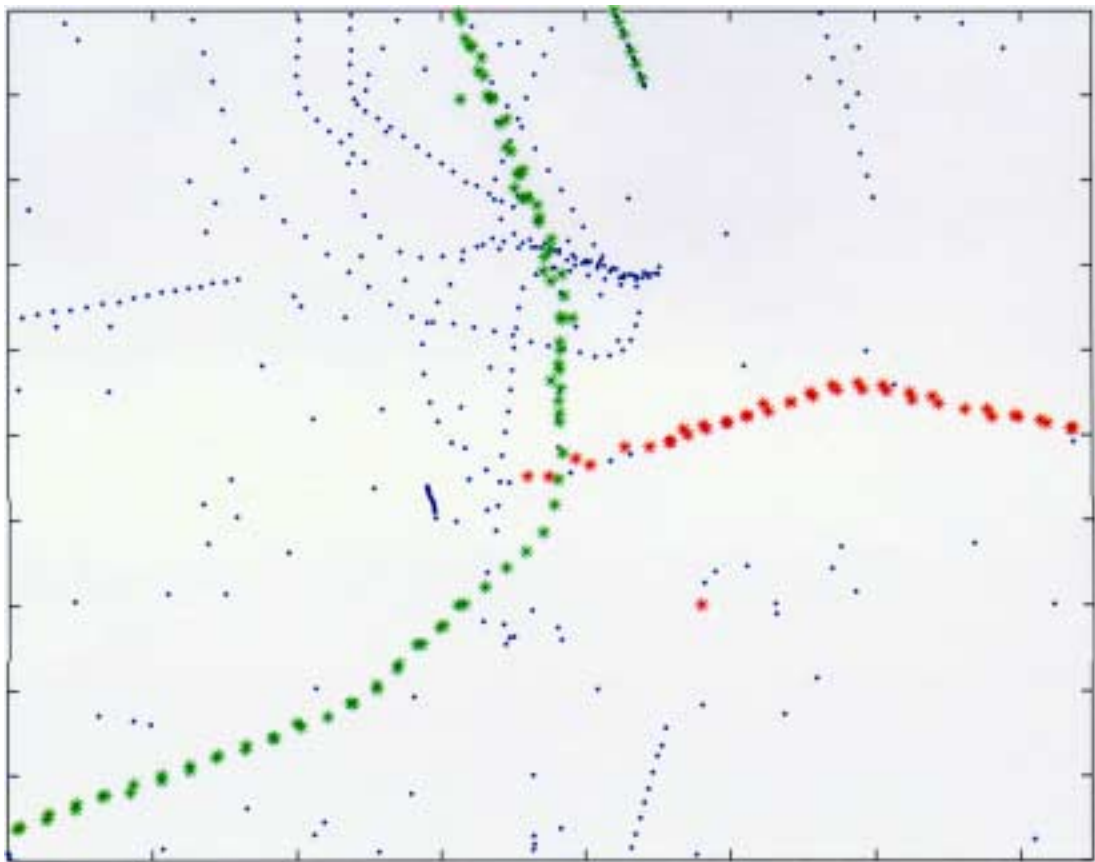
Figure 5. Aircraft tracks from the Finnish Air Force radar recording
Blue points are primary radar returns.
Red stars are secondary radar returns for AFL204.
Green stars are secondary radar returns for FIN2162.

AFL204 reported reaching FL70 at 16.44.00. The label information of the aircraft was first displayed on radar screens at 16.45.56, at which time it was shown to be on FL76. FIN2162 received a TCAS resolution advisory about the aircraft at the same time. AFL204 was simultaneously detected by two radars at Helsinki-Vantaa ATC, three

radars at the South Finland ACC and two Finnish Air Force radars. All radars indicated the same flight level for AFL204.

Considering the technical rounding used in radar systems, the difference between FL70 and FL76 is the same as the difference between the QNH and standard barometric pressure converted into altitude. It is therefore probable that the altimeter indicating feet was on QNH setting above the transition altitude, although the crew thought it to be on the standard setting. They flew at the 7000 ft altitude indicated by the altimeter and believed to be at FL70, but were actually at FL76. In his statement, the pilot-in-command told that the flight had been normal and the crew had not noticed anything unusual.

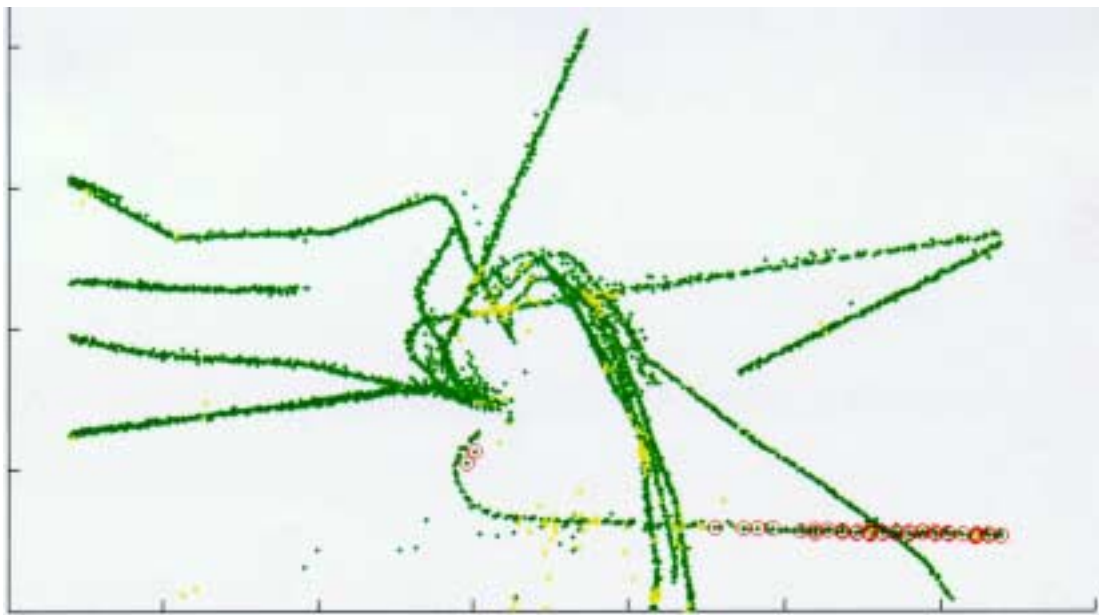
Mode A&C transponders have been determined to require periodical maintenance, since they are subjected to mechanical wear. The American FAR 43 regulation prescribes a maintenance interval of two years. The Eurocontrol study described above revealed that in France, one fifth of these transponder types were not in compliance with ICAO standards when they were brought to scheduled maintenance after two years in service.

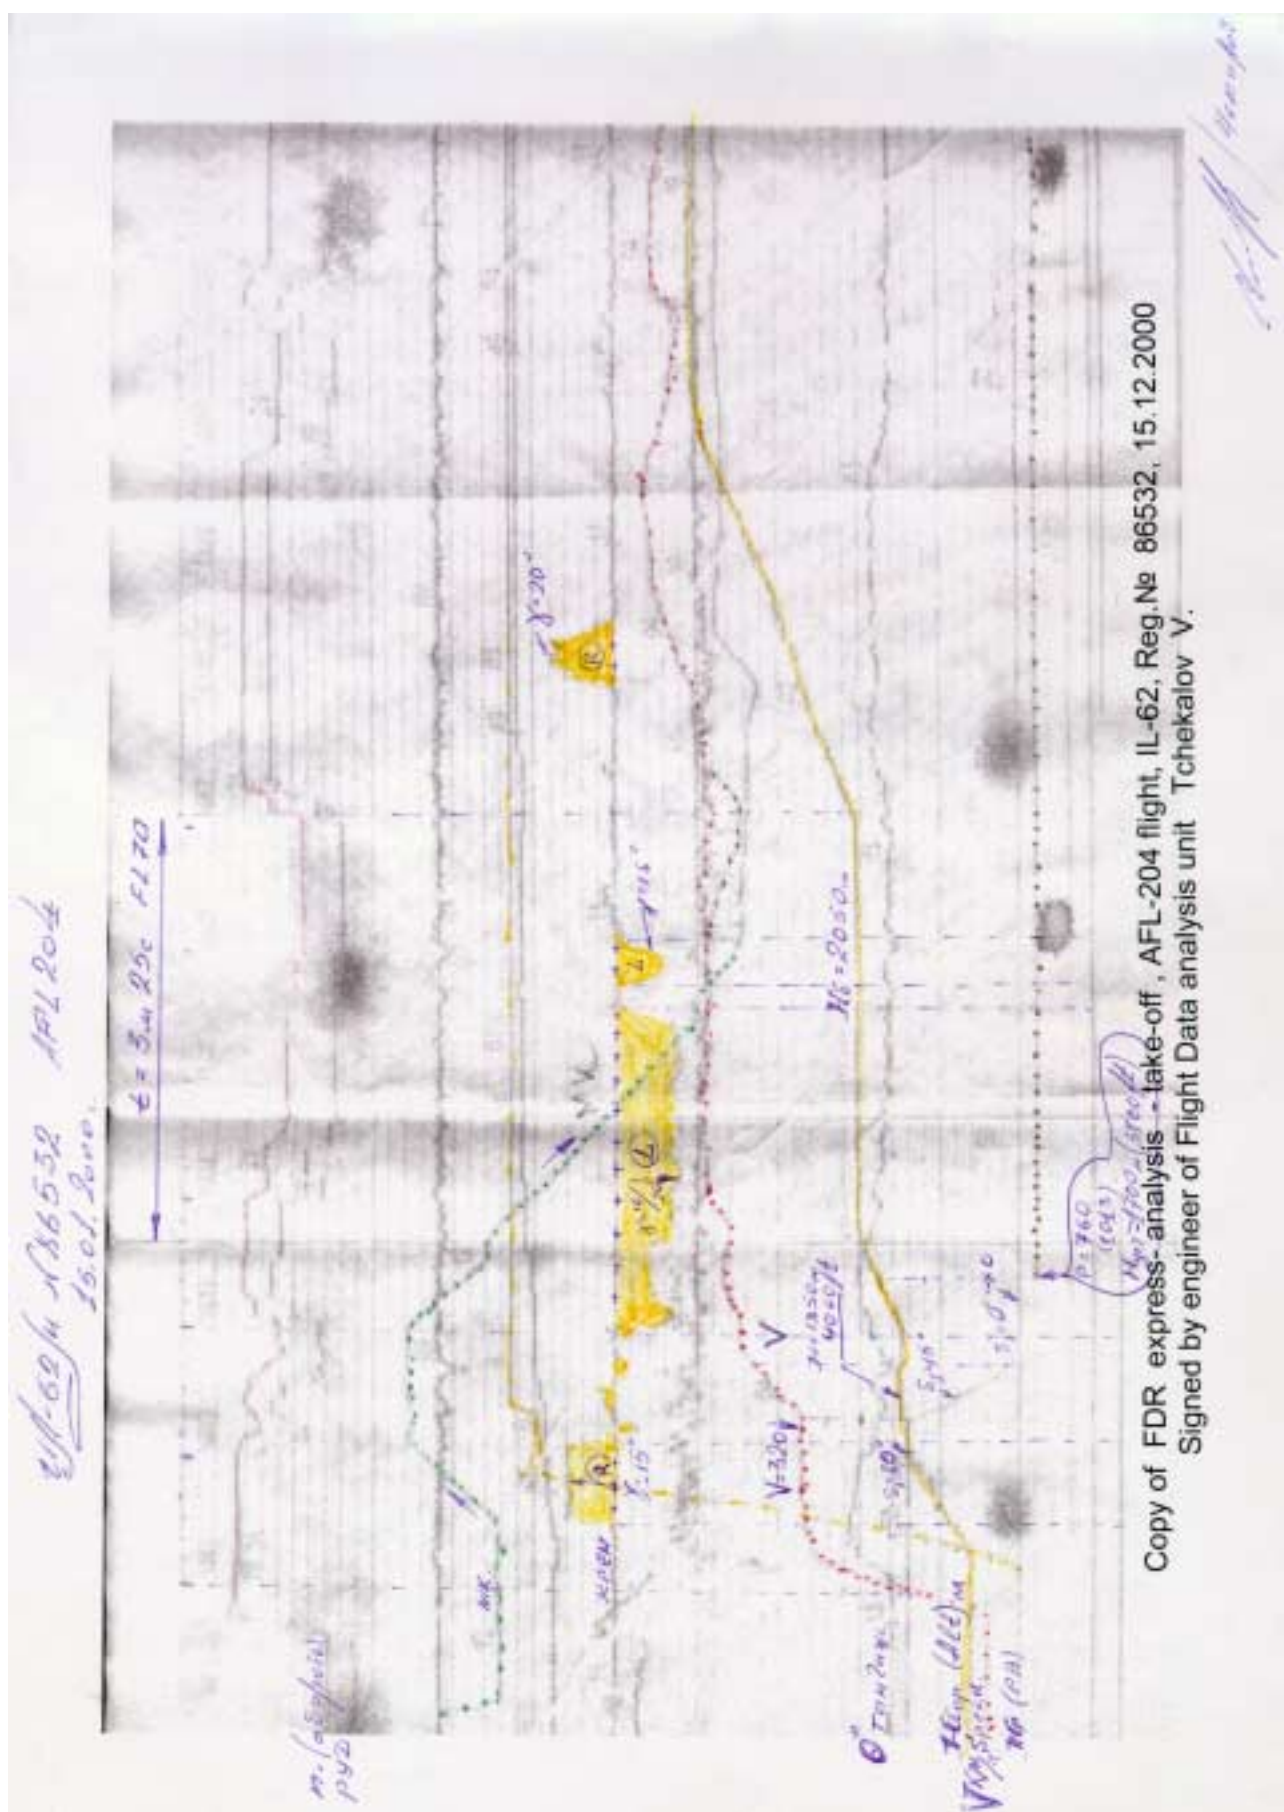
Report of Flight data analysis unit
AFL-204, 15.12.2000
A/p Helsinki

Flight AFL 204 , IL-62M, Reg. № 86532, 15.12.00 performed take-off in the Helsinki airport at 04.11 (Z) from RWY 22.
