Investigation report

B 5/2001 L

Aircraft damage in hailstorm west of Helsinki on 21.7.2001

Douglas DC-9-81

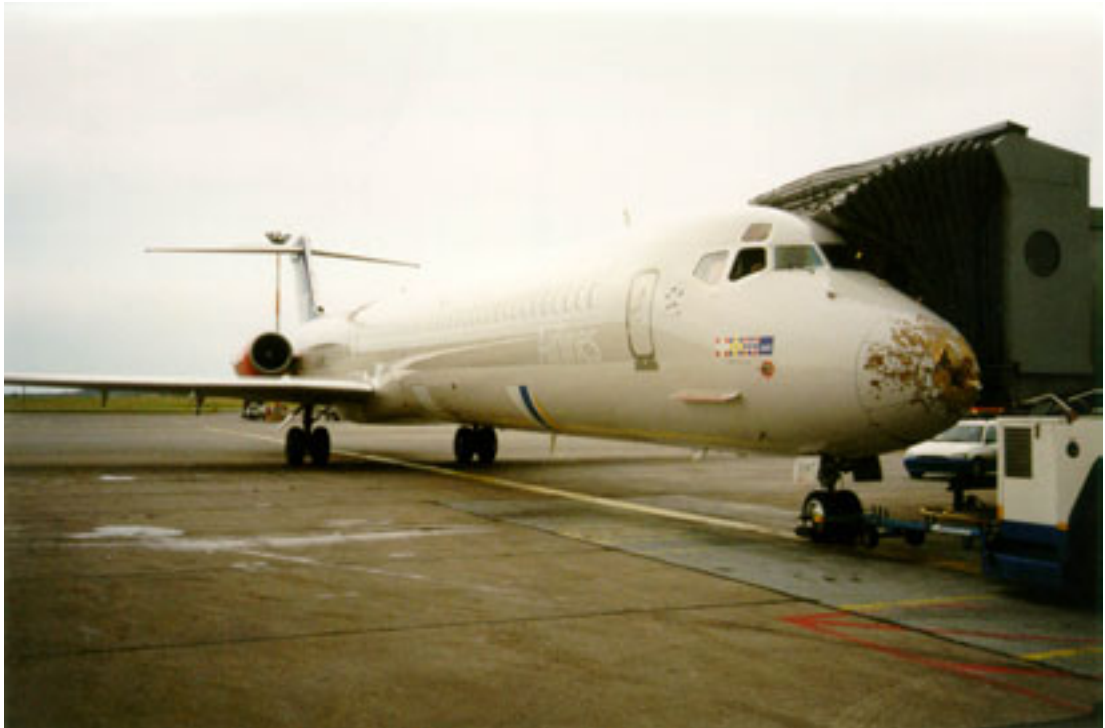
Figure 1. SAS1700, MD81 after the incident

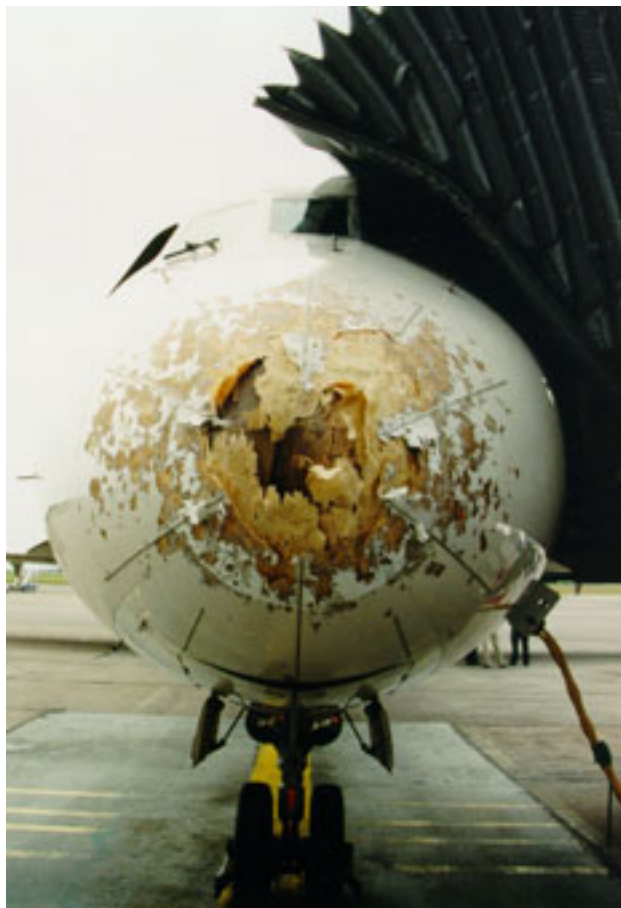
A hole of about 50 cm in diameter was torn in the radome, as a result of which the radar antenna surface was also dented by hail.

Figure 5. The damaged radome

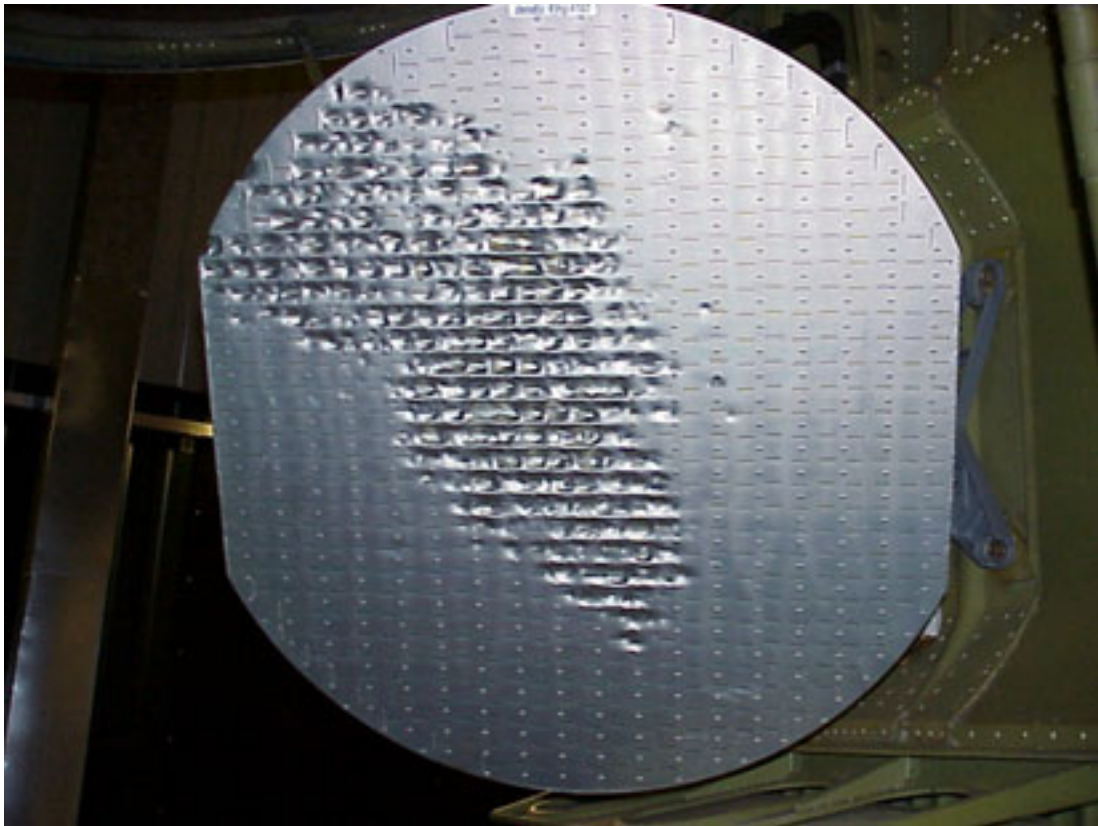
Figure 6. Dented radar antenna surface

The weather radar receiver/transmitter unit was removed from the aircraft and sent to Finnair Avionics Department for testing and read-out of fault memory. The unit was found to be serviceable. The fault list recorded showed that the malfunction in flight had been caused by antenna stoppage. The stoppage was simulated during the test.

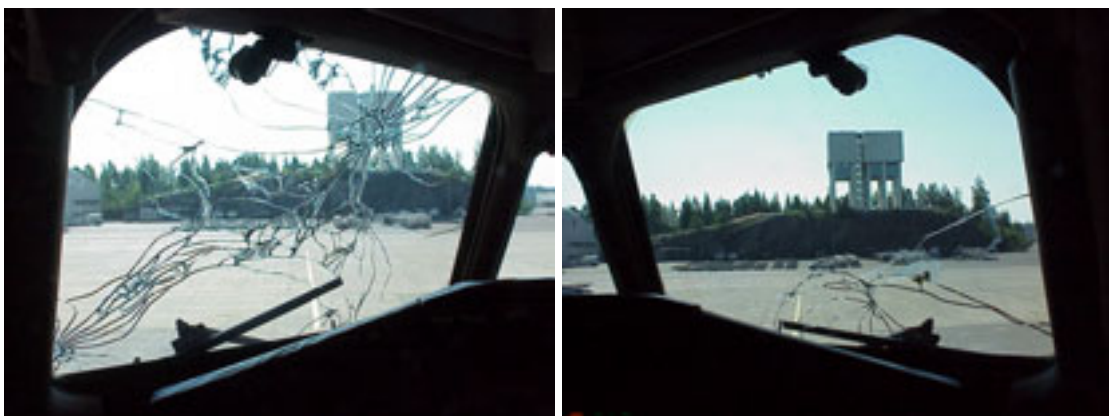
The outer surfaces of windshields in front of the captain and co-pilot were cracked. However, cracks in outer surface do not affect structural integrity of the windshield.

Figure 7. Left and right cockpit windshields as seen from the inside

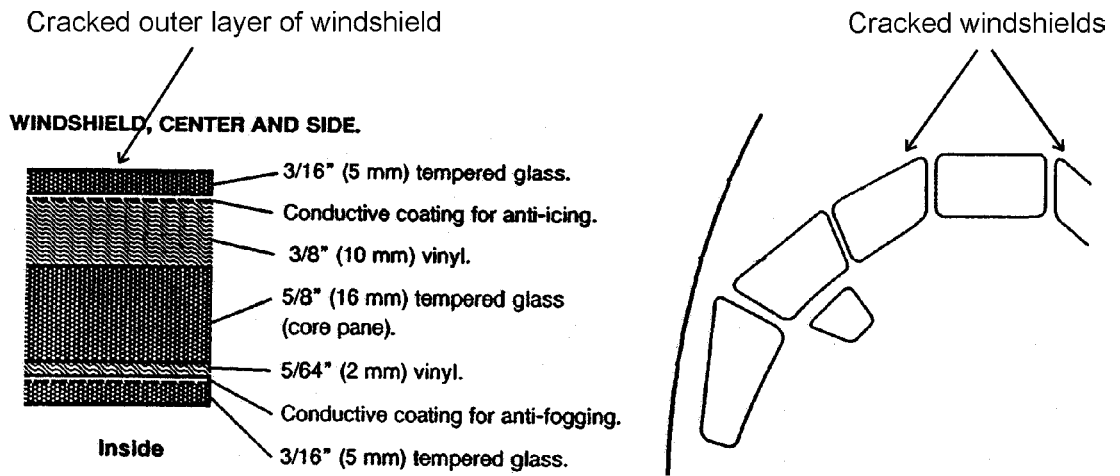
Figure 8. Windshield structure and location of the cracked windshields

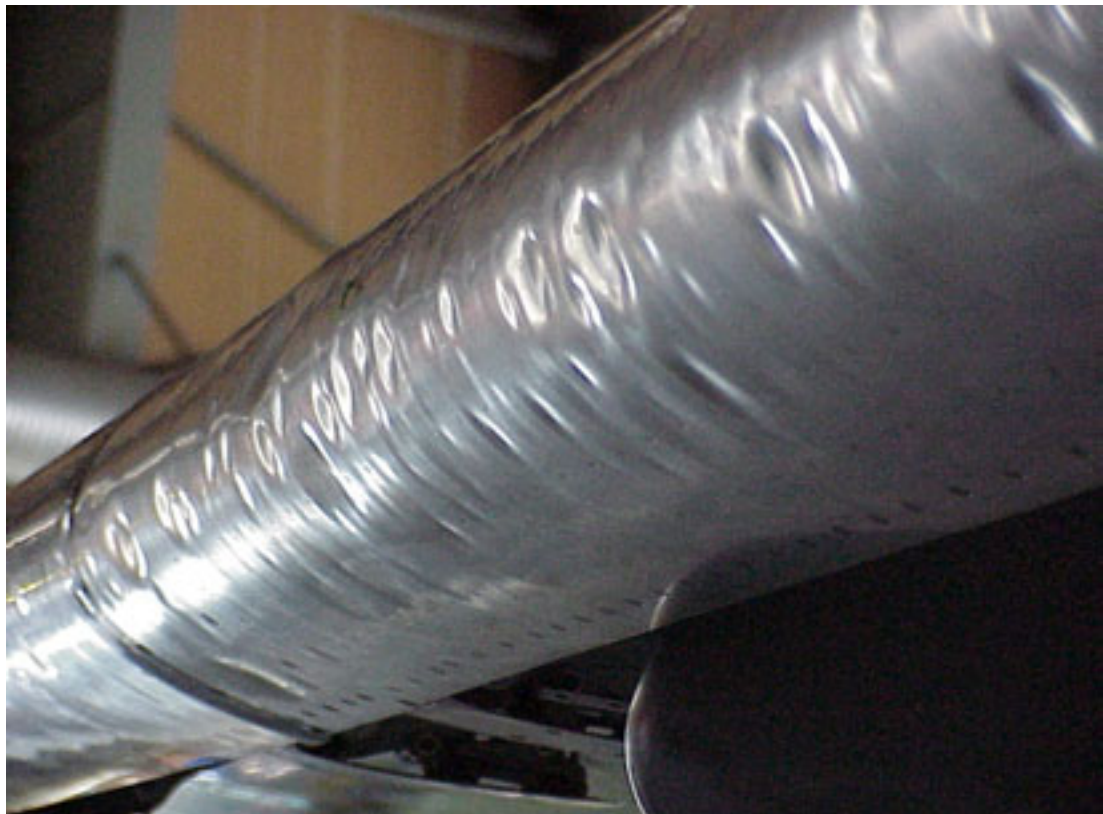
The slat panels on wing leading edges were dented by hail, as were the leading edges of horizontal and vertical stabilisers. The worst dents in both wings were found on slat panel no. 1 (the second panel from wing root). Both panels had about 120 dents in total. The largest dents were 70 x 50 mm² in diameter and 5 mm deep.

Figure 9. Right wing leading edge slat panel no. 1

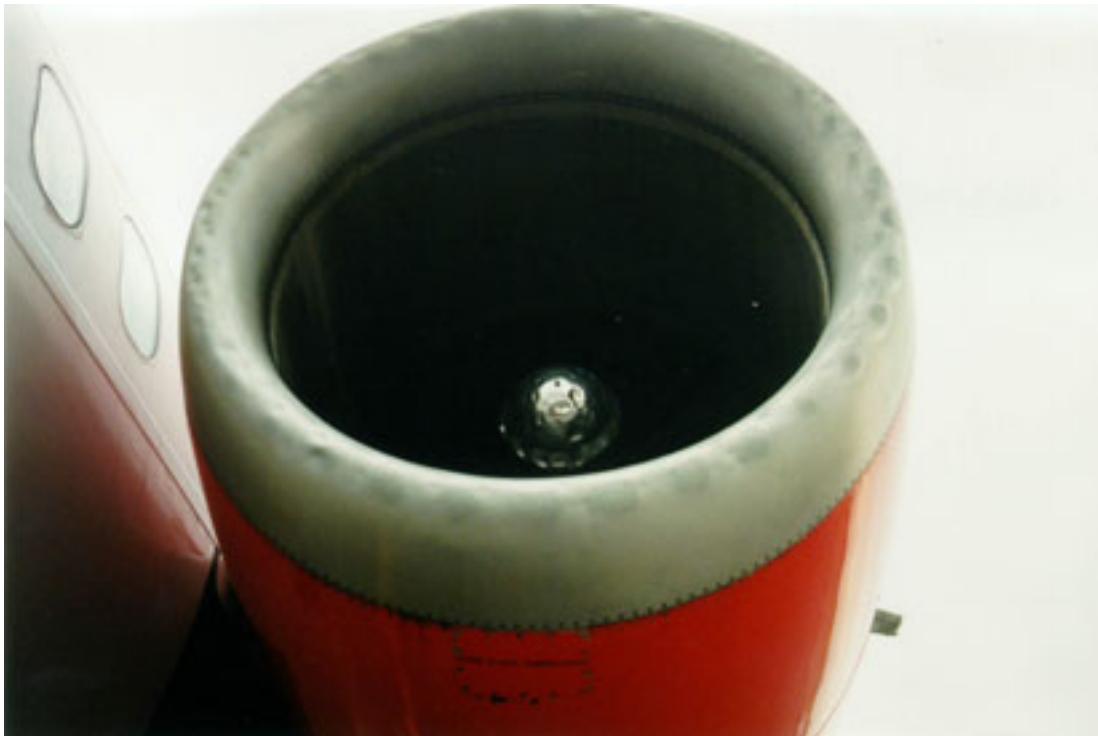
Moreover, the engine inlet cowls and the bullet in the centre of the compressor were dented in a similar way as the wings and stabilisers. The engines sustained no other visible damage.

Figure 10. Left engine inlet cowl

SAS made a boroscope inspection and test run to the engines. The inspections or test run did not reveal any internal damage or changes in performance.
