B 6/2001 L

# Serious aircraft incident in Turku terminal control area, Finland on 13.8.2001

OH-SAE, SAAB SF340A

OH-SAS, SAAB 2000

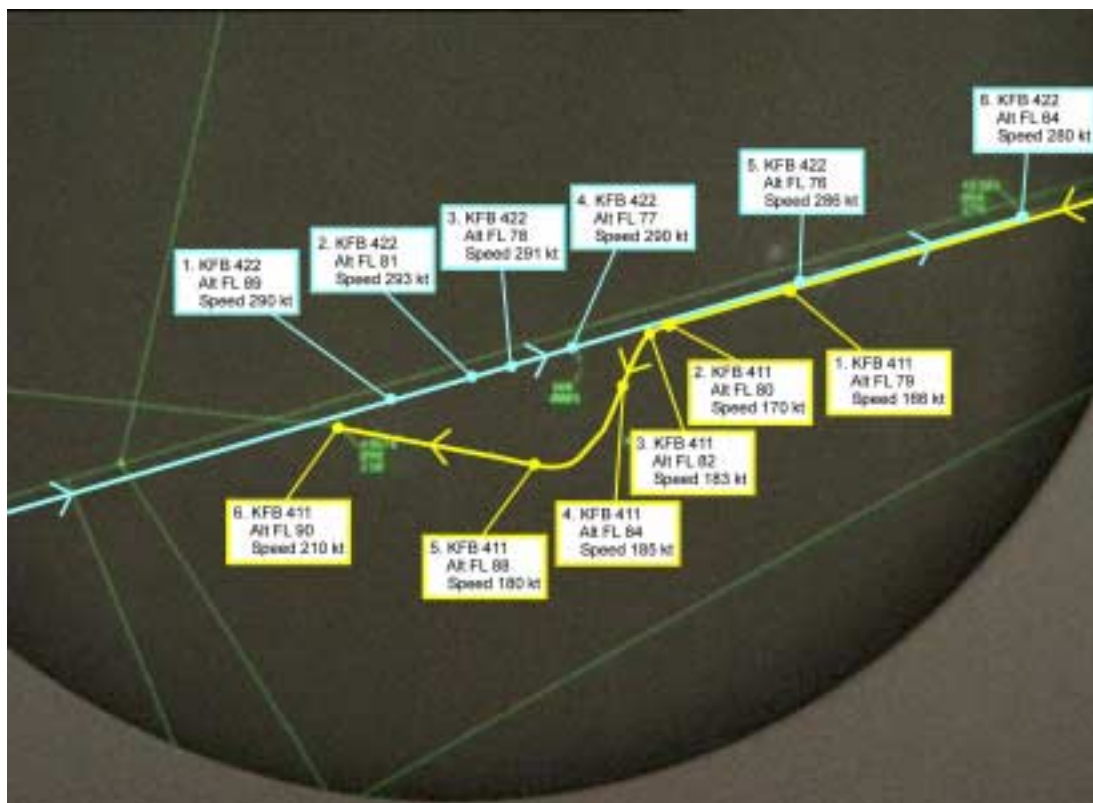
Picture 1. Sequence of events based on the radar record:

When the 1000 feet altitude separation was lost, the distance between KFB 411 and KFB 422 was 6.1 NM. When the two aircraft were at the same altitude, the distance between them was 3.1 NM. When KFB 411 started its avoiding turn, the distance was 2.4 NM, and the shortest distance between the aircraft was 1.1 NM.

The ground speeds, altitudes and distances between the two aircraft in this investigation report, and the flight tracks and times in Picture 1 are based on the MSSR record from Tampere ACC.

1. 16.08.30 1000 feet vertical separation is broken. Distance between aircraft 6.1 NM.
2. 16.09.09 Aircraft on the same level. Distance between aircraft 3.1 NM.
3. 16.09.15 KFB 411 begins avoiding turn left. Distance between aircraft 2.4 NM.
4. 16.09.33 Closest distance between aircraft 1.1 NM.
5. 16.10.10 1000 feet vertical separation re-established
6. 16.11.05 KFB 411 returns on route.
