Aircraft Incident Report

B 4/2002 L

TCAS manoeuvre south of Jyväskylä on October 29, 2002

DC-9-83, OH-LPH

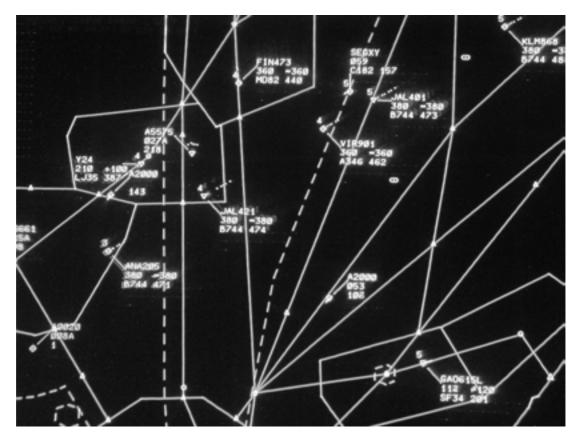
Figure 4. Part of R1 radar display at 12.30.30 hours

At 12.30.30 hours R1 cleared Finnair 473 to FL 130. The clearance was, however, conditional: "When ready, descend to FL 130" i.e. the pilots could initiate the descent at their discretion. Finnair 473 was then about 15 NM south of VOR/DME radio beacon LUONET. Virgin 901 was then at a distance of about 25 NM from Finnair 473. Neither R1 nor R2 noticed that radar separation with Virgin 901 would soon be lost. There was no other significant traffic with regard to the clearance of Finnair 473 to descend to FL 130. R1 had no telephone calls during 12.26.40 - 12.31.40 and R2 during 12.24.00 - 12.34.00. Both controllers and the sector assistant were in the sector suite during this time.

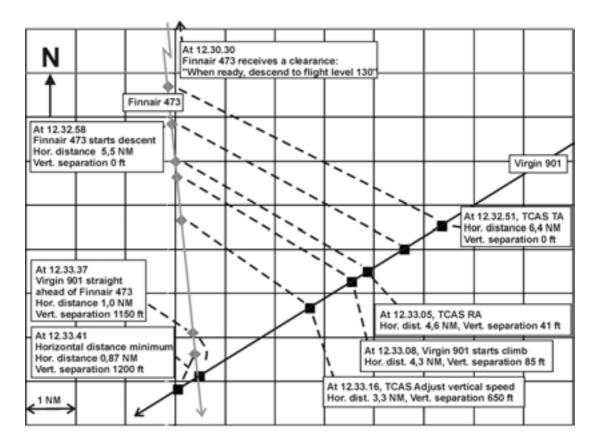
Figure 5. The flight tracks of the aircraft

R1 noticed that the aircraft would not collide and assumed that they would perform TCAS manoeuvres. He did not issue any clearances in order to avoid conflicts between the clearances and the TCAS advisories. He told that his decision not to say anything was affected by the fact that he was familiar with the mid-air collision which took place at the border of Germany and Switzerland in July 2002. His actions after Finnair 473 TCAS report complied with the valid instructions.
