Investigation report

C 10a/2002 L

Loss of Separation East of Turku Airport on 23.10.2002

HB-VNF Gulfstream G100

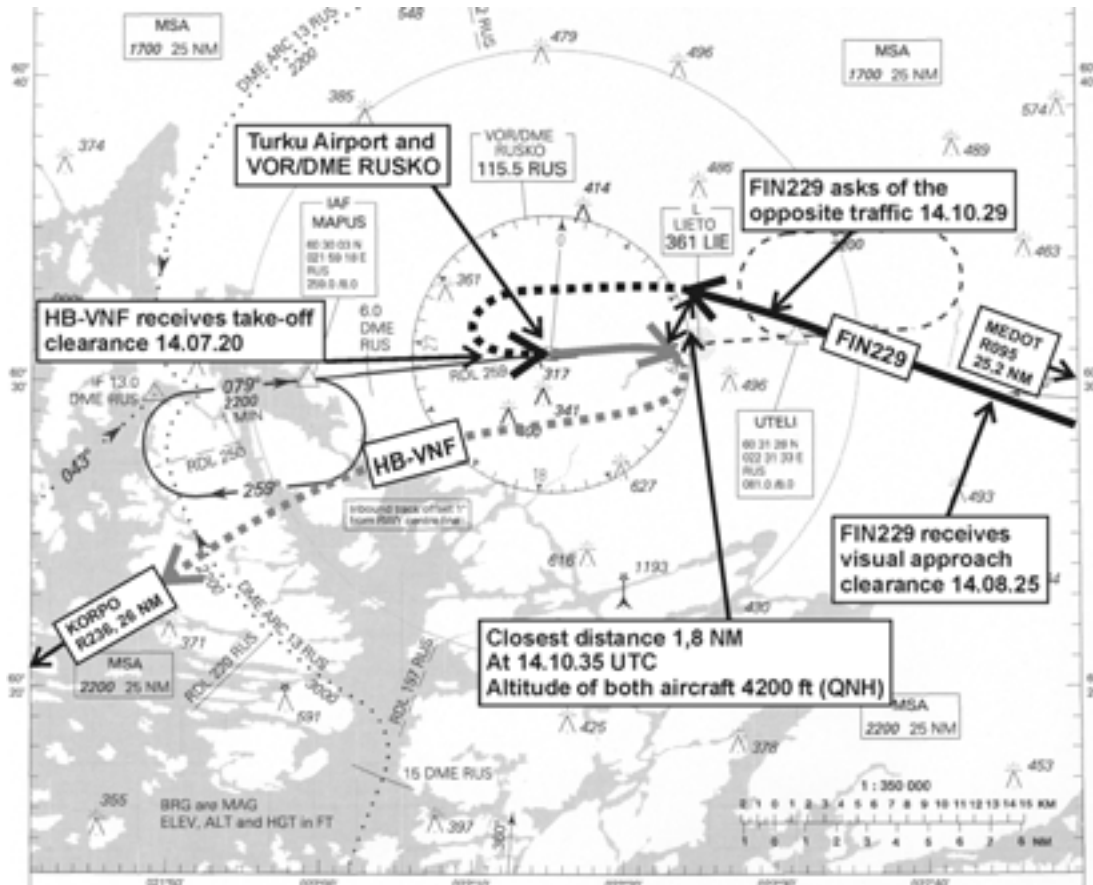
Figure 1. Flight tracks

The radar recording indicates that HB-VNF passed through the initial clearance altitude of 3200 ft at a distance of 3.0 NM from the airport at 14.10.00. The aircraft had climbed following the runway 08 direction. The distance to FIN229 was 5.0 NM at that time.

The radar recording indicates that HB-VNF continued its right-hand climbing turn. FIN229 continued at the altitude of 4500 ft (4200 ft on QNH) towards the left down-wind leg of runway 08. HB-VNF passed through the FIN229 altitude at 14.10.35, at which time the horizontal distance was 1.8 NM according to the radar recording. This was also the minimum distance between the two aircraft. Figure 1 illustrates the aircrafts' flight tracks based on the radar recording.

8. At the time when HB-VNF passed through the FIN229 altitude, the radar recording indicates that the distance between the two aircraft was 1.8 NM which was also the minimum distance between them.

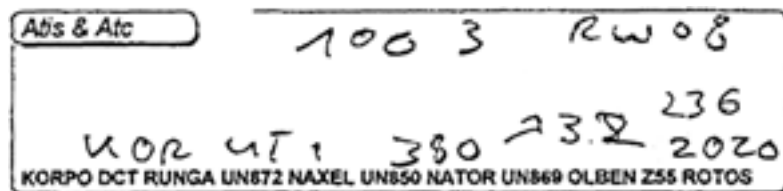
Figure 2. Notes in the upper corner on the HB-VNF operative flight plan

HB-VNF requested start-up clearance from the Turku tower and received it immediately. It requested taxi clearance 2 minutes 46 seconds later and received taxi clearance to holding position runway 08 including information on air pressure QNH 1003. The notes on the flight log about the taxi clearance are visible on the uppermost row in Figure 2.

HB-VNF called the Turku tower one minute after starting to taxi and reported to be ready to copy the route clearance. The pilots requested the clearance because the aircraft was equipped with a flight management system (FMS), into which the departure route data have to be entered manually prior to takeoff when the departure airport does not have any designated standard instrument departure route. The air traffic controller gave the clearance immediately: *"HNF, cleared to Bern via KORPO, UT81, RUNGA, flight level 380, after departure maintain 3200 feet until radial 236, squawk 2020"*. The first officer read back the clearance correctly except for the altitude of 3200 ft which he read as 3500 ft. The air traffic controller corrected the altitude to 3200 ft, after which the first officer read it back correctly. The note on the log about the clearance is visible on the second row in Figure 2. Also the altitude correction can be seen.

Although the first officer read back the clearance correctly, it is possible that the crew in carrying out takeoff briefing and setting the cockpit navigation aids for takeoff, misinterpreted the up arrow in front of the altitude marking 3.2 in the log. The commander stated in his report that they understood the clearance so that they would climb directly to 3200 ft and thereafter home to radial 236. Therefore they also set the aircraft altitude alerter at FL 380. Had they understood the first restrictive altitude to be 3200 ft in the route clearance, they would have set altitude alerter at 3200 ft. In manual controlling the altitude alert function would have informed about the approach of the set altitude and about reaching it, whereas in autopilot mode it would have stopped the climb and levelled the aircraft at this altitude.
