## Investigation report

C 10b/2002 L

# Loss of Separation in the Turku Terminal Area on October 31, 2002

OH-SAI	Avro RJ85
SE-LNV	Jetstream 32

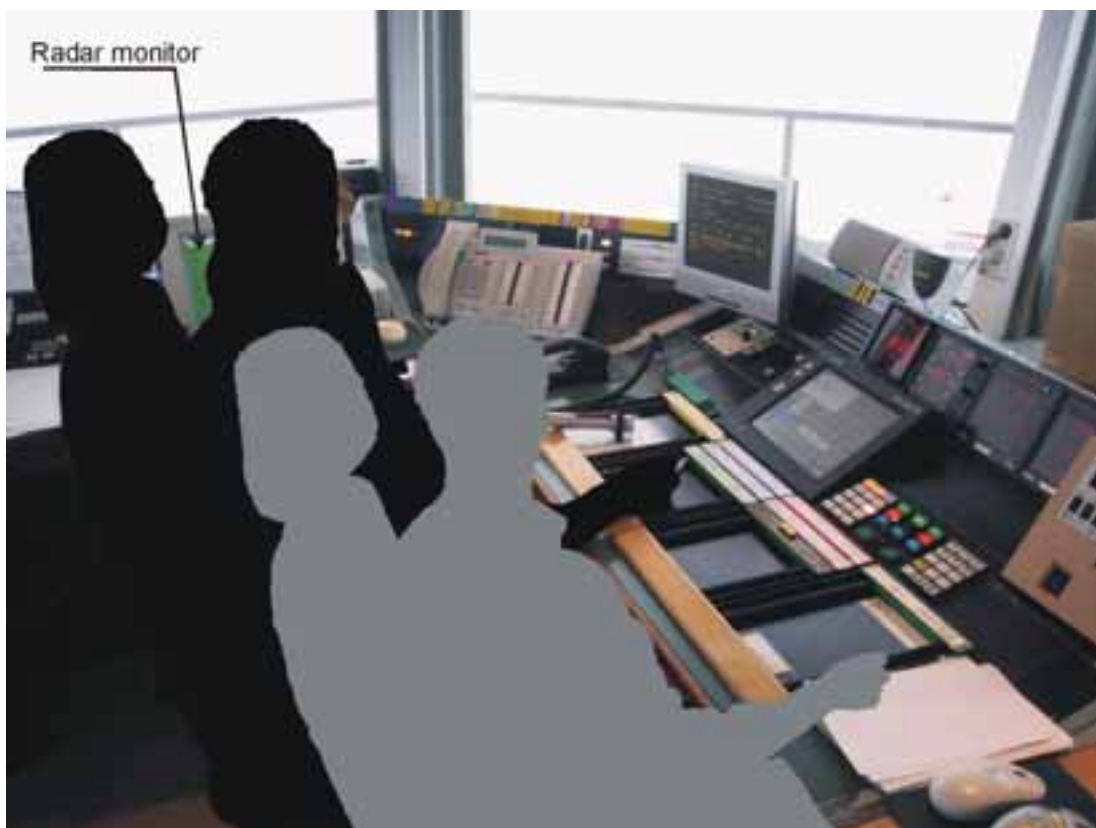
The air traffic controller moved back two to three meters to the right from the student who was sitting at the workstation. At that time daylight conditions prevailed and the visibility was good. The traffic consisted of VFR flights in terminal area. The students had practiced handling this kind of traffic in Avia College's simulator. The student handled the radio communications, made notes of the traffic on the controller's flight strips and took care of the Air Navigation Services system (ANS). She worked well.

The air traffic controller took care of the telephone communication and also made some phone calls not related to operative air traffic control. He could hear the radio communications from the air traffic control loudspeakers and gave air traffic control clearances which the student forwarded by radio to the aircraft. In the Turku air traffic control there was no possibility of monitoring/override system for supervising telephone and radio communications in training situations in accordance with the Finish Civil Aviation Administration's instructions for on-the-job training.

Figure 1. The air traffic controller's view from his position

dent moved so that he was between the student at the workstation and the air traffic controller, which further limited the air traffic controller's possibility of getting information from the strips or radar monitor. An air traffic controller on sick leave came to the air traffic control and took a seat at the above-mentioned computer terminal.

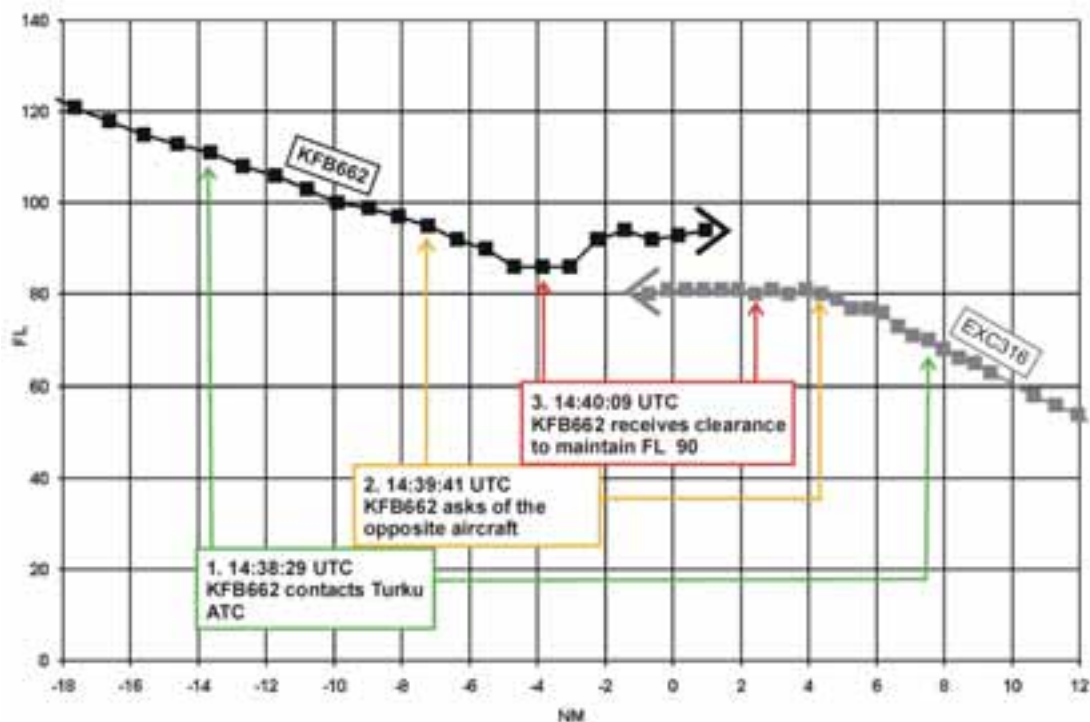
Figure 2. Altitude profiles of KFB662 and EXC316 based on the radar recording

craft had already passed through it. KFB662 climbed to this clearance altitude after having visited FL 85, where it had remained in level flight for a while waiting for the air traffic controller's instructions after having received a TCAS traffic advisory. The vertical separation minimum halved, but there was no collision hazard for the two aircraft.

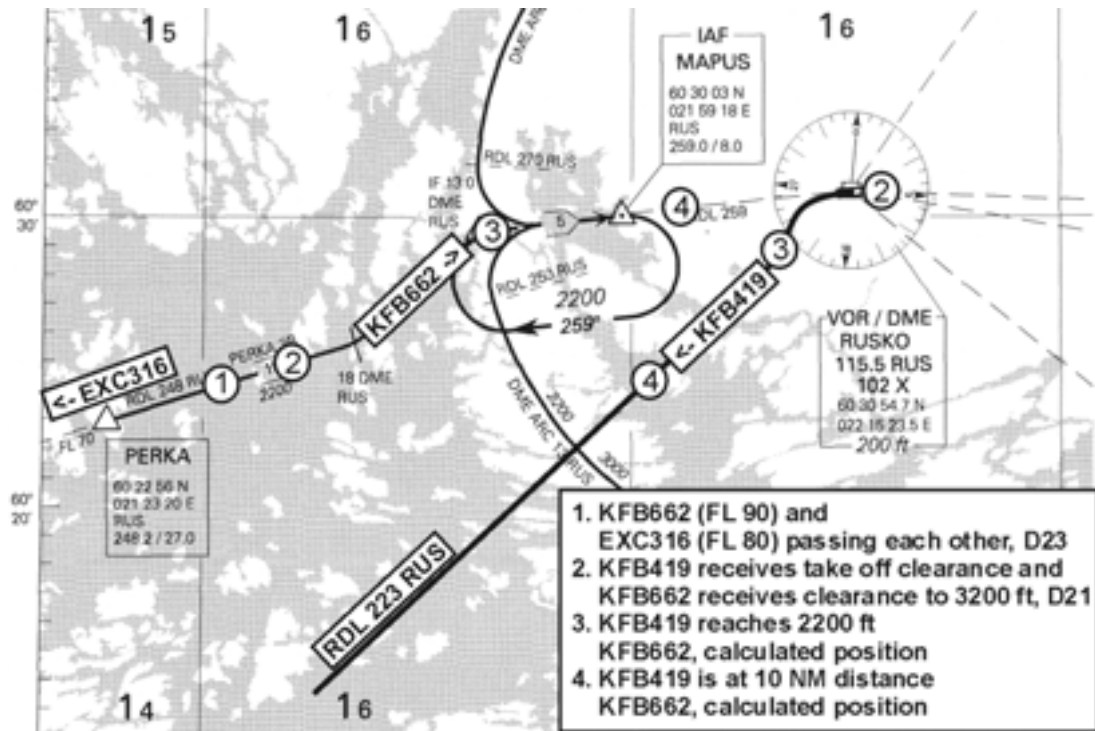
Runway 08 was in use in Turku. The air traffic controller used, however, runway 26 to all traffic. As a traffic situation solution it is not a well-functioning method to use opposite runways (08 and 26) for three departing and one arriving aircraft, all on the same route and the fastest of the departing aircraft last in the departure sequence with clearance to climb above the other departing aircraft. The air traffic controller should have used only one runway for KFB419 and KFB662. Then the arriving KFB662 would have been cleared to approach runway 26 from the beginning on which it finally landed, or the departing KFB419 would have used runway 08 which was the runway in use in Turku. Fig-

ure 3 illustrates the calculated locations of KFB662 and KFB419 based on the radio communications.

Figure 3. Flight tracks of KFB662 and KFB419

If KFB662 had used runway 08 for landing and KFB419 had taken off from runway 26, as originally planned, KFB419 should have taken off at the latest when the arriving KFB662 was PERKA inbound.

The use of opposite runways is a flexible solution, but risky. This easily leads to a situation in which the arriving aircraft cannot land on the planned runway and given clearances have to be quickly changed resulting in increased risk of misunderstandings.
