## Incident report

C 2/2002 L

# Loss of separation south east of Helsinki-Vantaa, Finland on 11.1.2002

RA11962     Antonov An -12

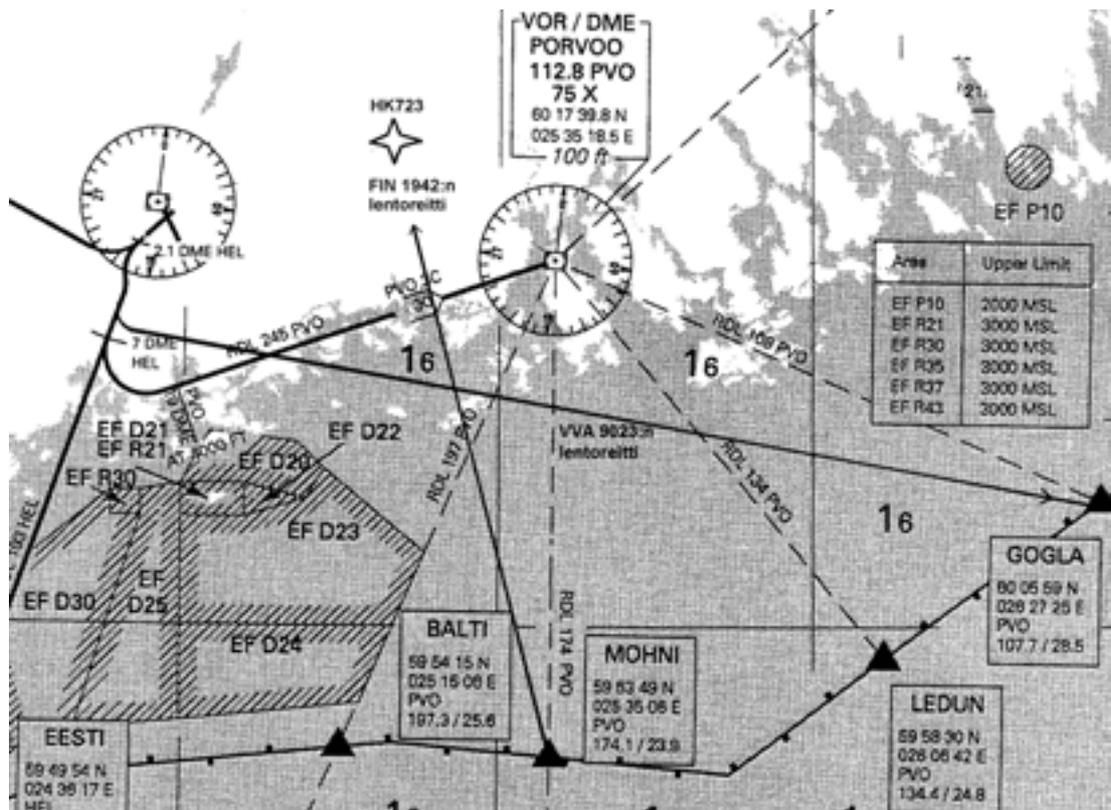
Picture 1. Routes of the aircraft

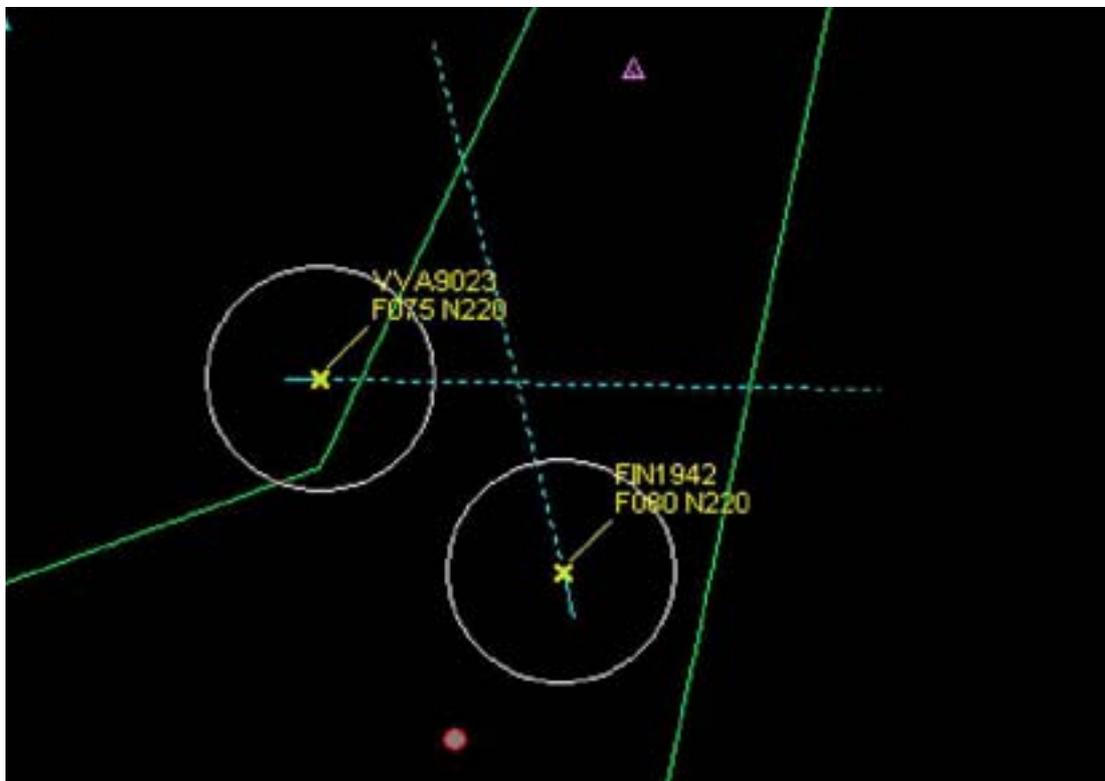
Less than a minute later, at 15.56.05, the cockpit crew of FIN1942 and both controllers noticed that VVA9023 had not maintained flight level 70, but was passing flight level 75 climbing. The distance between the aircraft was about four nautical miles and their flight paths were crossing. In addition to this the commander of FIN1942 had visual contact of VVA9023. According to his statement he found An-12 continuing its climb.

Picture 2. Positions and C-mode altitudes of the aircraft in the beginning of the evasion

Despite that the TCAS-system of FIN1942 had not yet given evasion instruction and the air traffic control had not yet had time to interfere, the cockpit crew decided to take evasive manoeuvre by a gentle climb over VVA9023. The commander informed the APP controller, who gave them clearance to climb to flight level 90 and allowed it to turn at pilots discretion. The horizontal evasion was possible, hence other incoming traffic was far enough in south west although at the same flight level.

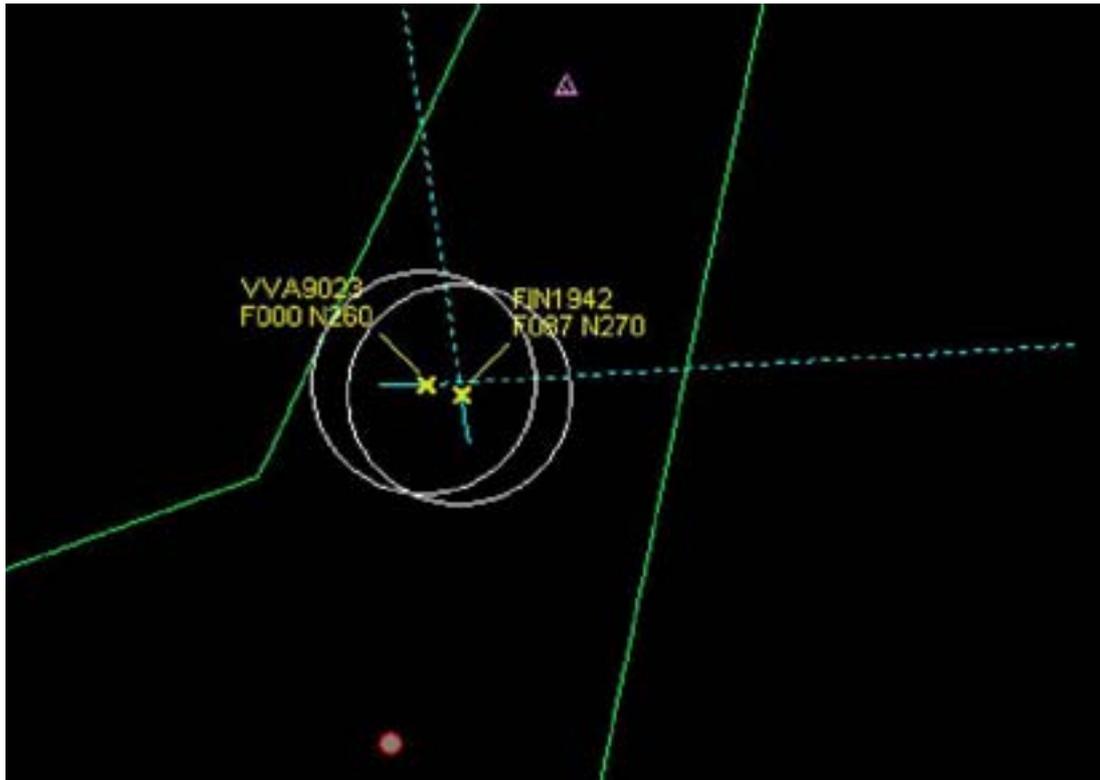
At 15.56.10 when the air traffic controller ordered VVA9023 to descend to flight level 70, the aircraft did not descend immediately. According to the radar recording it maintained flight level 74-73 for approximately 20 seconds, which after C-mode altitude indication of

VVA9023 disappeared for approximately 20 seconds from radar screen. When the altitude indication resumed, the aircraft was at flight level 70. The reason for altitude indication disappearance could not be solved during the investigation. Possible reasons could be either communication interruption between the transponder of VVA9023 and SSR radar or that the transponder of VVA9023 did not send the C-mode information at that time.

Picture 3. The positions and C-mode altitudes of the aircraft at the passing moment
