Investigation Report

C 3/2002 L

Violation of the Radar Separation Minima in the Vicinity of Helsinki Terminal Area on 17 January 2002

HA-LMD Fokker F28 Mk0070

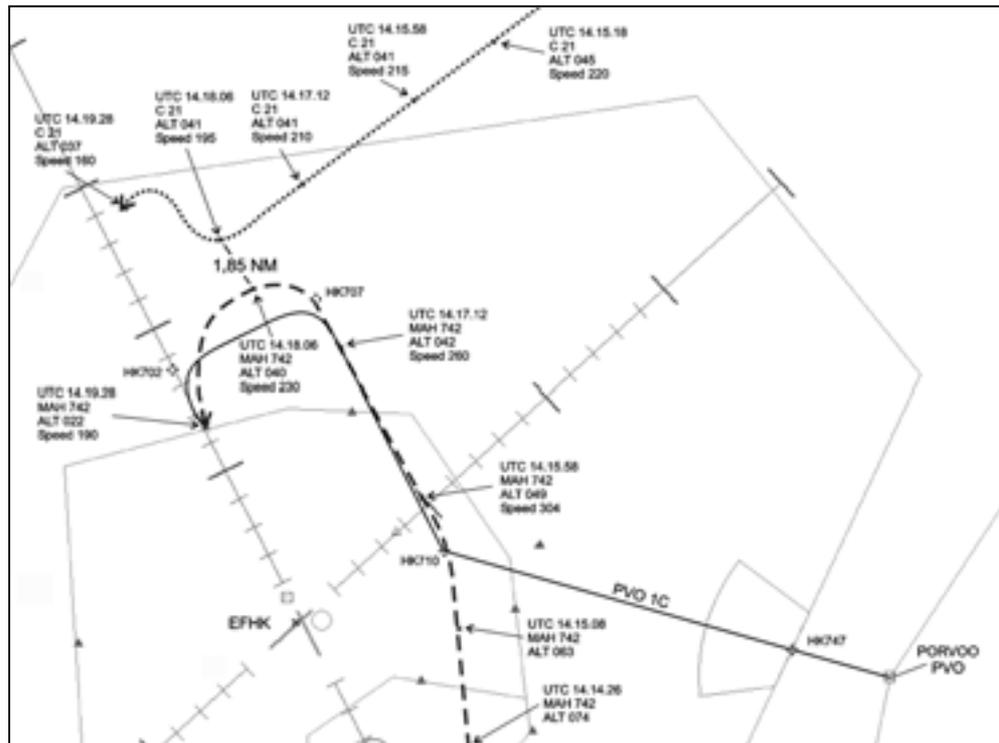
At 14.17.32, after noticing that MAH742 did not initiate a left turn in accordance with the PVO 1C transition before waypoint HK707, ARR ATCO told MAH742 immediately to initiate a left turn to heading 220°. MAH742 acknowledged this order. According to the cockpit crew, the Flight Management System (FMS) of the aircraft initiated the turn for base leg simultaneously. The crew saw the Fokker 27 (C21) above them when starting the turn until they dived into clouds. At 14.17.47 ARR ATCO told Finnish Air Force C21 to turn right to heading 330°. At that point, C21 was maintaining 4100 feet. The top of the clouds was at about 3800 feet, and so both aircraft were above clouds in visual flight conditions. The aircraft were at the closest 1,85 nautical miles from each other.

Picture 1. Flight paths of MAH742 and C21

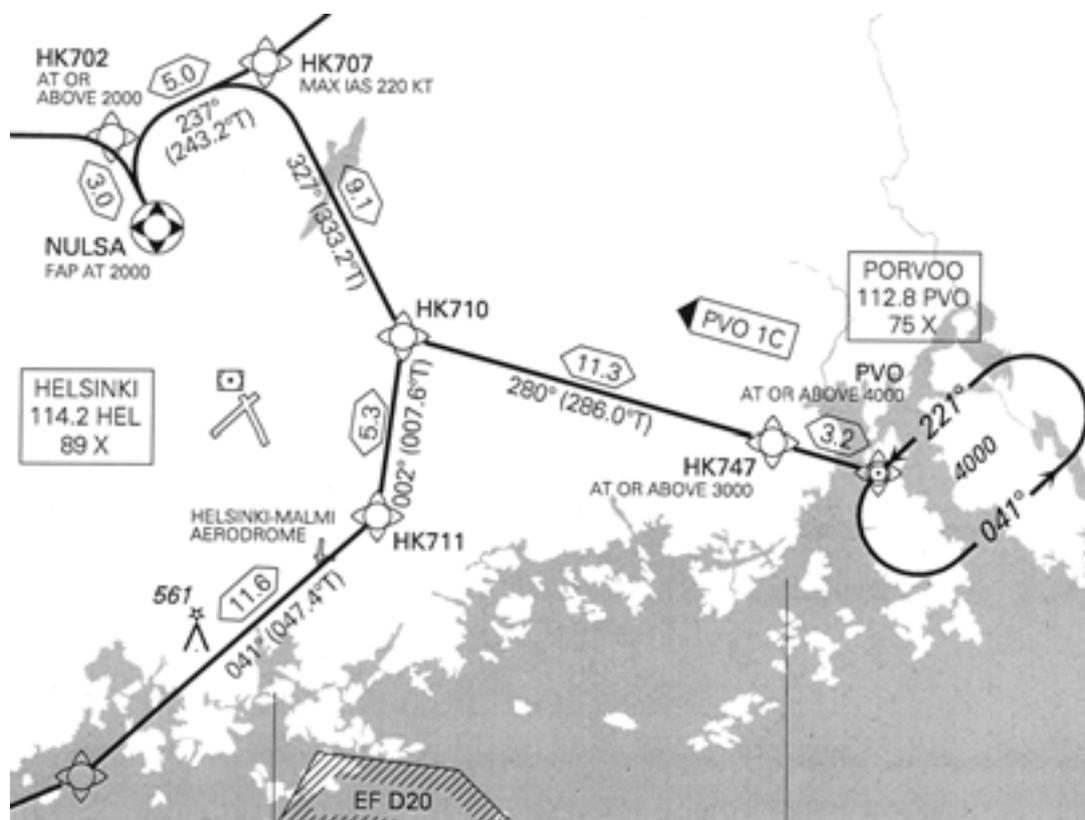
ends at the NULSA waypoint. The transition has six waypoints altogether. There is no accuracy requirement for the RNAV procedure on the chart.

Picture 2. Short RNAV transitions for runway 15 at Helsinki-Vantaa according to AIP

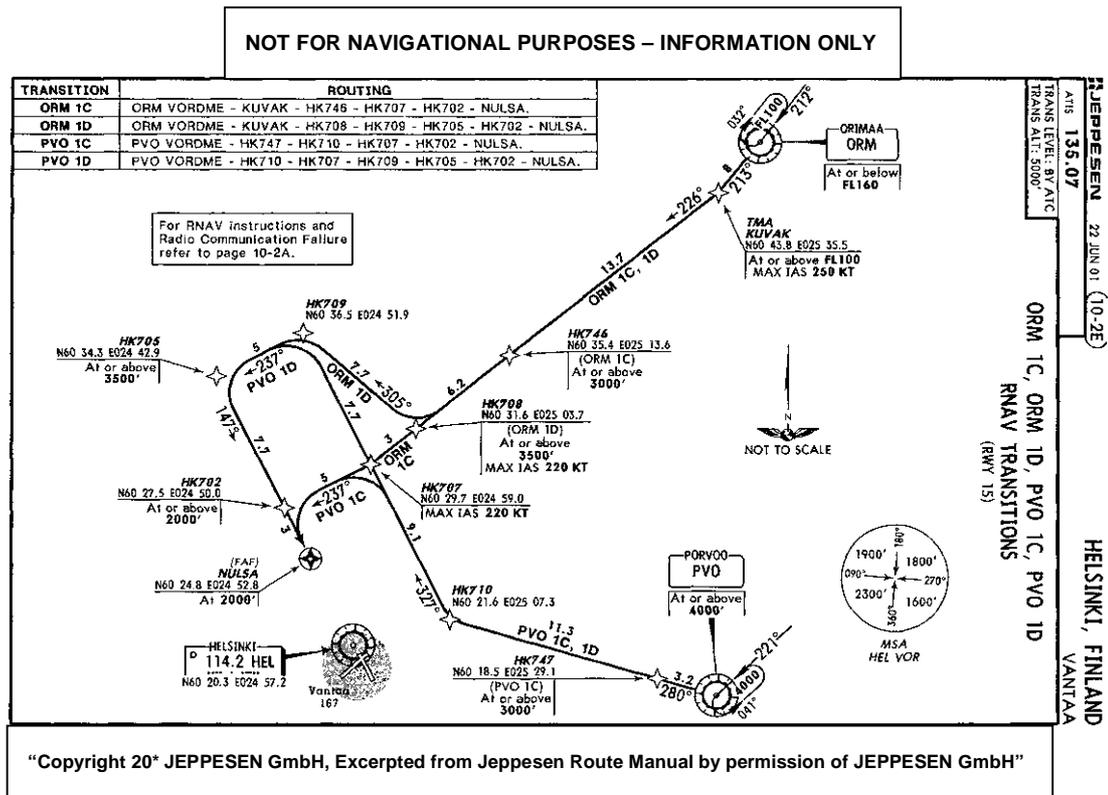
The cockpit crew used for navigation the Jeppesen chart shown in Picture 6, illustrating both the short transition route PVO 1C and the long route PVO 1D for runway 15. The information on the chart was in accordance with the data published by FCAA in AIP Finland. The investigators see that it could have been possible to mistake between the short and long transition routes effective at the time of the occurrence, especially because they were published on the same page of the chart. If the cockpit crew had chosen PVO 1D as their transition route, MAH742 would have flown over HK707 as it now did. However, the flight would have continued directly towards waypoint HK709. If the required navigation performance of Helsinki-Vantaa PVO 1C had been published in Jeppesen Route Manual as required in EUROCONTROL instructions, the cockpit crew of MAH742 could have noticed the accuracy requirement for the procedure and requested a new alternative arrival clearance.

Picture 5. Extract from Jeppesen Route Manual Page 10-2E, 22 JUN 01
