Investigation report

C 9/2002 L

Loss of separation over BALTI on 6.9.2002

OH-LYV DC-9

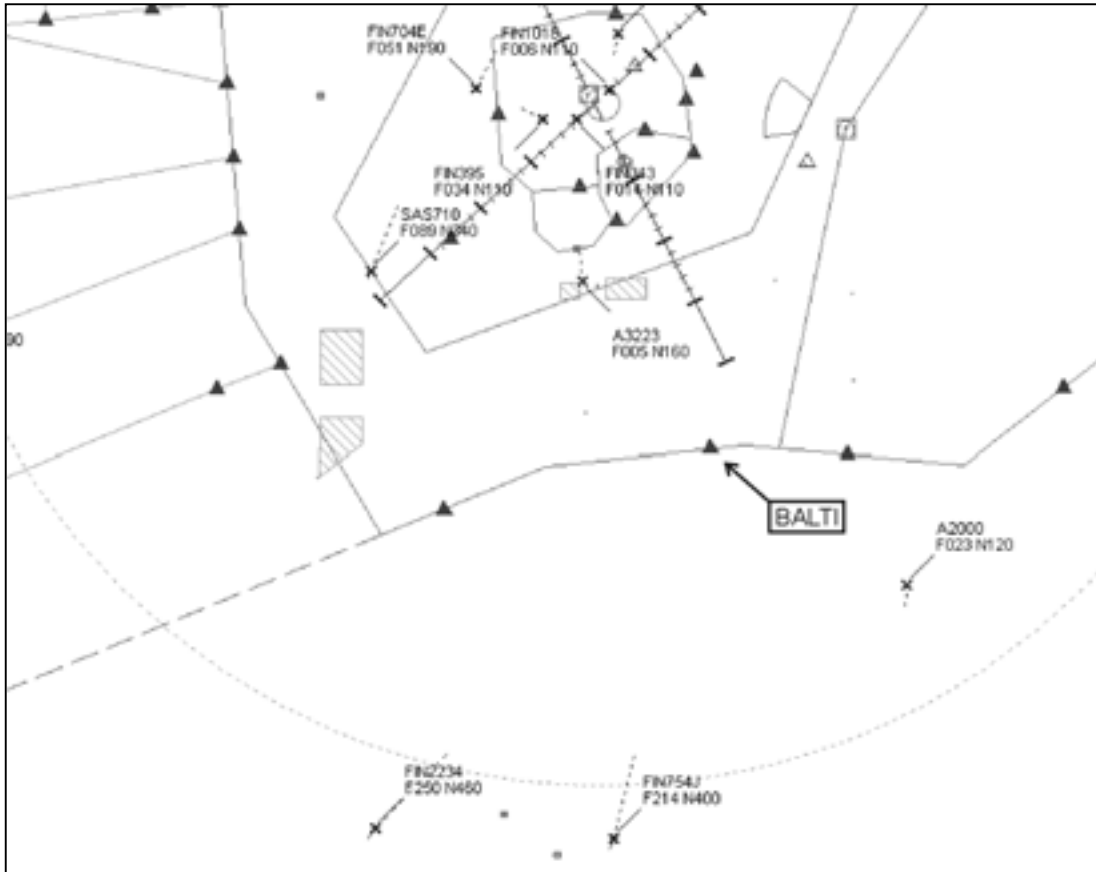
At 09.47.50 TLL-APP asked about FIN754J's rate of descent: *"Finnair, report rate of descent."* The crew reported that the aircraft was descending 2000 feet per minute. At 09.48.00 the controller told FIN754J to maintain the rate of descent 2000 ft/min or more: *"Finnair 754J, maintain rate of descent 2000 feet per minute or more."* The crew read back the restriction: *"2000 feet per minute or more, Finnair 754J"*. Thereafter TLL-APP called FIN2234 and, at 09.48.10, cleared it to descend to FL 130 at a rate of descent of 2000 ft/min or less: *"Finnair 2234, continue descent to FL 130, rate of descent 2000 feet per minute or less."* The pilot-in-command of FIN2234 (PNF, pilot not flying), who was handling the radio communications, read back the clearance: *"130 and 2000 or less, Finnair 2234."* According to radar recordings, the vertical distance between the two aircraft when they acknowledged the rate of descent restrictions issued by the controller was about 3500 feet, while FIN754J was flying lower.

Figure 1. Positions and flight levels of the aircraft when the rate of descent restriction was issued at 09.48.00 UTC

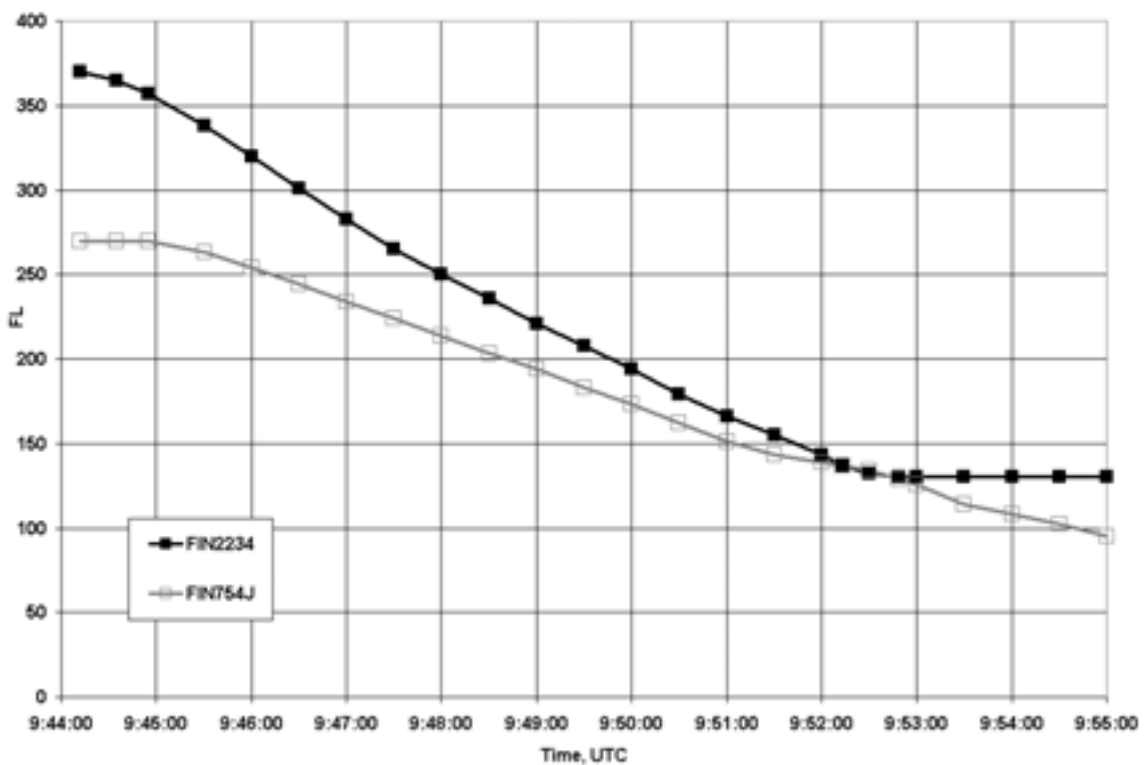
The controller monitored both aircraft's descent and noted that FIN2234 was faster and the vertical distance was decreasing, but assumed that a vertical separation of at least 1000 feet would be maintained until the planes were handed off to Helsinki approach frequency. The Tallinn controller did not adjust their speeds, since he was not sure which one Helsinki approach would take in first. The controller did not inform Helsinki approach of the restrictions, because he assumed that vertical separation would be maintained by the rate of descent restrictions. When the radio contact was transferred to Helsinki approach, the planes had not reached their cleared flight levels yet.

Figure 4. Flight profiles

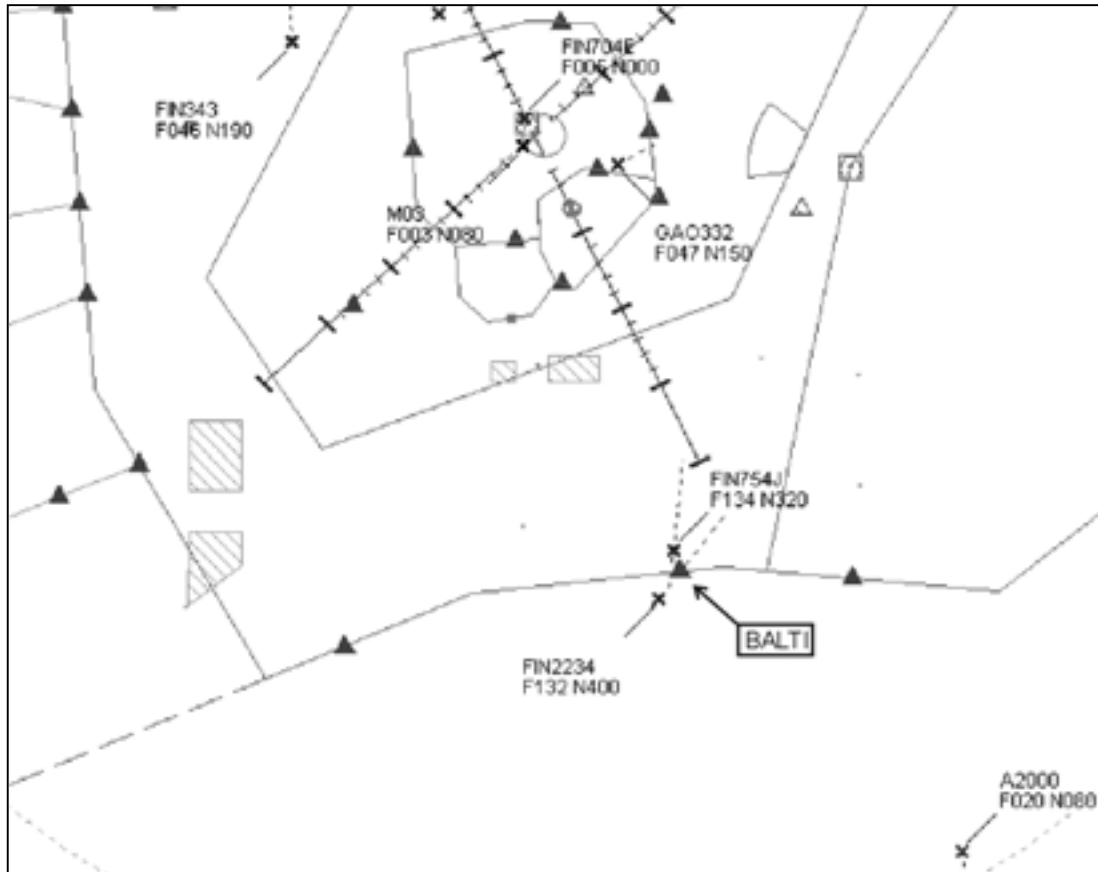
The controller noticed the loss of standard vertical separation between the aircraft. Although FIN2234's flight path would have passed behind FIN754J at an angle of about 30°, he instructed FIN2234 to turn right using the word "immediately": *"Finnair 2234 right heading 090 immediately."* The crew read back the heading and reported having the

traffic in sight: *"Right heading 090 and traffic in sight, Finnair 2234."* Simultaneously at 09.52.20 the Tallinn controller, who had perceived the situation developing, telephoned and told about the restriction issued. The call was answered by the assistant. Because of the unusual nature and obscurity of the message, the Tallinn controller had to repeat it, and the situation was practically over during the phone call.

Figure 7. Positions and flight levels of the aircraft at 09.52.30
