Investigation report

C 1/2003 L

Loss of separation west of Helsinki-Vantaa airport on 22.1.2003

RA-85185 Tu-154M

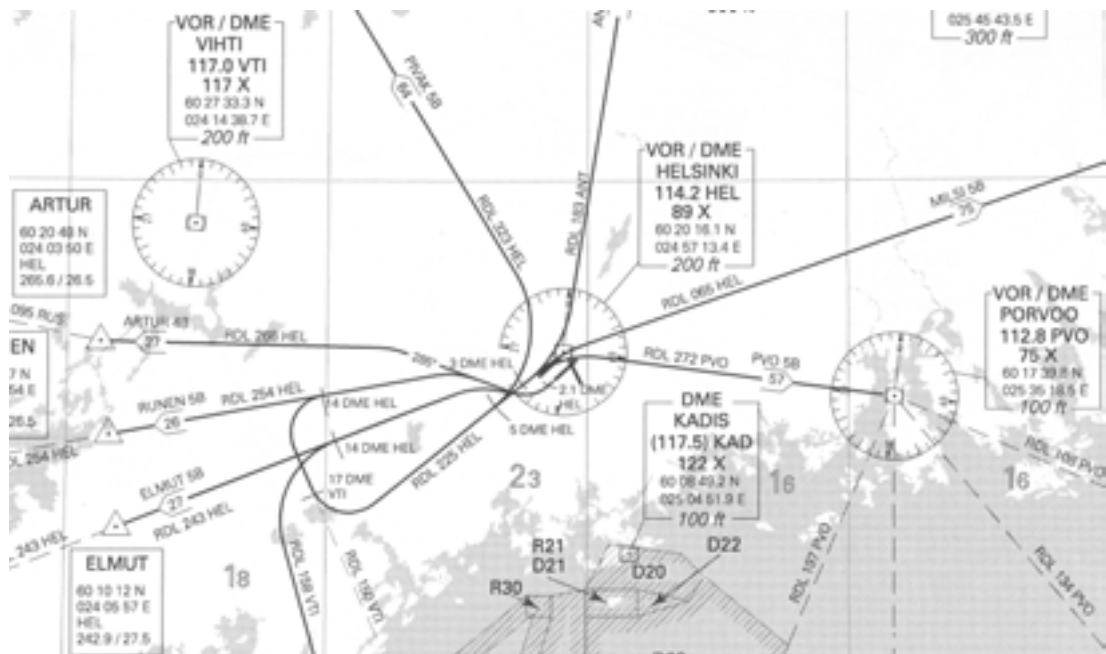
Figure 1. Standard Instrument Departures ARTUR 4B and PORVOO 5B

Finnair Oyj's ATR72, OH-KRC with callsign FIN225, departed from runway 22L to Turku at 18.53 UTC and was cleared to follow the Standard Instrument Departure (SID) ARTUR 4B. Pulkovo Airlines Tu-154M, RA-85185 with callsign PLK230, departed from the same runway to St.Petersburg at 18.55 and was cleared to follow SID PORVOO 5B. The SIDs are presented in figure 1.

The beginning of both SIDs is identical. They turn right to track 285° at a distance of 2.1 NM from HEL VOR/DME. After this the aircraft is supposed to intercept and follow HEL VOR/DME radial 266 with ARTUR 4B and radial 254 with PORVOO 5B. The SIDs include instructions to contact Helsinki Radar when passing 1500 ft (QNH), and to climb initially to 4000 feet. Both the Finnish Aeronautical Information Publication (AIP) and the Jeppesen Airway Manual contain the following instructions:

Climb to 4000 ft or assigned altitude if lower. Climb to higher level only when cleared by ATC. When passing 1500 ft contact Helsinki Radar.

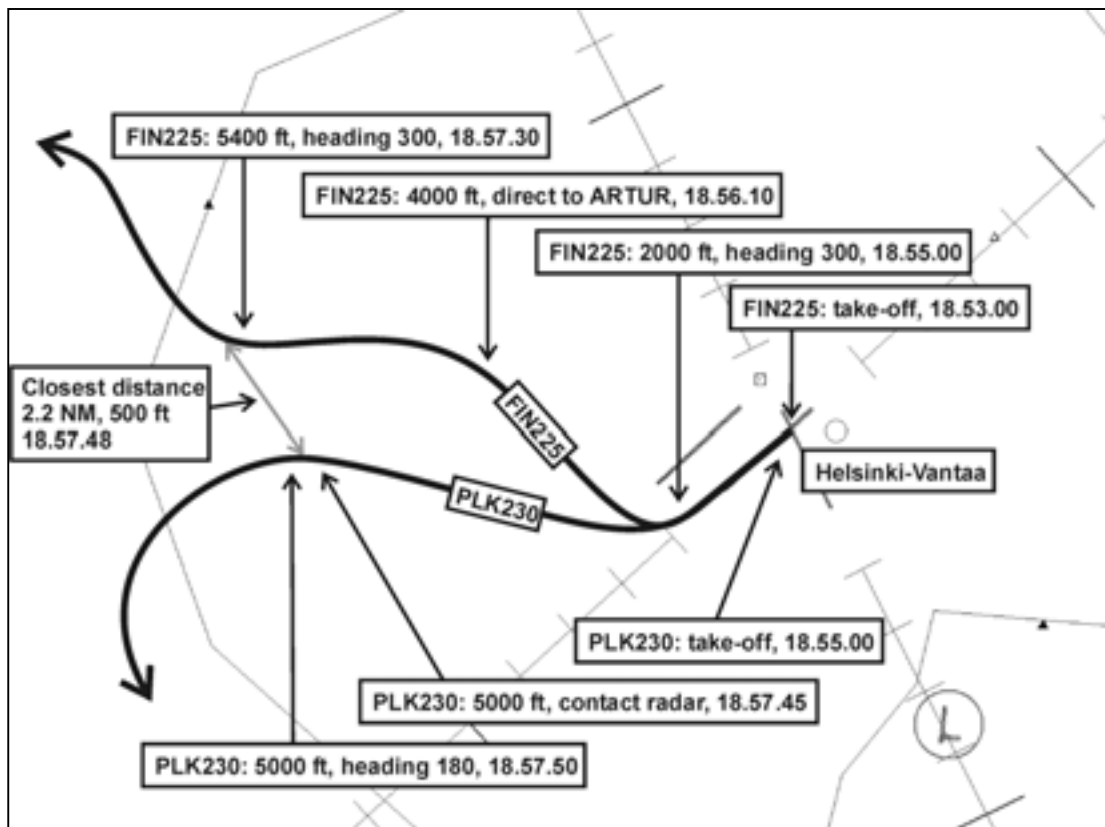
Figure 2. Flight tracks of the aircraft

There was no danger of mid-air collision, but the Accident Investigation Board Finland decided to investigate the incident because the required 3 NM radar separation was lost. The closest horizontal distance between FIN225 and PLK230 was 2.2 NM according to the Helsinki radar recording. The vertical distance between the aircraft was 500 feet at that time. It should have been at least 1000 feet for the required vertical separation to exist. If the vertical separation is less than 1000 feet, horizontal separation must be at least 5 NM. The flight paths of the aircraft were divergent at the closest point of approach. The radar controller had the situation under control at all times even though PLK230 was not able to establish radio contact with him before it had climbed above the initial climb altitude.
