## Investigation report

B 1/2005L

### **Serious incident at Kittilä airport on 4 January 2005**

Tupolev Tu-154M

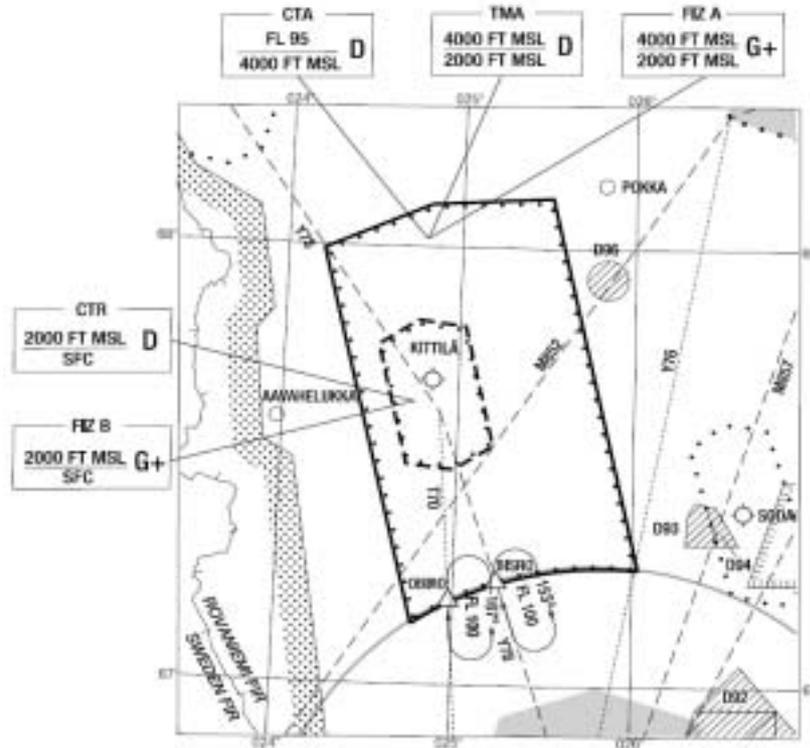
This temporary arrangement was published in AIP Finland supplement 66/2004. The purpose of the temporary airspace structure change was to guarantee the safe and flexible conduct of air traffic to Kittilä aerodrome in response to changes in traffic volume. This was implemented by providing ATC services at Kittilä aerodrome during times of high traffic volume and by controlling Kittilä traffic from a separate feeding sector that was established at Rovaniemi ACC. At the time of the incident this arrangement was not in force. Air traffic clearances did not make use of airspace class D between 4,000 ft and FL 95.

Figure 1. Airspace structure (Source: Finnish AIP)

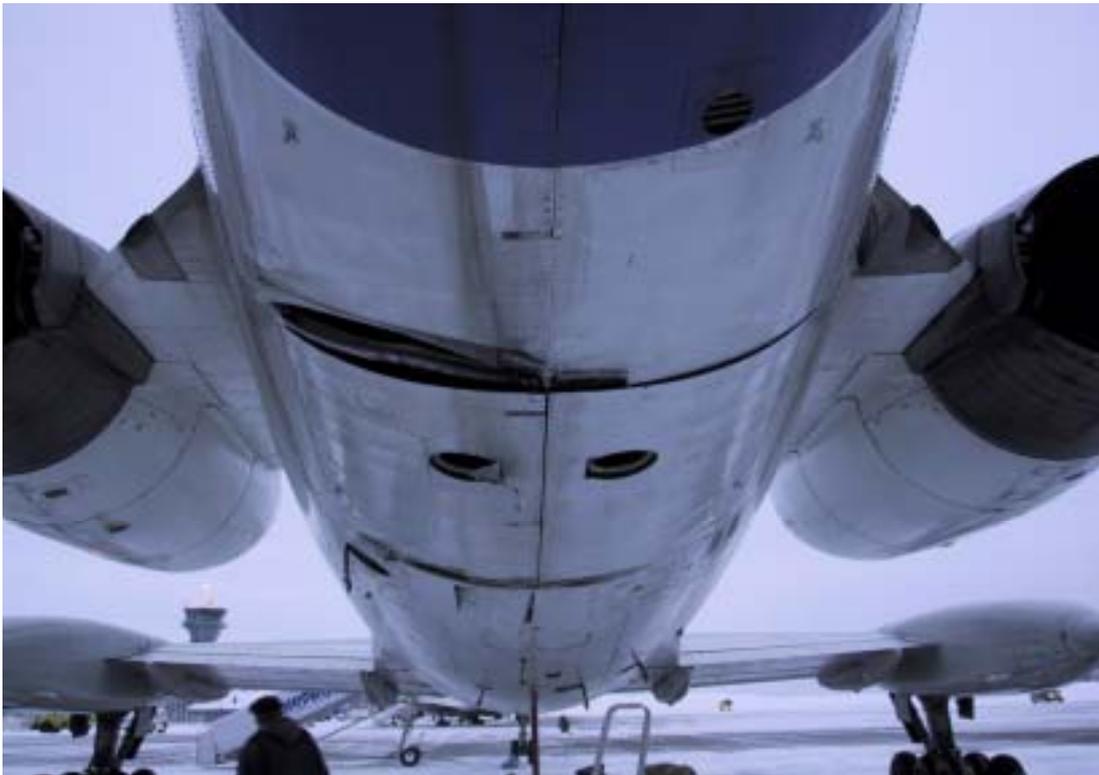
Figure 3, Fuselage tail end damage

The tips of both trailing edge flap shrouds on number 1 flap rails on both wings were dented, torn and laterally shifted. The affected area was approximately 300 x 200 mm. Fuselage skin panels were torn on the lower right side between bulkheads 68 and 69.

The tears were ca. 600 mm long. The fuselage itself was structurally intact. The glass top cover of the lower beacon light was broken.

The APU (Auxiliary Power Unit) air inlet flap hinge fixtures were damaged. The inlet flap was bent and after the aircraft taxied to the stand and the crew started the APU, it got stuck in its opening. The left bracket was damaged and the right bracket had shifted. There was a 30 mm long tear in the fuselage panel. The APU air duct was deformed; a 150 mm section had moved all the way to the number 2 engine oil reservoir strut. The reservoir itself was intact. The vertical firewall between the APU cowlings displayed shallow depressions, approximately 0.15 mm deep. The depth of the depression for the entire length of the lower wing spar (area) was approximately 8 mm. The rearmost antenna was deformed.

The detachable mount for engine number two front and middle cowl doors was damaged. The cowling displayed some deformation; the skin panel was bent inwards and also partially torn. The panel stiffener had been deformed. Cowl attachments and both cowl door locks were intact.

The door mountings of avionics compartment no. 5 were torn. The cargo door mounting was damaged on the left side. There were dents in the fuselage skin, although no damage on the inside. Rearmost bulkheads displayed dents and deformation.

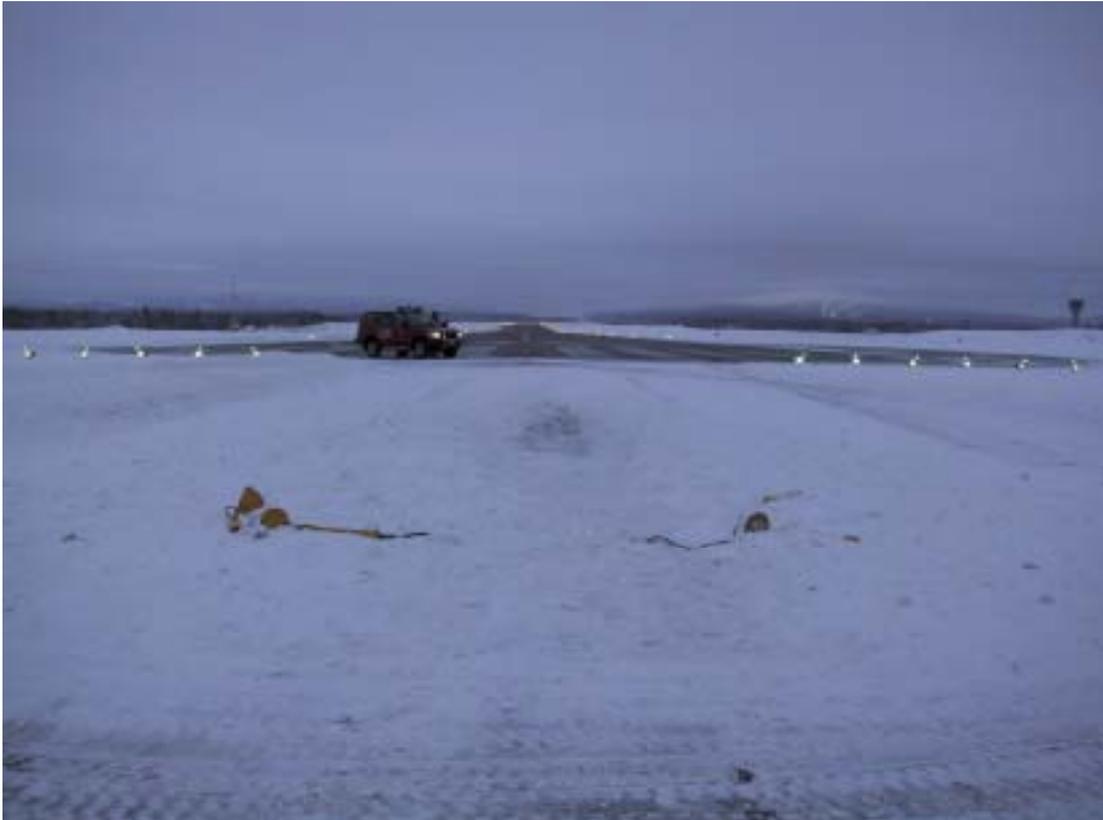
Figure 4. Touchdown point

The first time the undercarriage touched down was 25 metres before the runway 34 threshold lights. The tail cone left marks 30 metres before the threshold and the trailing edge flap tips left marks 19 metres before the threshold. When the fuselage tail end touched down, it broke four approach lights prior to the threshold.

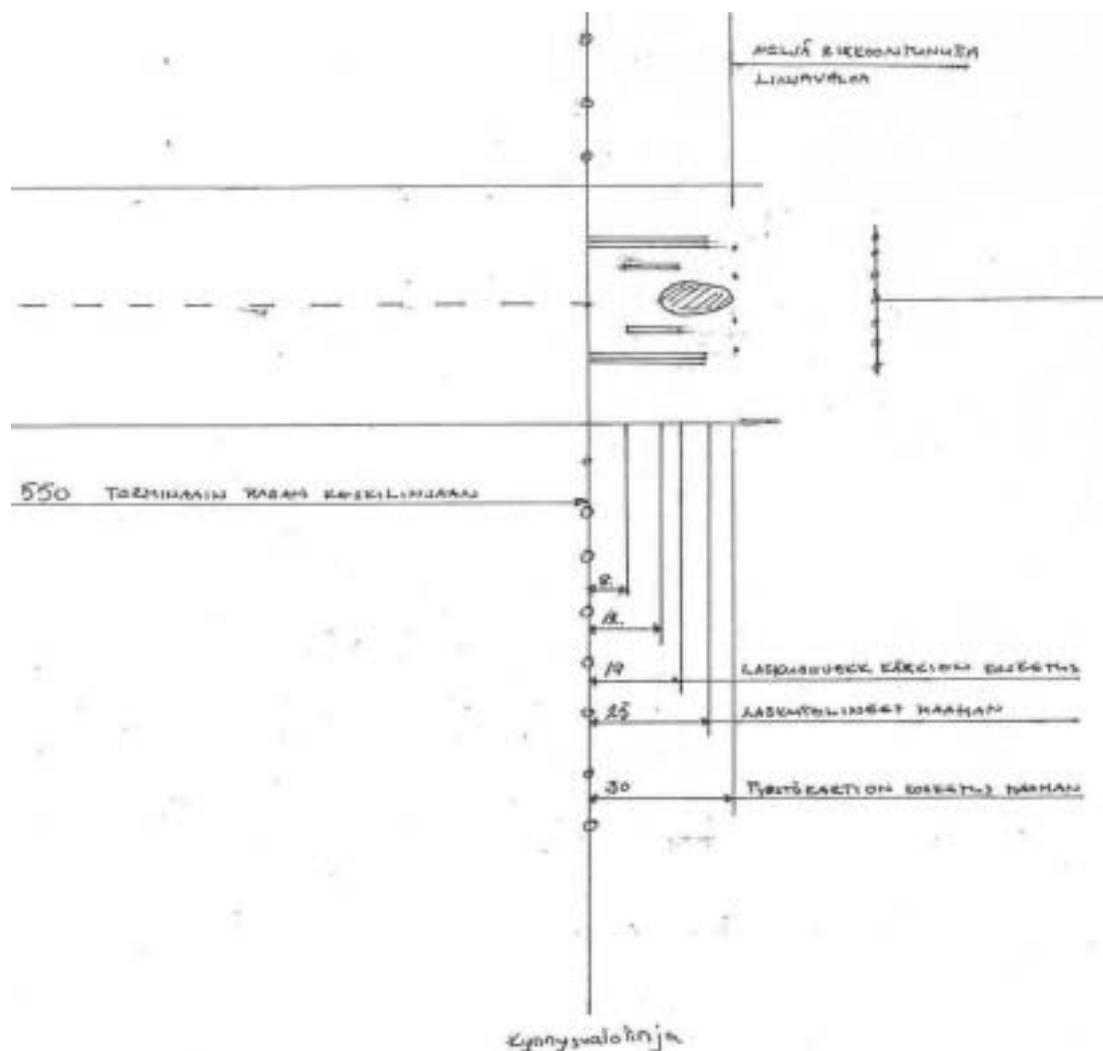
Figure 5. Site sketch (Source: Kittilä police)

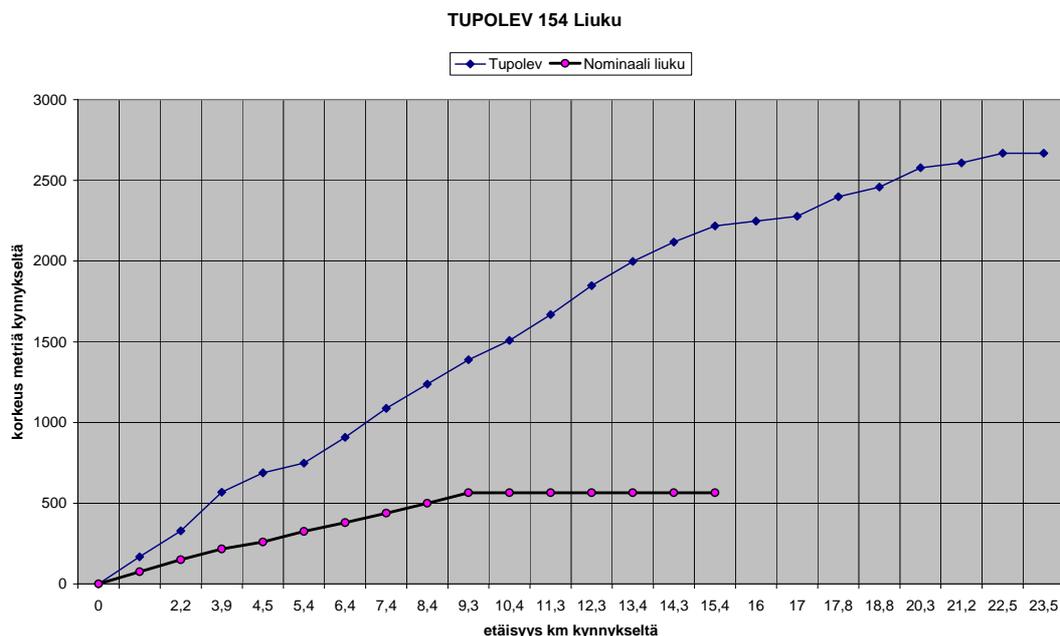
The flight profile of the aircraft was analysed on the basis of recorded radar information. The following table, plotted on the basis of said data, illustrates the descent profile.

Table 1. Descent profile, plotted on the basis of radar data
