Investigation report

C6/2005L

Helicopter accident in the vicinity of the Vuomaselkä in Sodankylä on 21.9.2005

OH-HAY

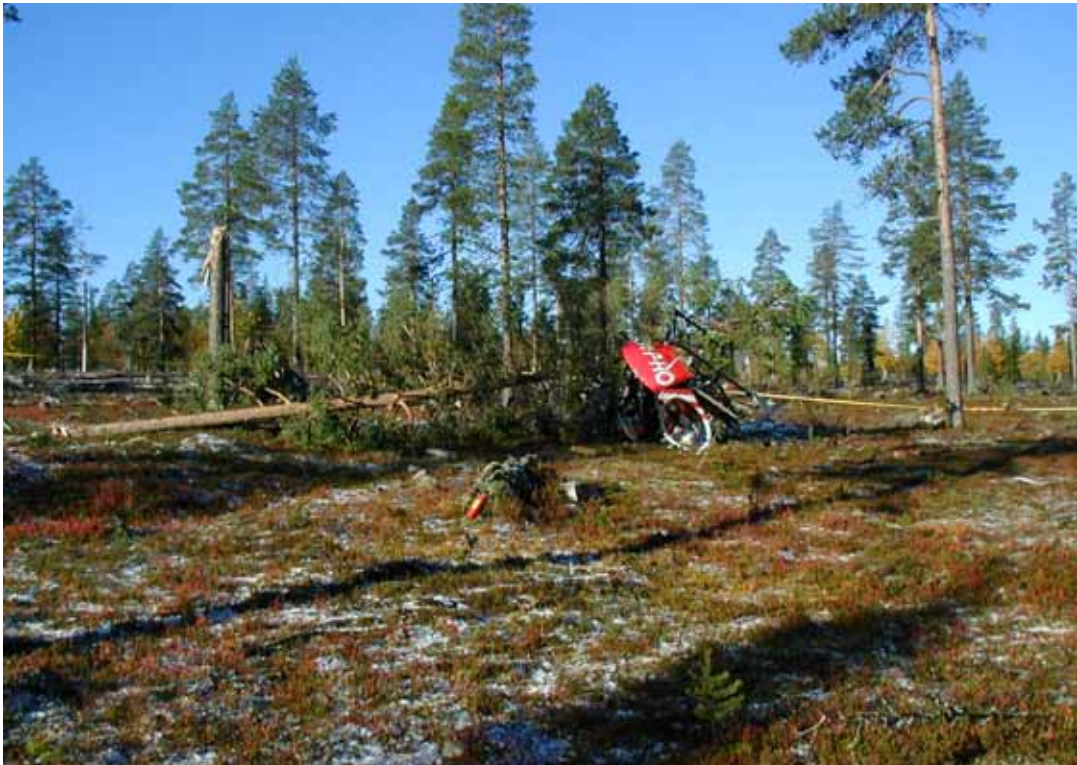
Figure 1. Place of the helicopter impacting on the ground. The helicopter flight direction was from the left to the right. The tree on the left was cut by the main rotor blades.

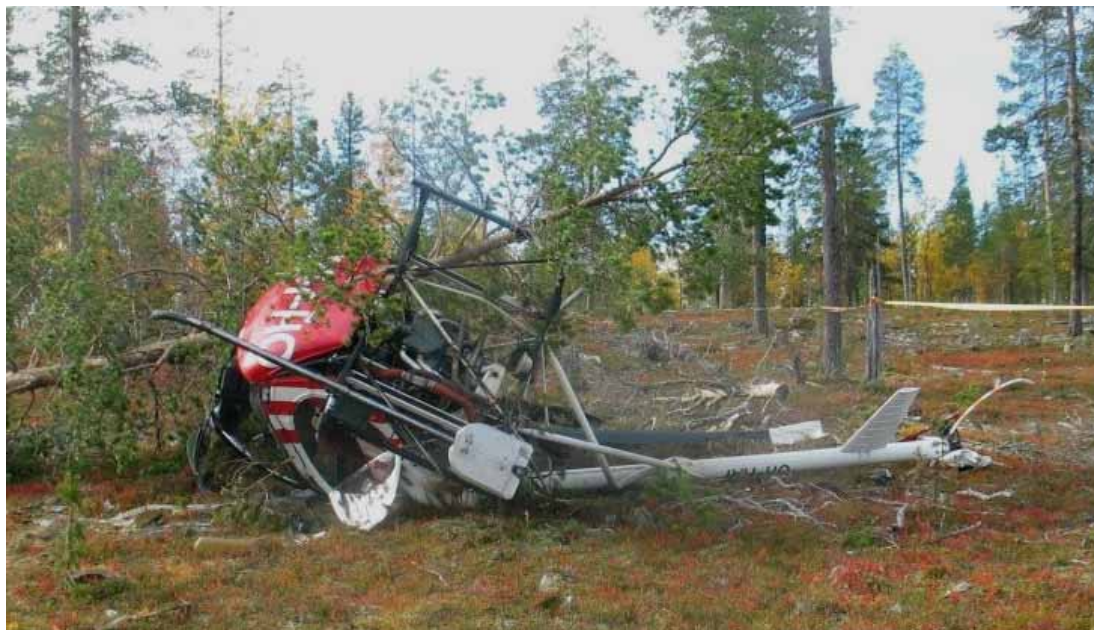
Figure 2. An overview of the helicopter at the accident site.

The helicopter was substantially damaged.

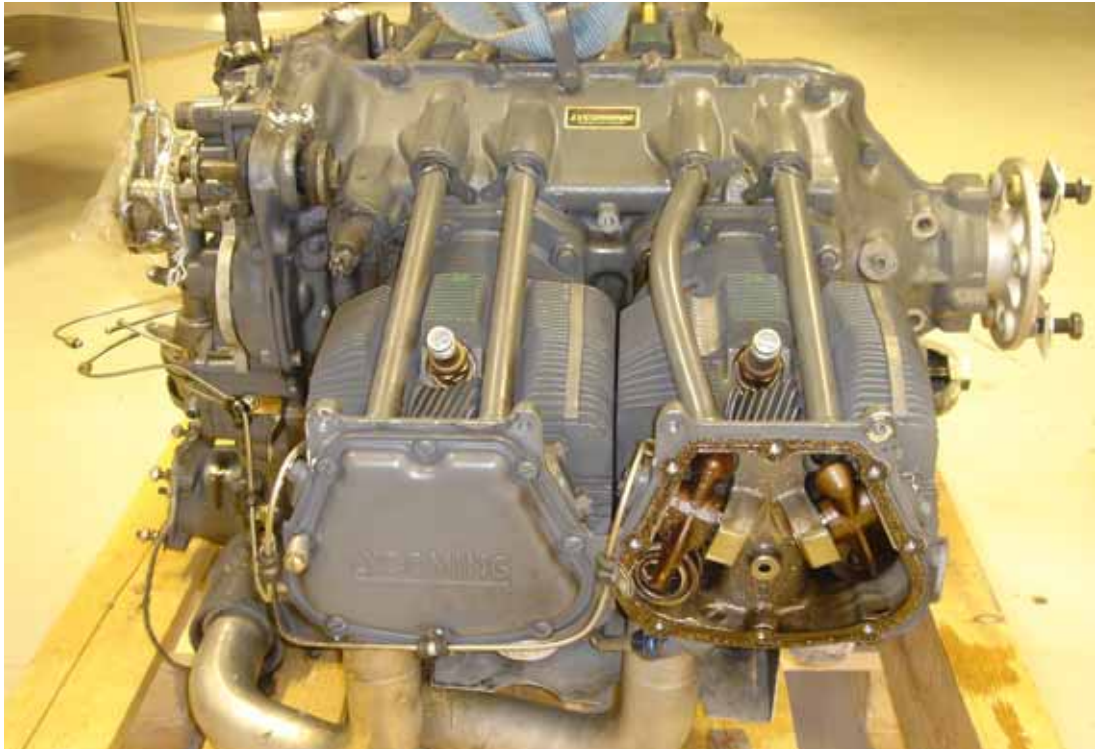
In the external inspection it was noticed that the shroud tube of engine cylinder number 1 intake valve pushrod was bent. A closer inspection showed, that the outer valve spring seat of the intake (P/N LW10077, Lot 17328 33-04) was broken apart and the valve had freely moved into the cylinder. Within the cylinder the valve was broken in several pieces. The valve shaft was broken above the valve plate and pushed by the piston the valve shaft had pushed the valve guide out of its place. The majority of the valve seat pieces were in the intake channel and a portion in the damaged cylinder.

Figure 3. The bent shroud tube of cylinder number 1 intake valve pushrod.

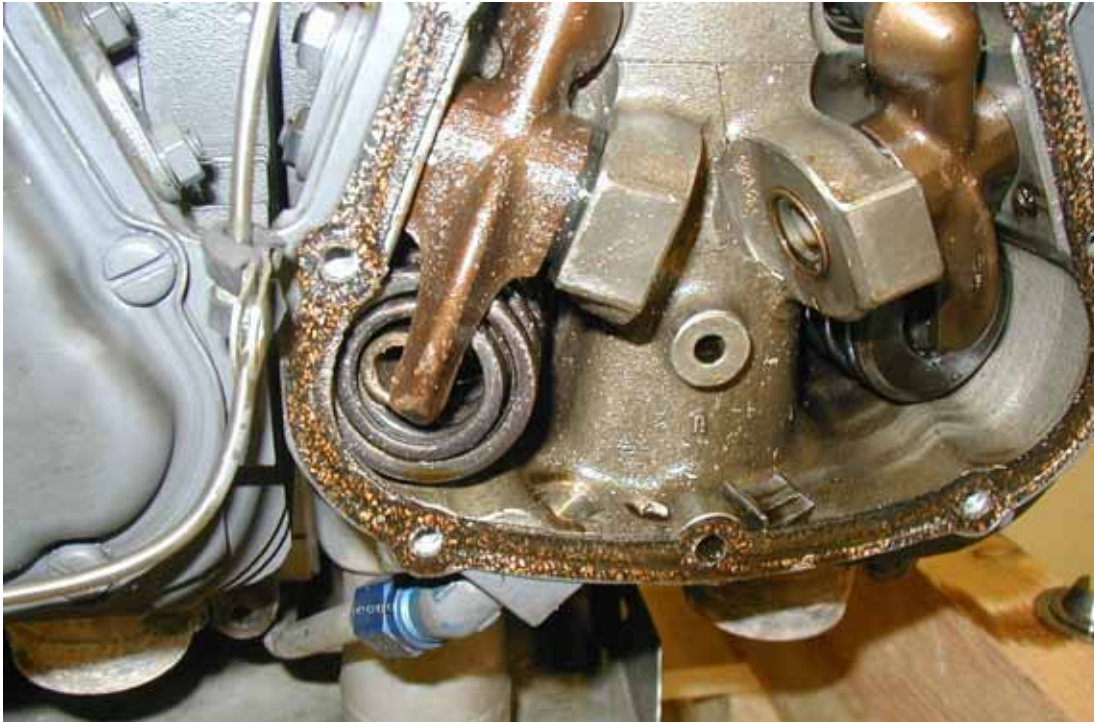
Figure 4. The intake valve of cylinder number 1 had moved into the cylinder.

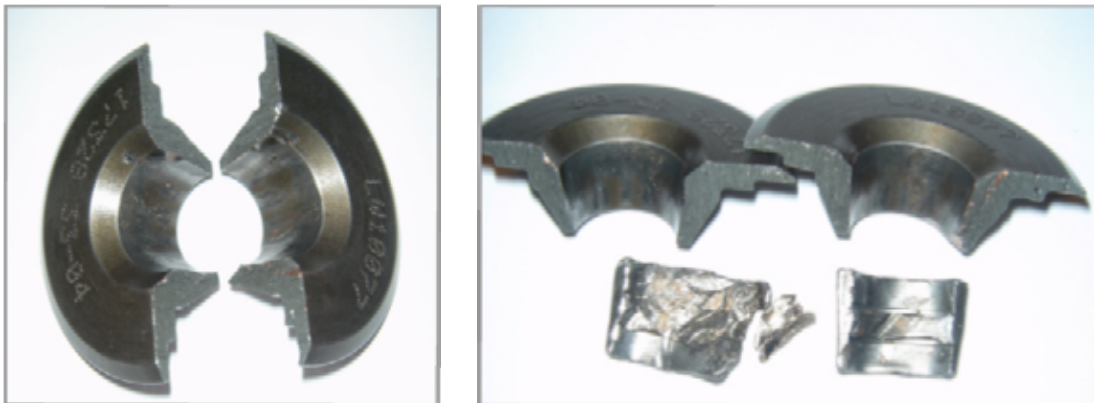
Figure 5. The broken outer valve spring seat and valve retaining keys of cylinder number 1 intake valve.

Besides the engine cylinder number 1 broken intake outer valve spring seat there were fractures in intake valve spring seats of three other cylinders. According to the investigations of Oulu University the most probable cause for the fracture of the intake outer valve spring seats is a weak carbon case hardening (thin layer and low hardness) with a ferrite web formed in the surface in the carbon case hardening. At the same time the entire advantage of the carbon case hardening, a compression stress in the surface, is lost. Cylinder number 4 spring seat and thickness barely fulfil the minimum requirements of the engine manufacturer. The hardness of the carbon case hardening of cylinder 1, 2 and 3 on the contrary did not fulfil the minimum requirement. Moreover the thickness of the hardened layer was less than claimed by the requirements. Consequently the hardening had failed and the spring seats did not endure normal usage a longer time.

1. The European Aviation Safety Agency, EASA, and the Federal Aviation Administration, FAA; should take action so that all intake outer valve spring seats P/N LW10077 of production lot 17328 33-04 of Textron-Lycoming engine HIO-360-D1A shall be replaced by corresponding spring seats of another production lot.

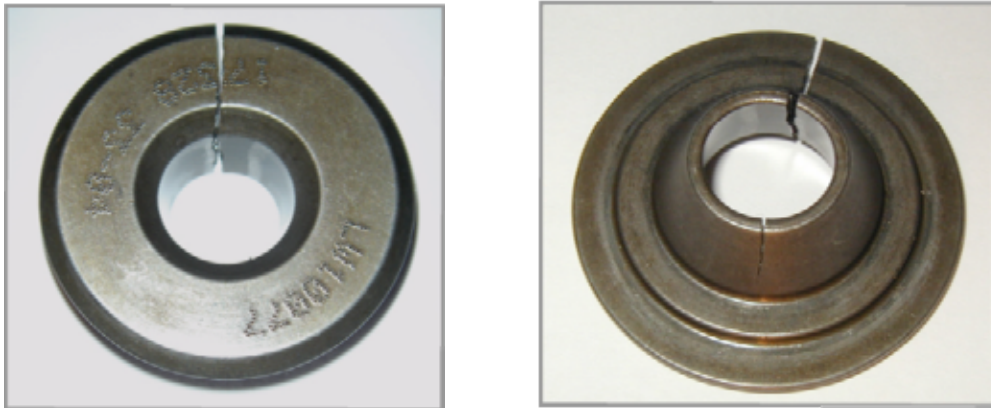
It was further noticed, that also the intake outer valve spring seat of cylinder number 4 was almost broken apart. All cylinders were removed and their intake valve mechanisms were dismantled. Then it was noticed that there were emerging fractures also in the lower edges of the locking cones of cylinders number 2 and 3 outer spring seats. All damaged spring seats were from the same production lot.

Figure 6. Intake outer valve spring seat of cylinder number 4.

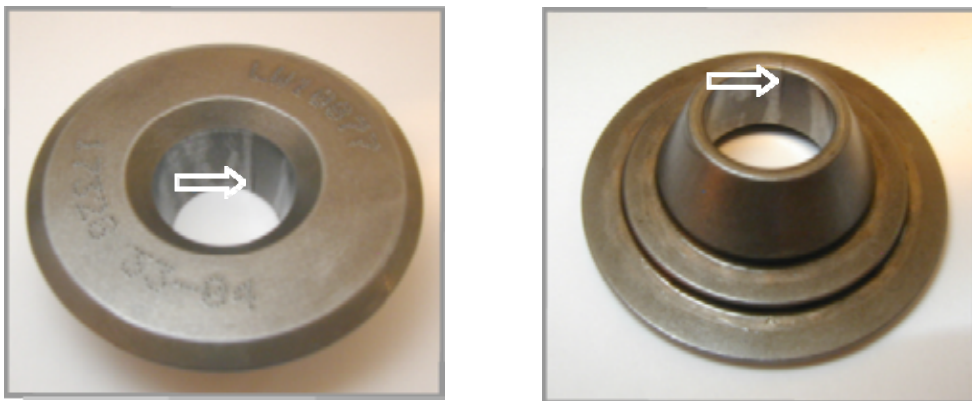
Figure 7. Intake outer valve spring seat of cylinder number 2.

8. There were fractures also in intake outer valve spring seats of engine cylinders numbers 2, 3 and 4.
9. All damaged outer spring seats of intake valves were from the same production lot.

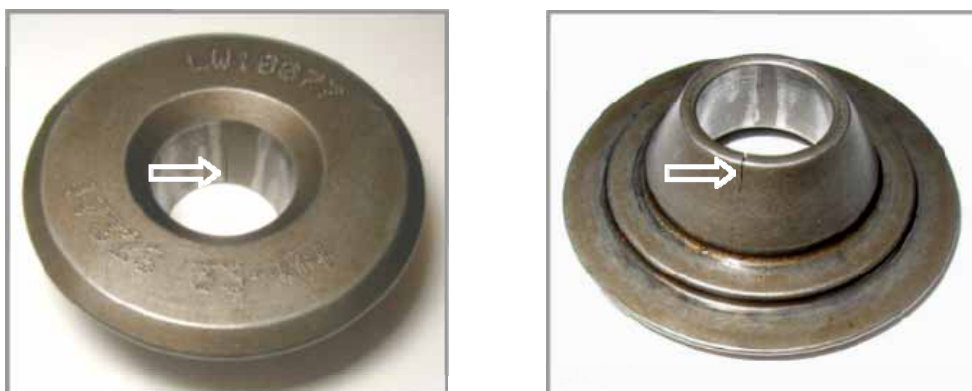
Figure 8. Intake outer valve spring seat of cylinder number 3.

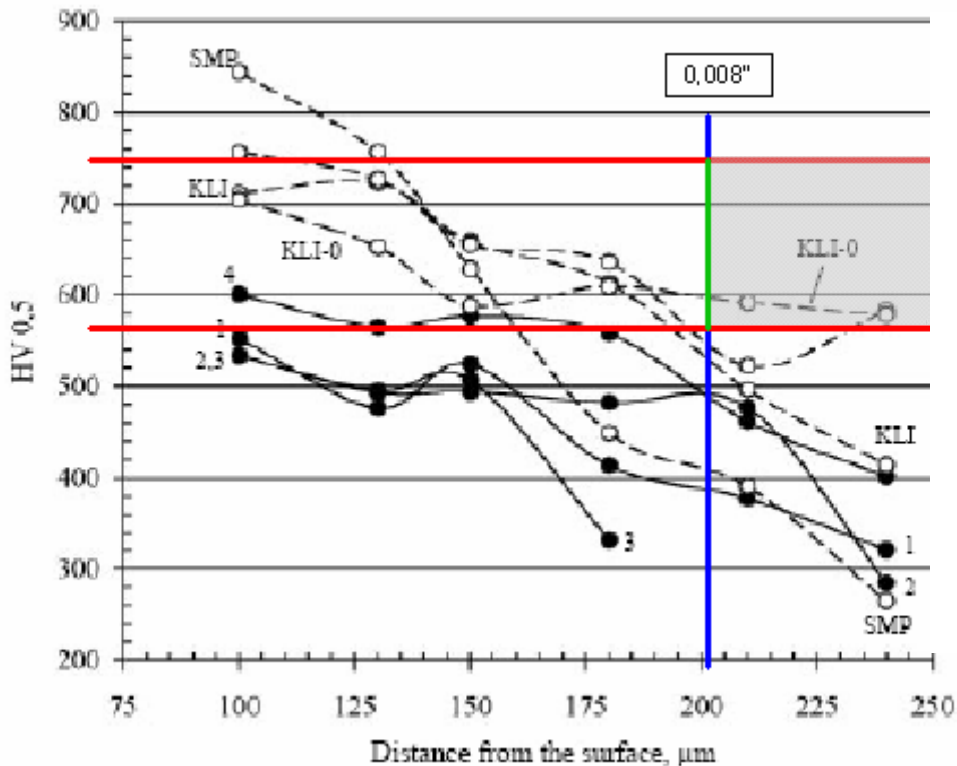
"Small differences in macrohardness values and differences in the inclusion structure can not explain the failure of the valve spring seats. Neither were any marks of fatigue visible in the scanning electron microscope examination but the overloading is the reason for the failure. The most evident reason for the cracking of the valve spring seats is improper carburization (thin layer and low hardness) in which even soft ferrite grains are present in the hardened layer. This also means that compressive residual stresses were lower than desired."

The hardness profiles of the case hardened layer of the intake outer valve spring seats from the cylinders 1–4 are presented by black circles and continuous lines. Reference spring seats (KLI, KLI-0, WITHOUT CODE, SMP) are presented by white circles and dashed lines. Hardness profiles should pass through the area coloured grey. Grey area presents the design specification for hardness in given distance from the surface (hardness 87–91 HR15N at 0.008"–0.014").

Figure 9. Hardness profiles of the case hardened layer of the intake outer valve spring seats.

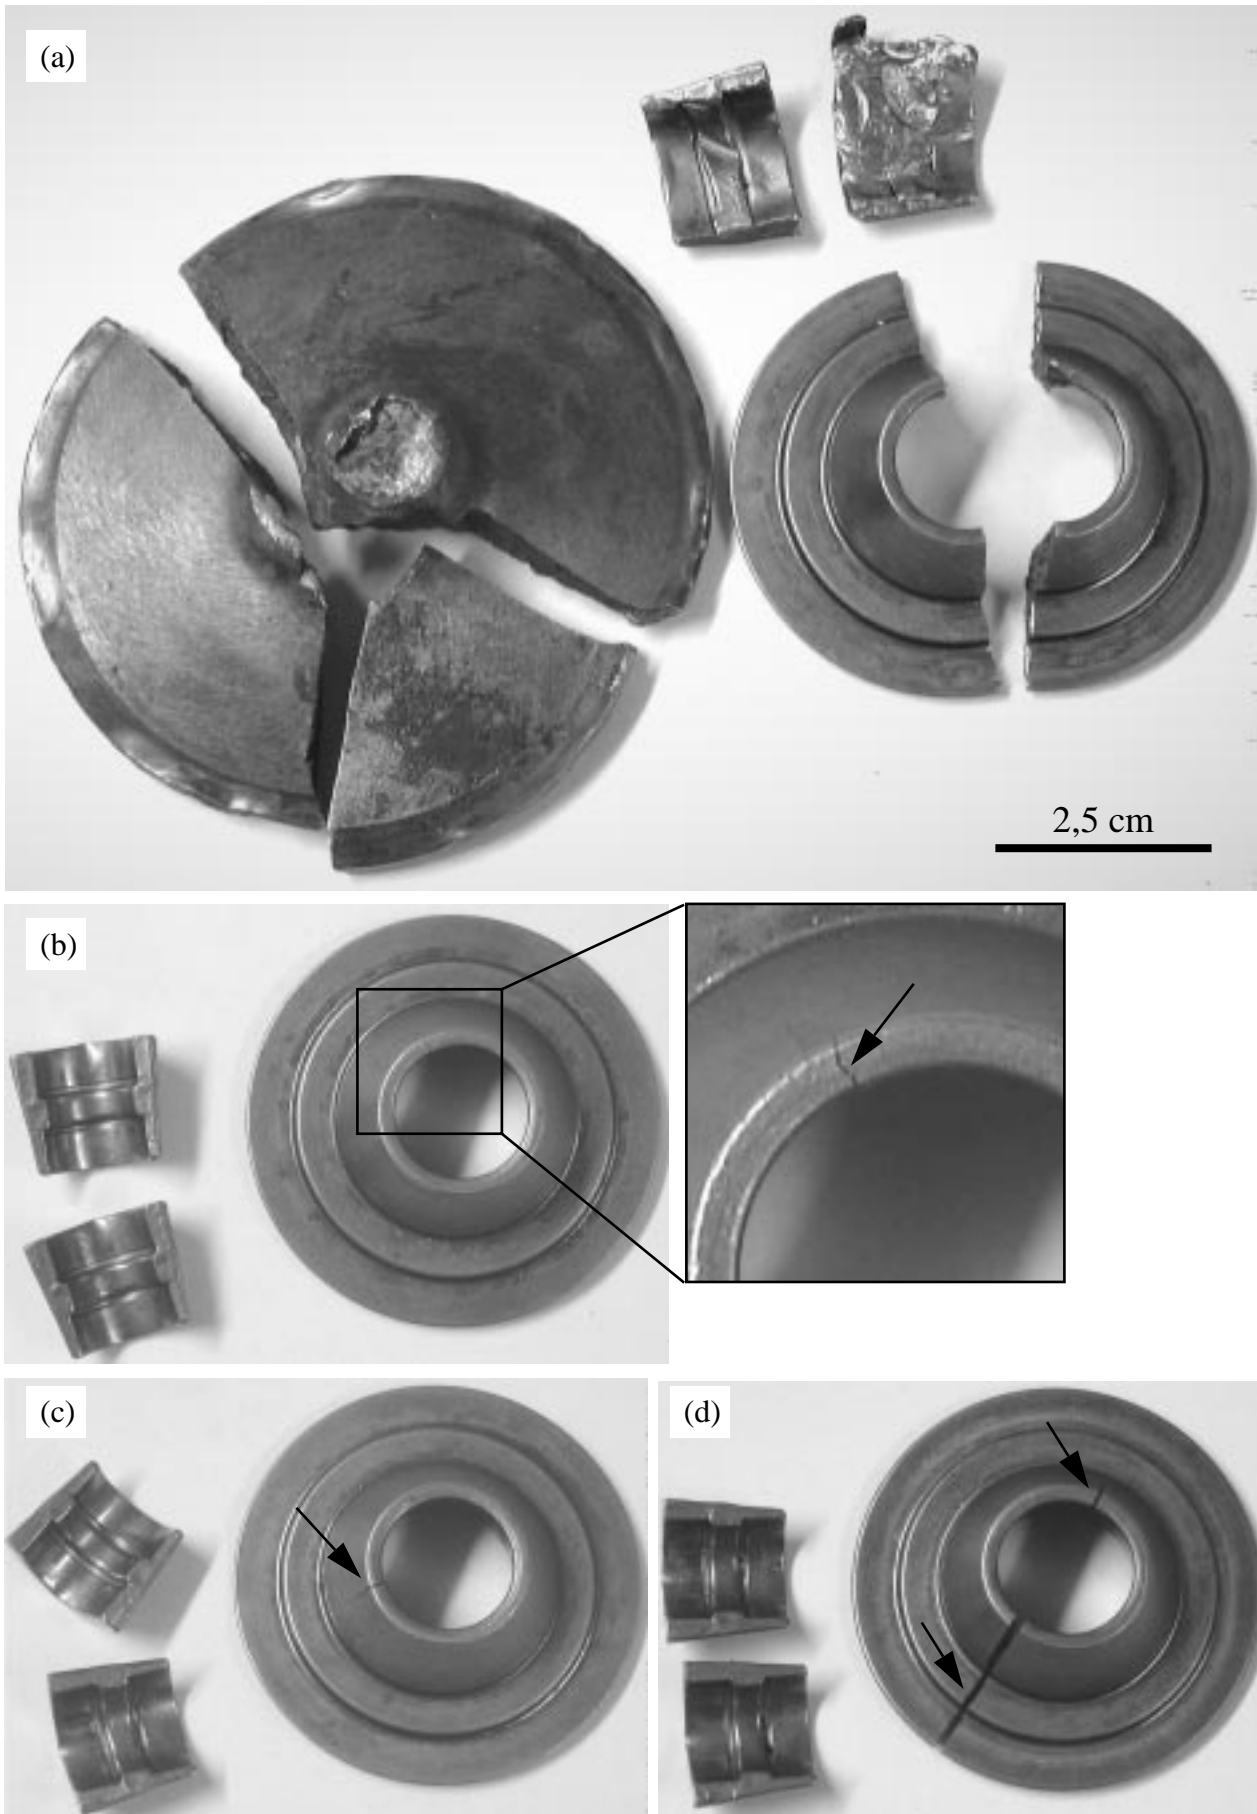
Fig 1. Damaged intake valve train components. (a) Splits intake valve, spring seat and deformed valve retaining keys of cylinder 1, (b,c,d) Cracks (arrows in Figs.) in the spring seats of cylinders 2, 3 and 4 (respectively) and the valve retaining keys of the same cylinders.

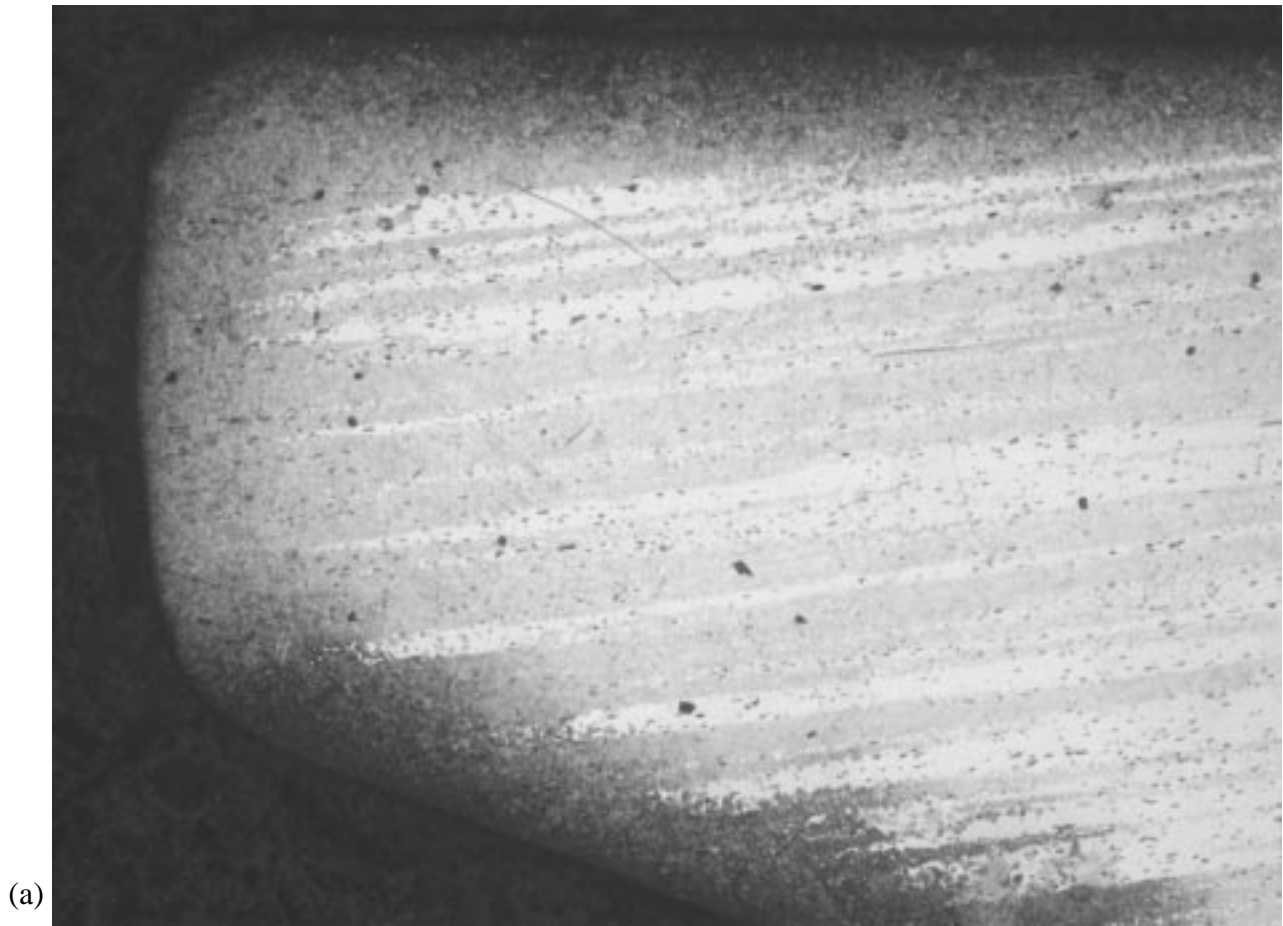
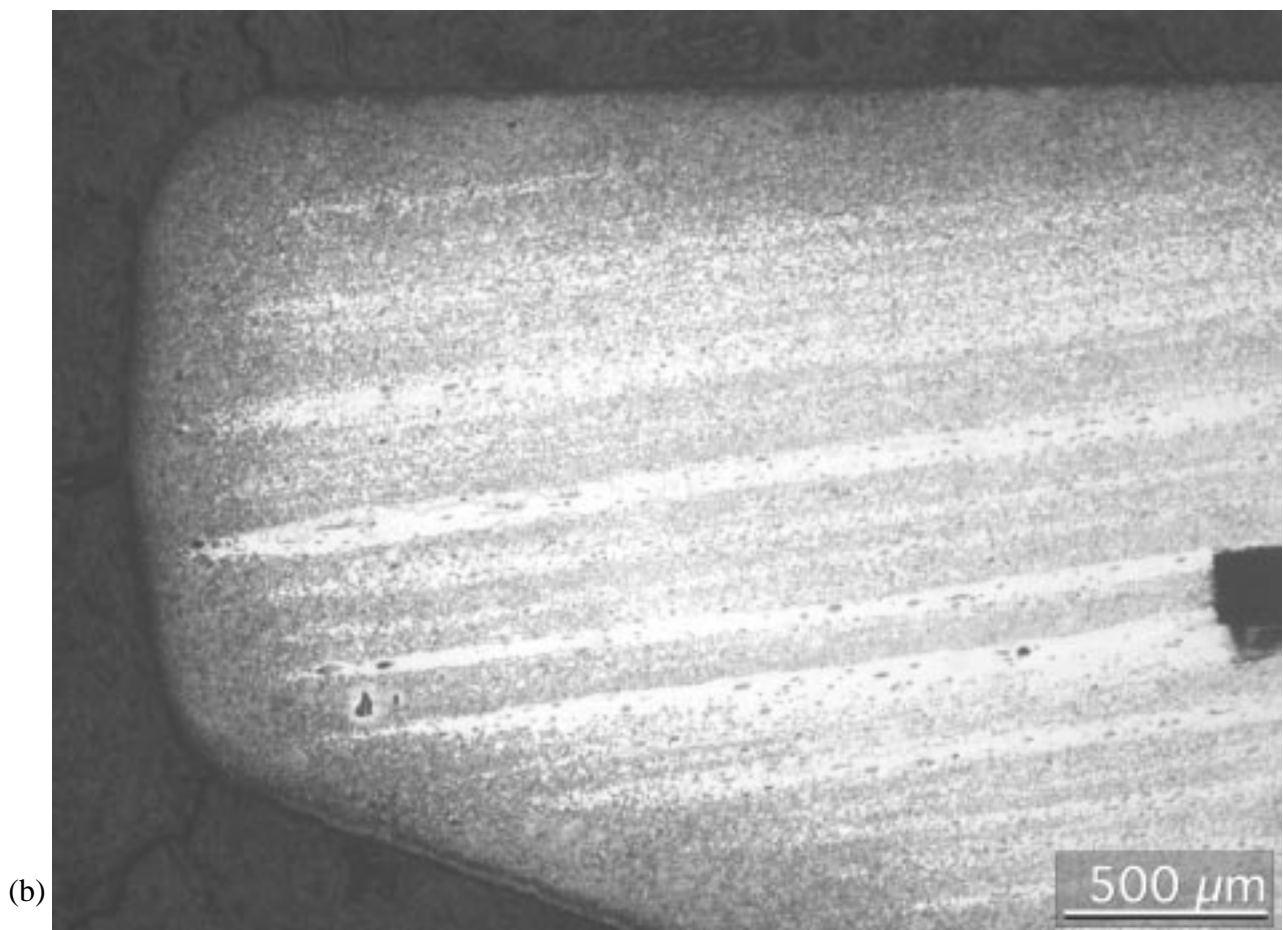
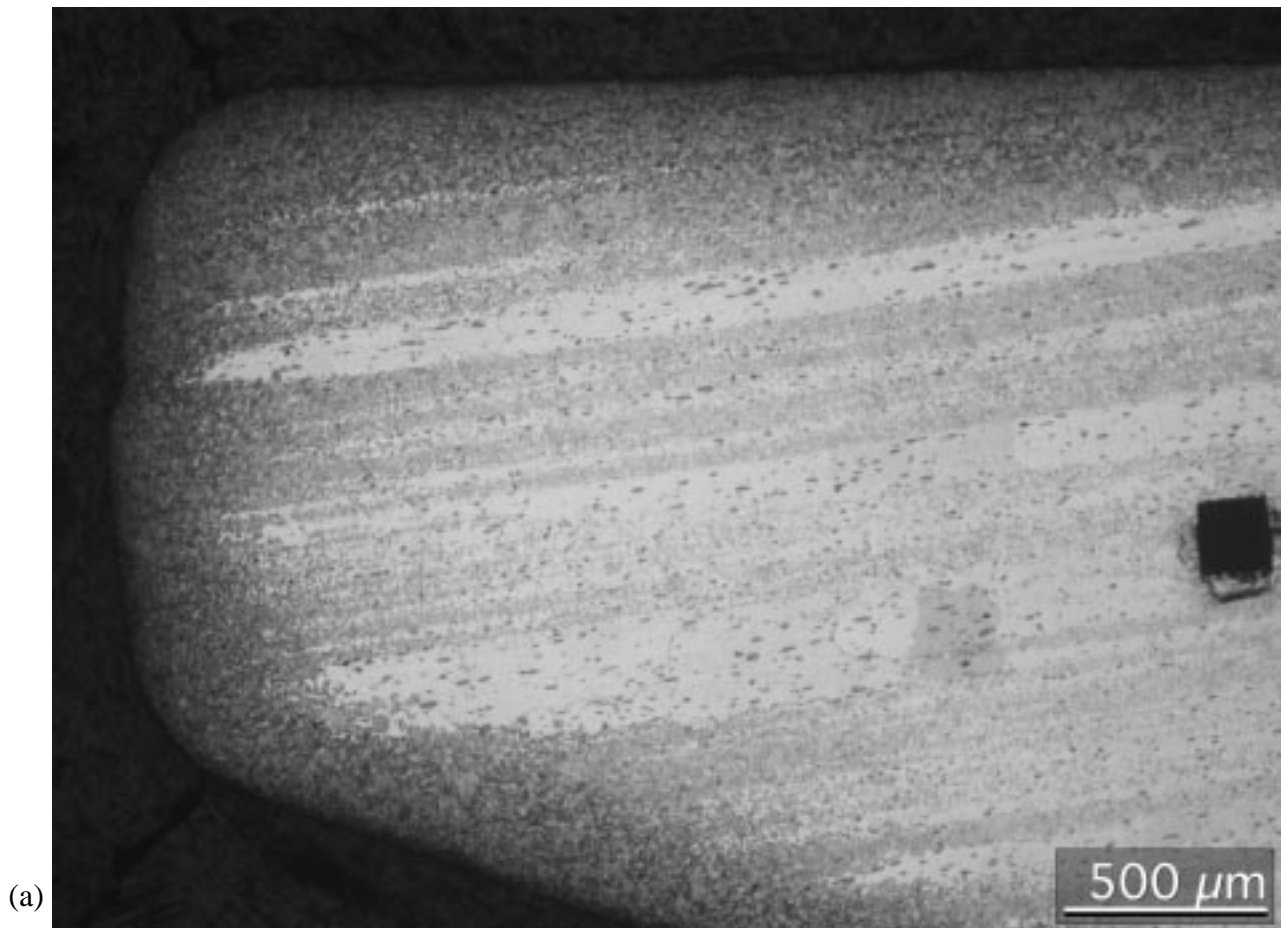
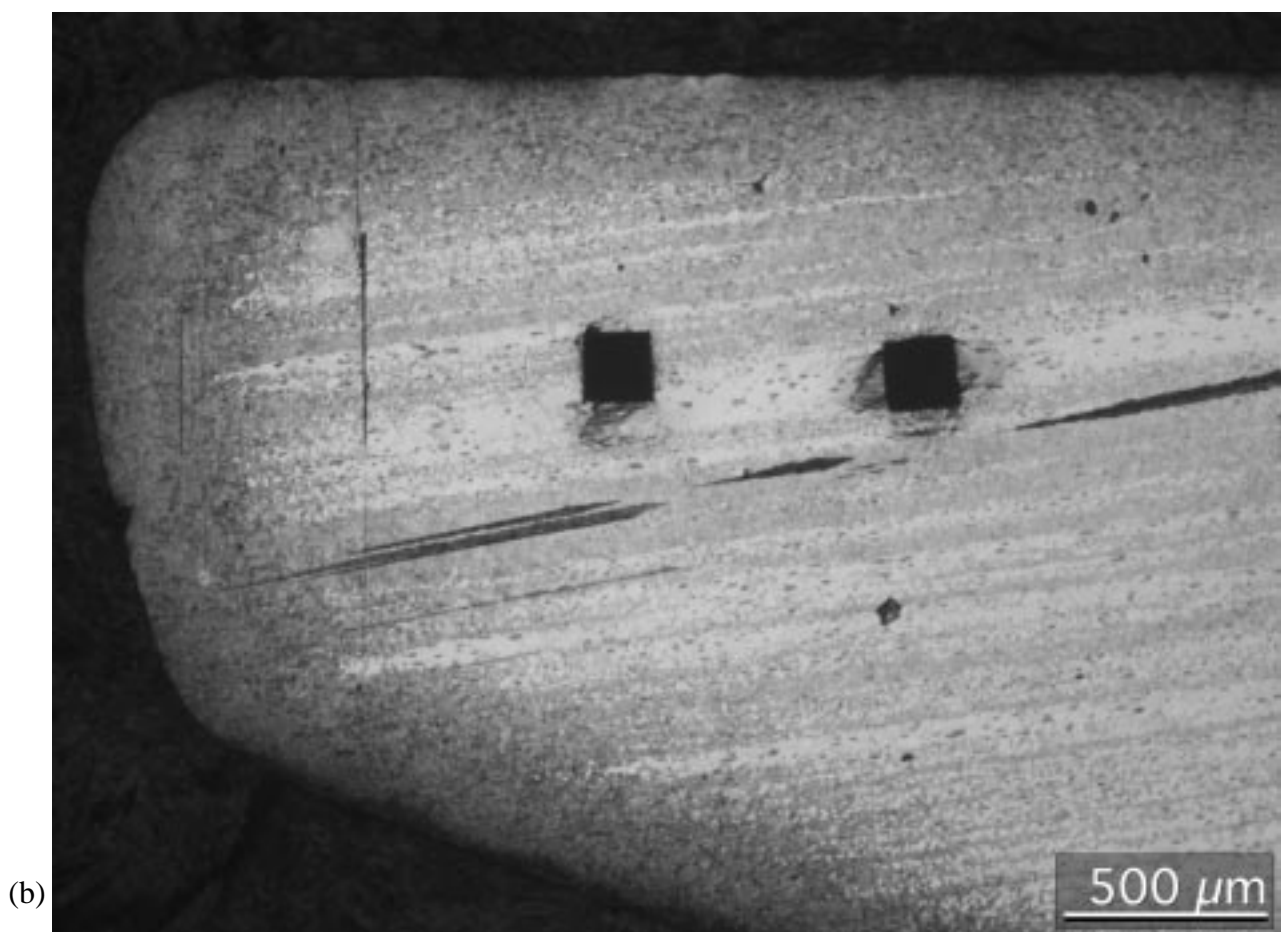
According to the microstructure studies, the spring seats have been case hardened (after machining). The base material itself is so-called a free cutting steel containing copious manganese sulphides (MnS), which enable fast machining using automatic turning lathe. The case hardened layer is clearly visible as the dark area on the micrographs taken from the cross-section surface as seen in fig.2c of spring seats (**Figs. 3-6**). The average thickness of the carburization layer (dark areas in figs. 3-6) in the failed spring seats is 0.2-0.3mm and in the reference spring seats 0.2-3.5mm. The measured

Fig 3. Case hardened layer (dark) on a spring seat (cross section is shown in fig. 2c), (a) Cylinder 1, (b) Cylinder 2. Optical microscope.

Fig 4. Case hardened layer (dark) on a spring seat (cross section is shown in fig. 2c), (a) Cylinder 3, (b) Cylinder 4. Optical microscope.

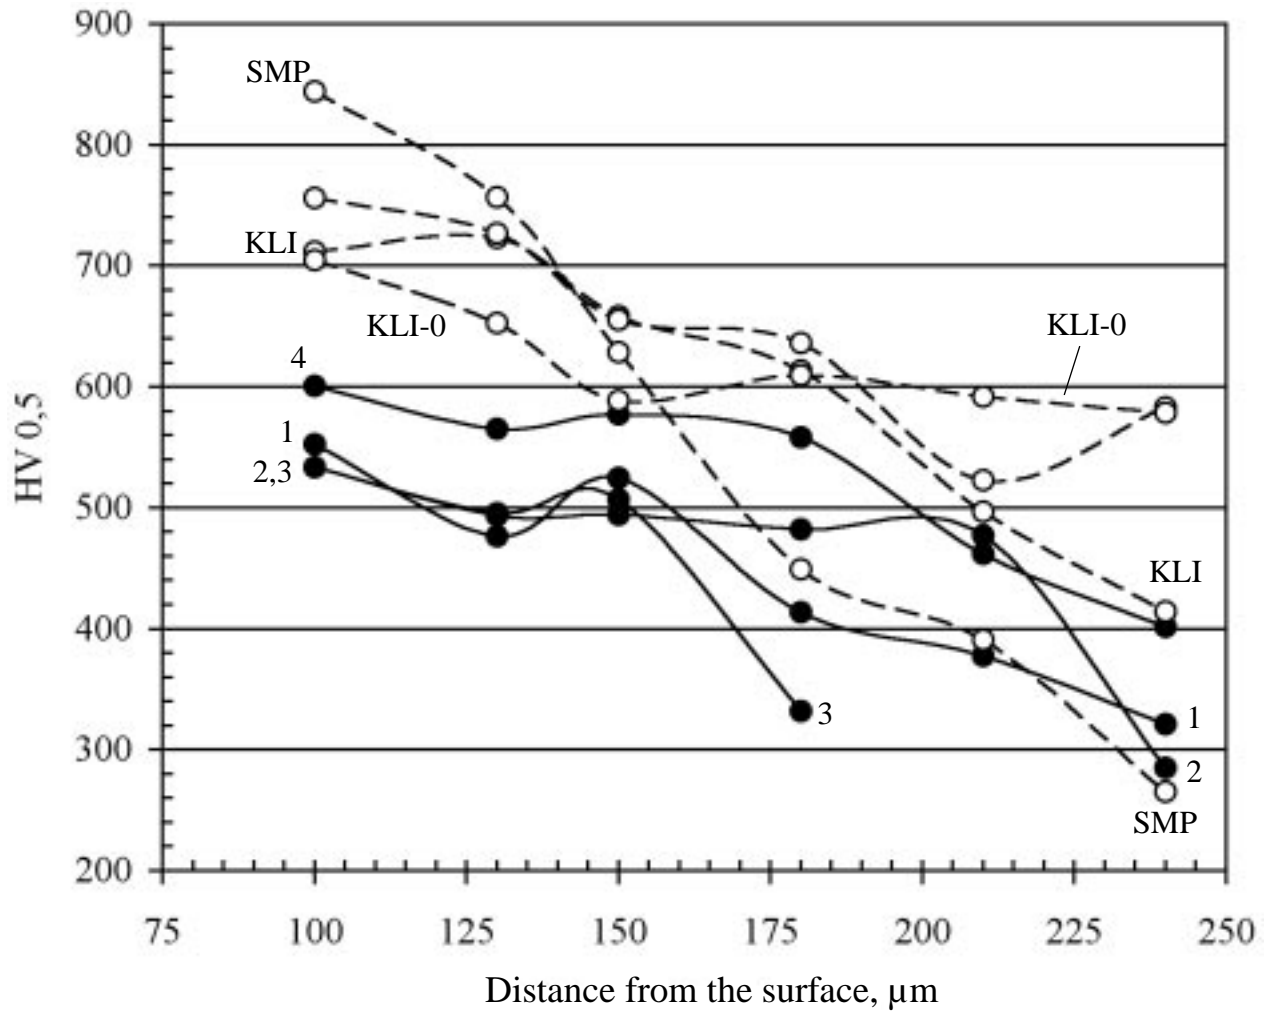
hardness values in the case hardened layer (measuring site in fig. 2) near the surface (circa 100 μm from surface) in the failed spring seats are 553-601HV0.5 and in the reference spring seats 665-844HV0.5. The case hardened depth, corresponding to the distance from the surface at which the hardness is equal to 550HV (SFS-EN ISO 2639), is circa 0.16mm in the reference spring seats. In the failed spring seats, the hardness profile is mainly below the threshold value of 550HV. (**Table 2, Figs. 7,8**).

Fig 7. The hardness profiles of the case hardened layer of the spring seats. Cylinders 1-4, black circles and continuous lines. Reference spring seats (KLI, KLI-0, WITHOUT CODE, SMP), white circles and dashed lines. (Values in table 2).

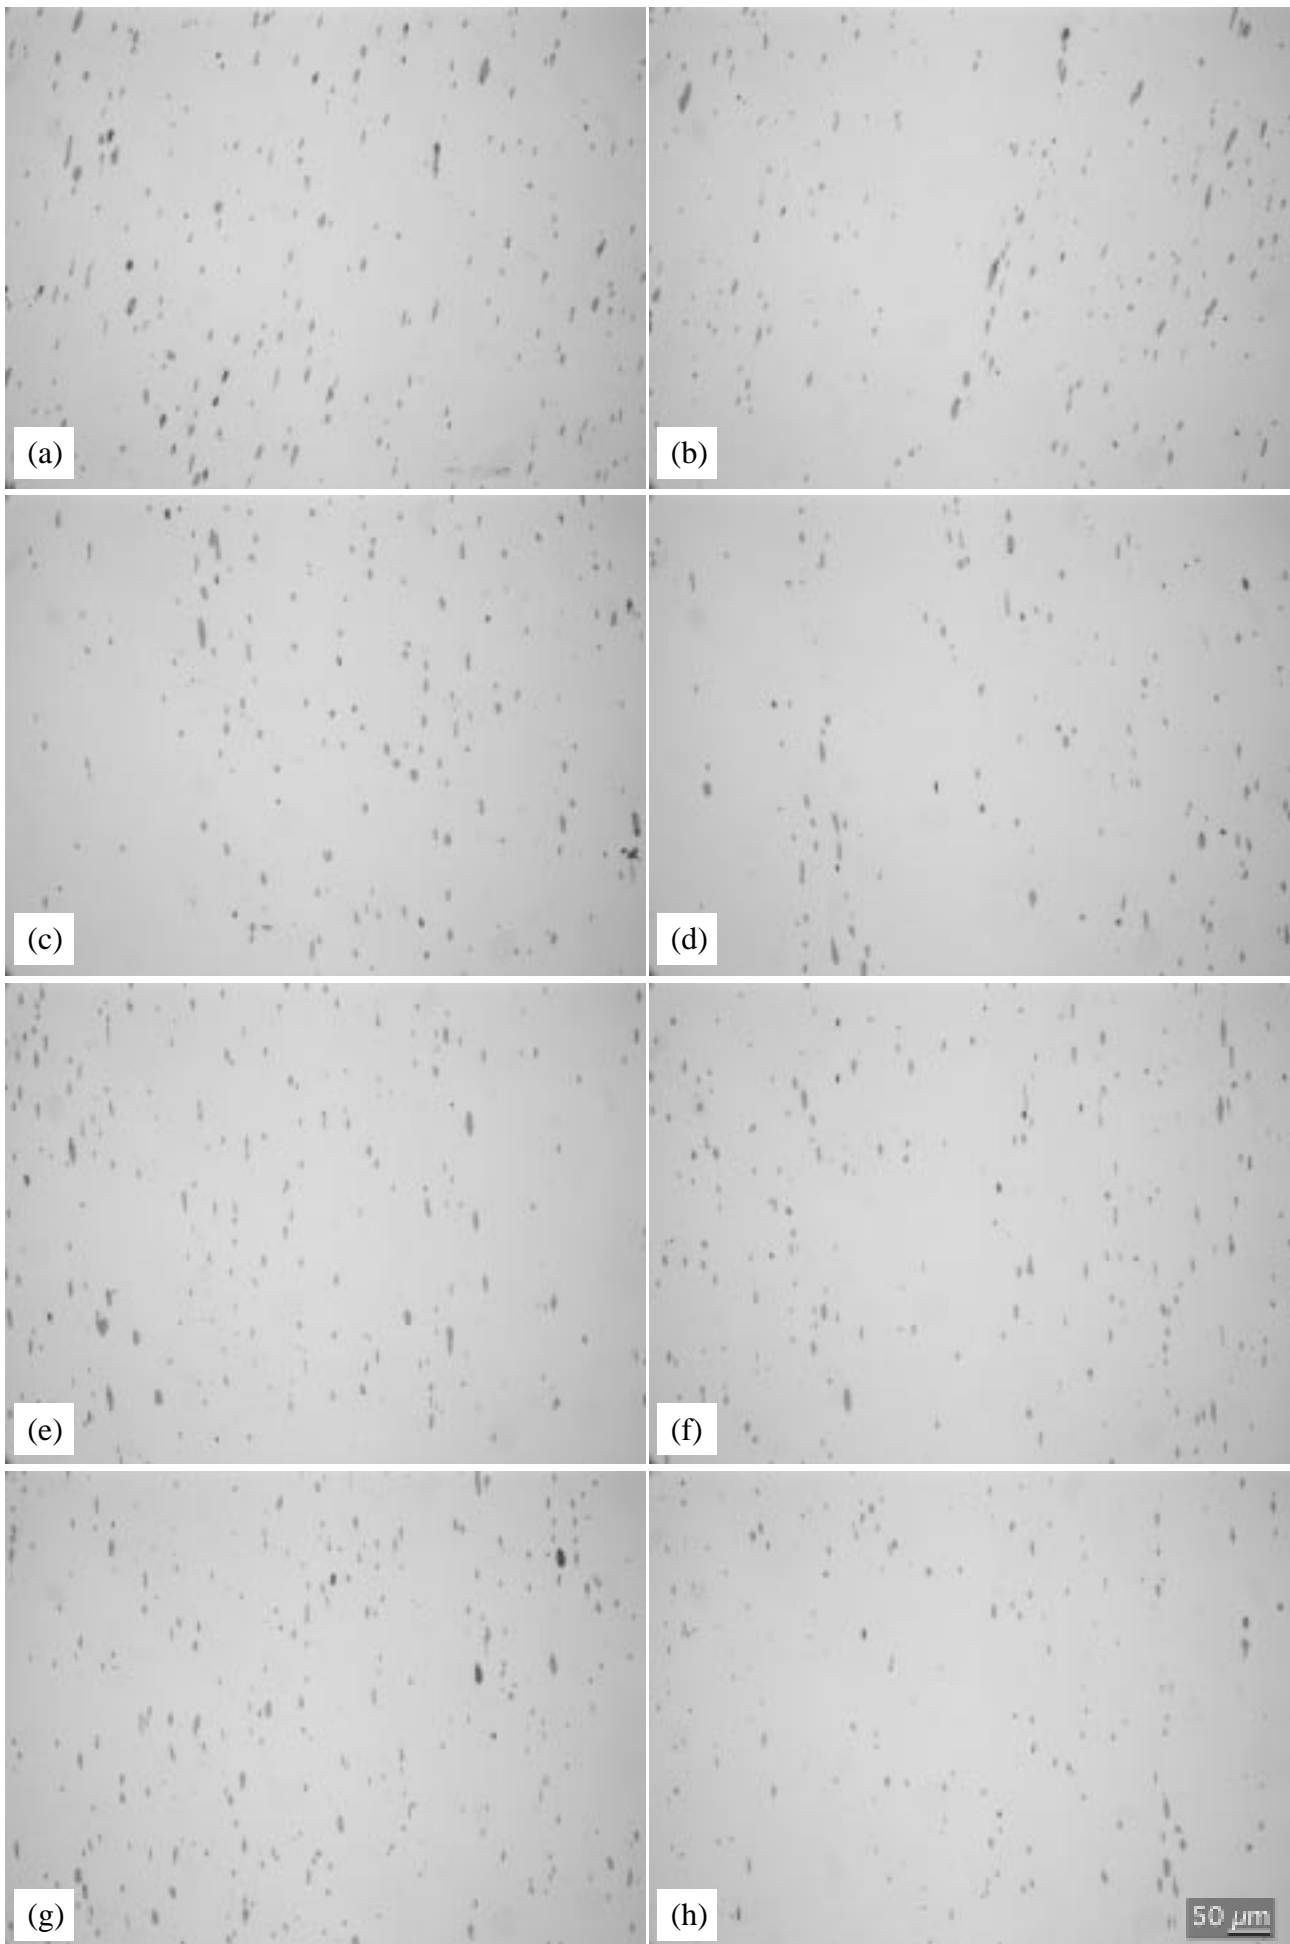
According to the digital image analysis (**Figs. 9,10, Table 3**) the phase fraction of MnS inclusions in the failed spring seats is 1.4-1.8% and in the reference spring seats 1.1-2.0%, whereas the number of inclusions is 447-639kpl/mm² and 153-204 kpl/mm², and the average area is 24-32 μm^2 and 98-119 μm^2 , respectively.

Fig 9. Inclusion structures of the spring seats (cross section in fig. 2c). **(a,b)** Cylinder 1, **(c,d)** Cylinder 2, **(e,f)** Cylinder 3, **(g,h)** Cylinder 4. Inclusion analysis in table 3. Ground and polished surface. Optical microscope.

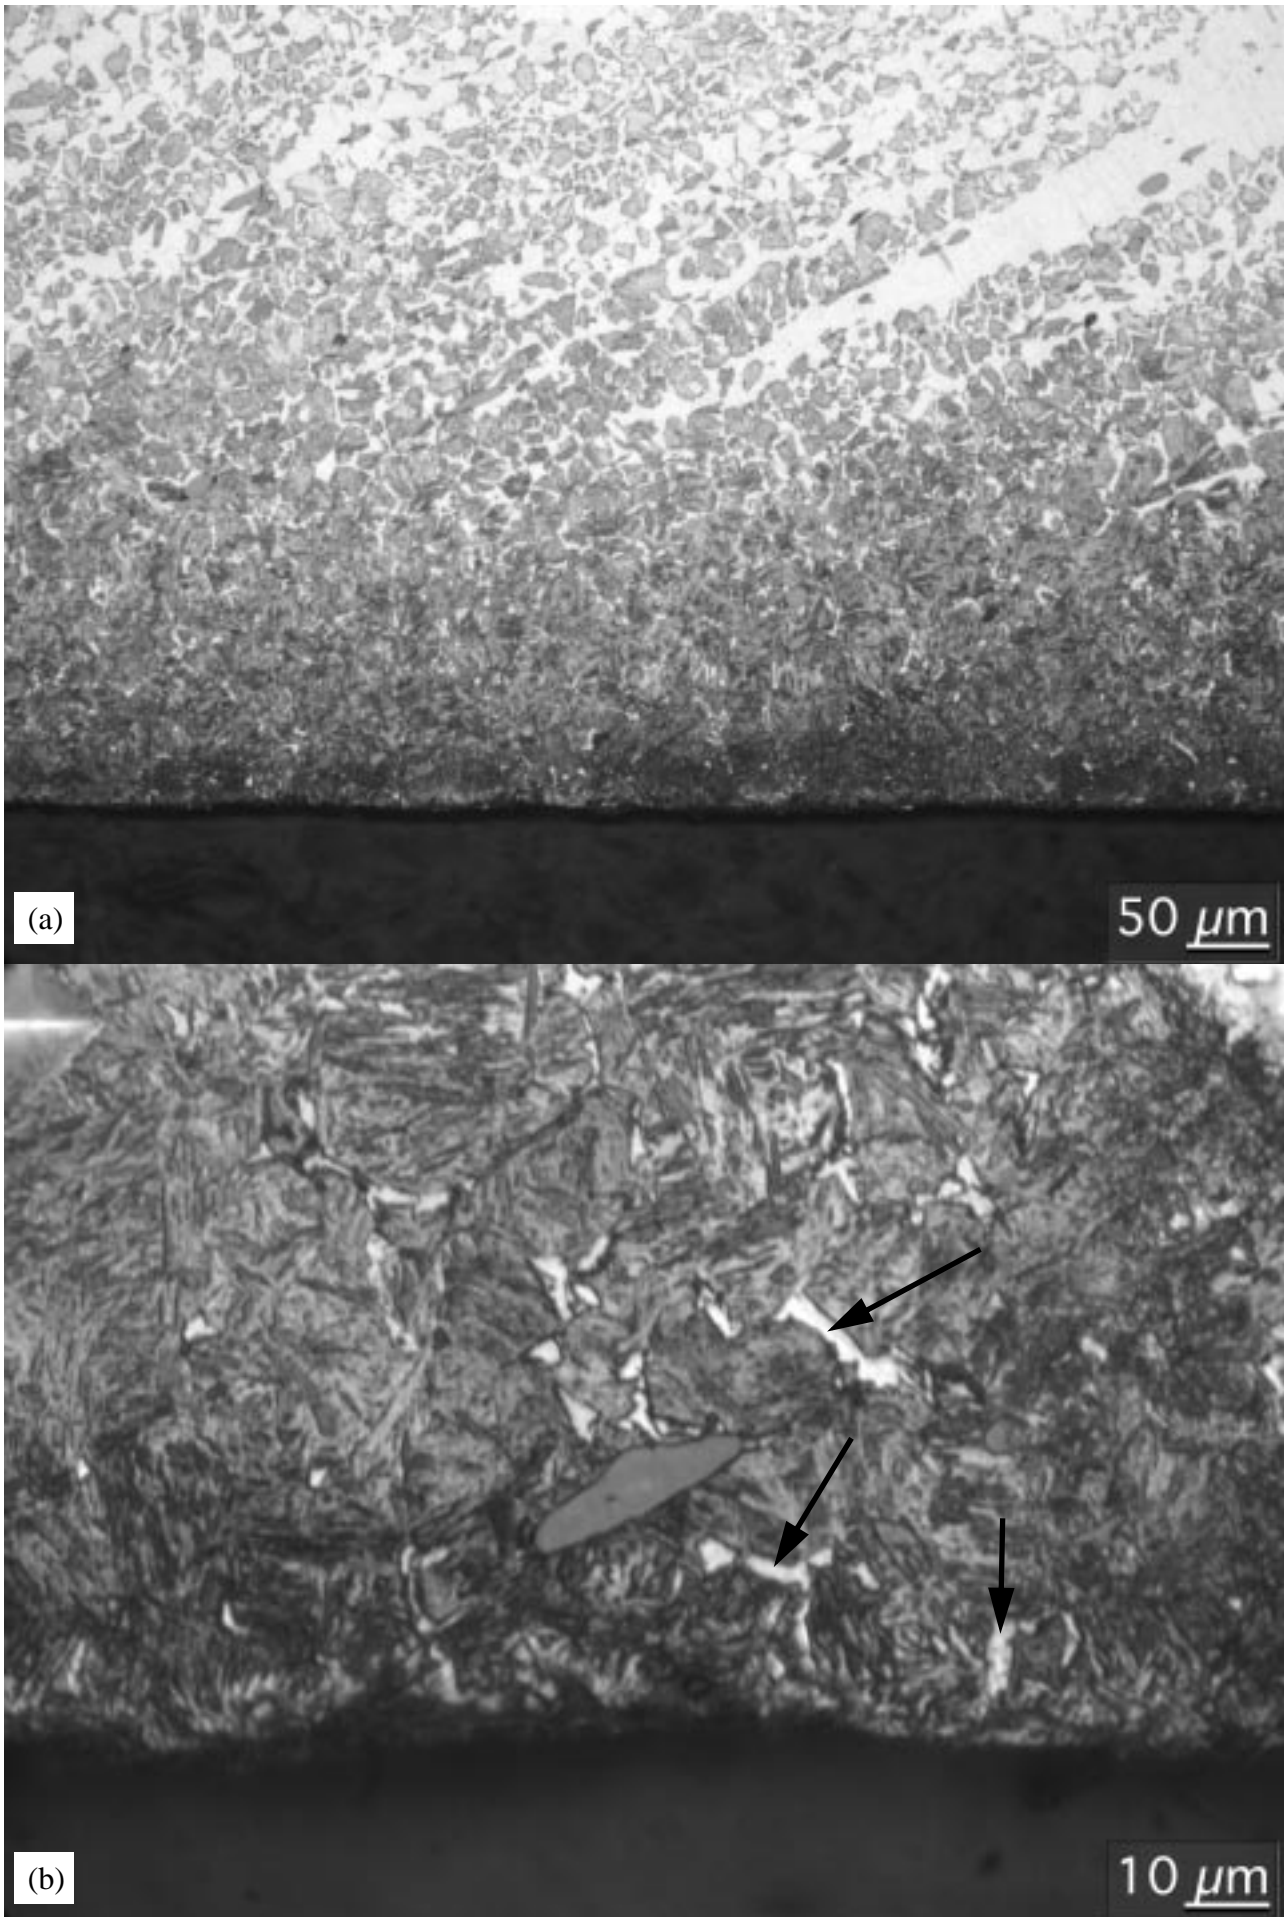
The spring seat core has a banded microstructure, where fine grained ferrite-pearlite bands (or ferrite-bainite bands) and coarse grained ferrite bands alternate. In the failed spring seats the ferrite grain size in ferrite band is on average larger than in the reference spring seat (**Figs. 11,12**). In addition, in failed spring seats a ferrite network in many places extends to the surface of the case hardened layer at the location of the ferrite band (**Fig. 13**). Similar ferrite network is also visible in the microstructure observed on the surface of the spring seat 2 at the crack site (**Figs. 2f,14**). Instead to that, in the reference spring seats the corresponding network was not found.

Fig 13. Micrograph of the case hardened layer spring seat (cylinder 2). Ferrite network (arrows in figure b) extends into the surface of the case hardened layer. Optical microscope.
