Investigation report

C6/2005L

Helicopter accident in the vicinity of the Vuomaselkä in Sodankylä on 21.9.2005

OH-HAY

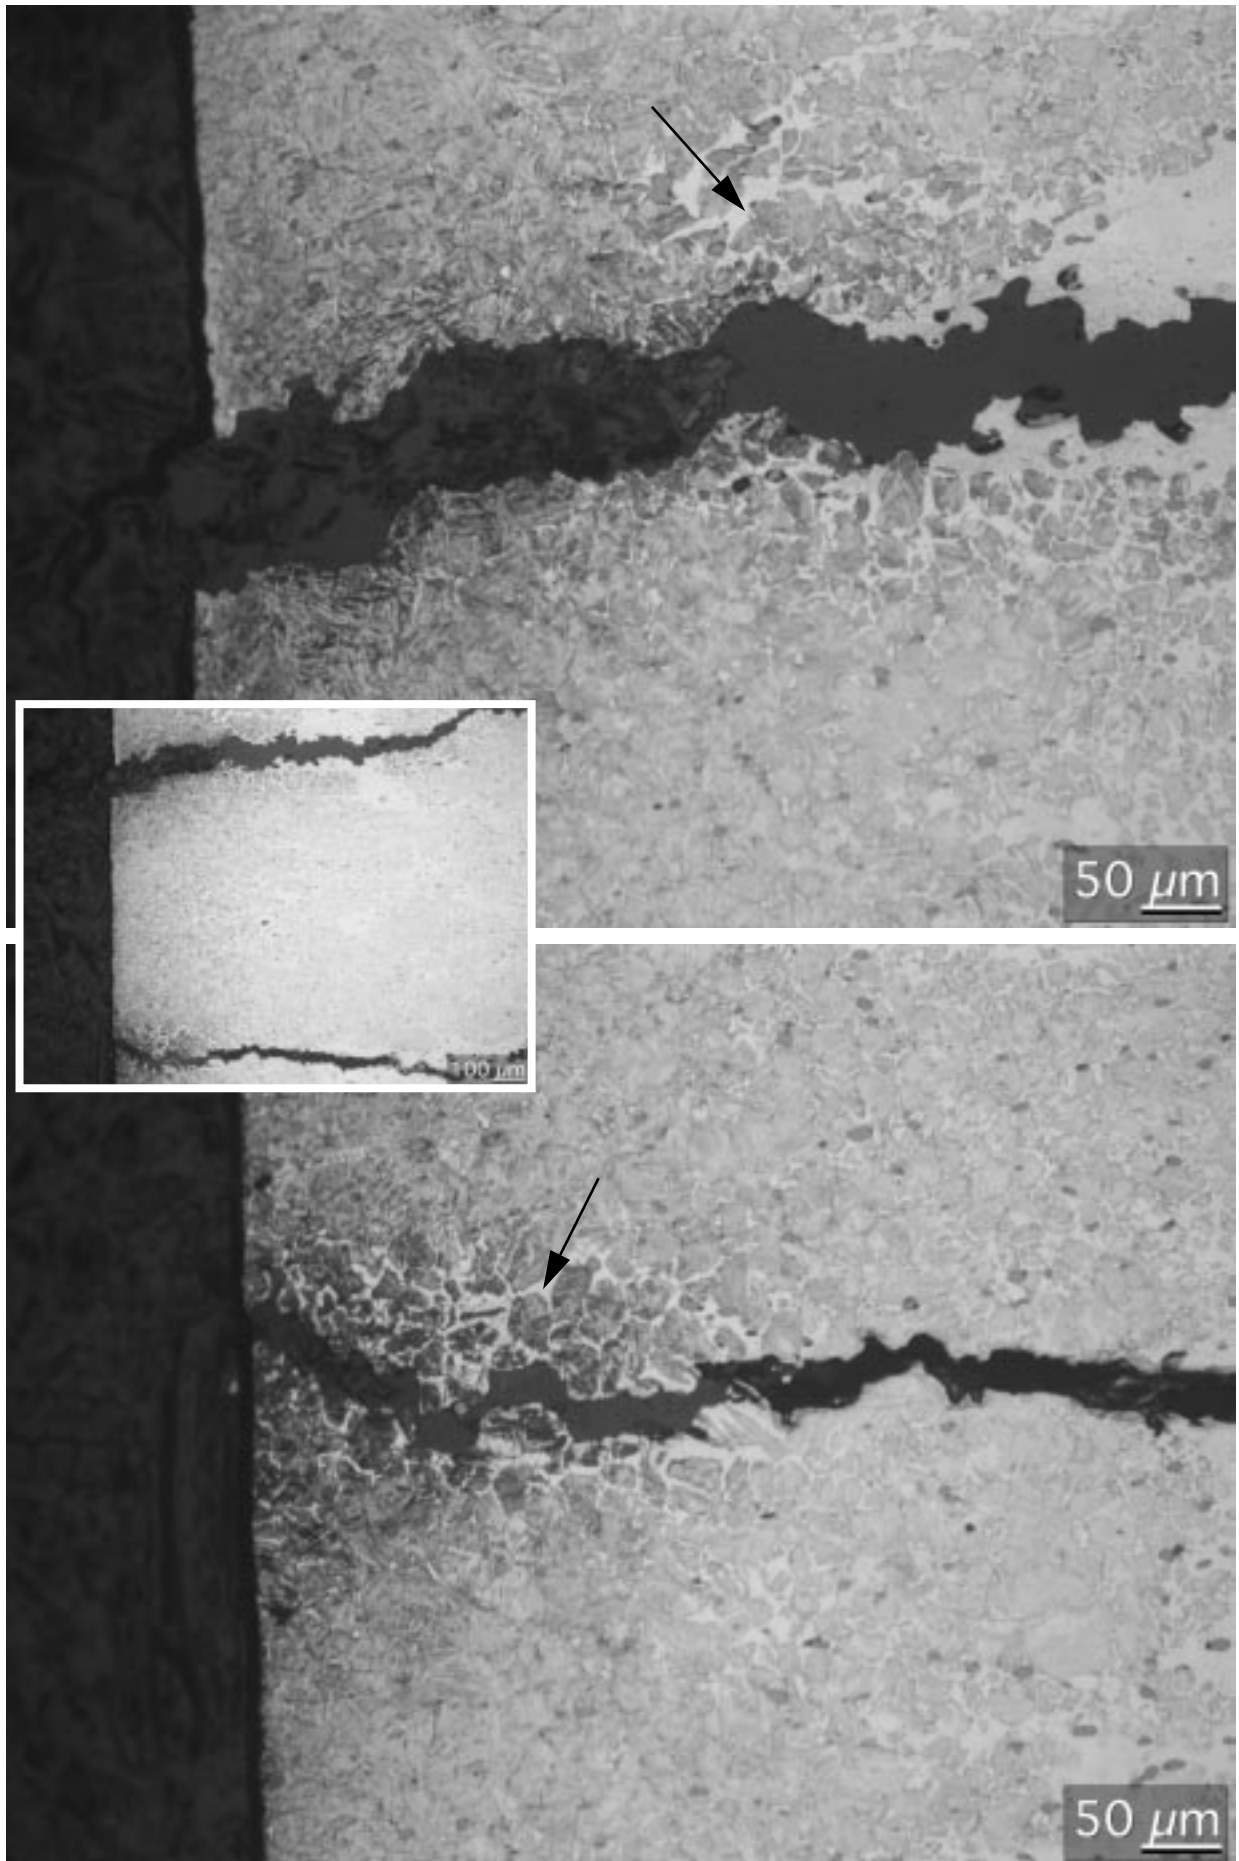
Fig 14. Micrograph of the spring seat at the crack site (cross-section in fig. 2f). Light areas (arrows) are ferrite. Optical microscope.

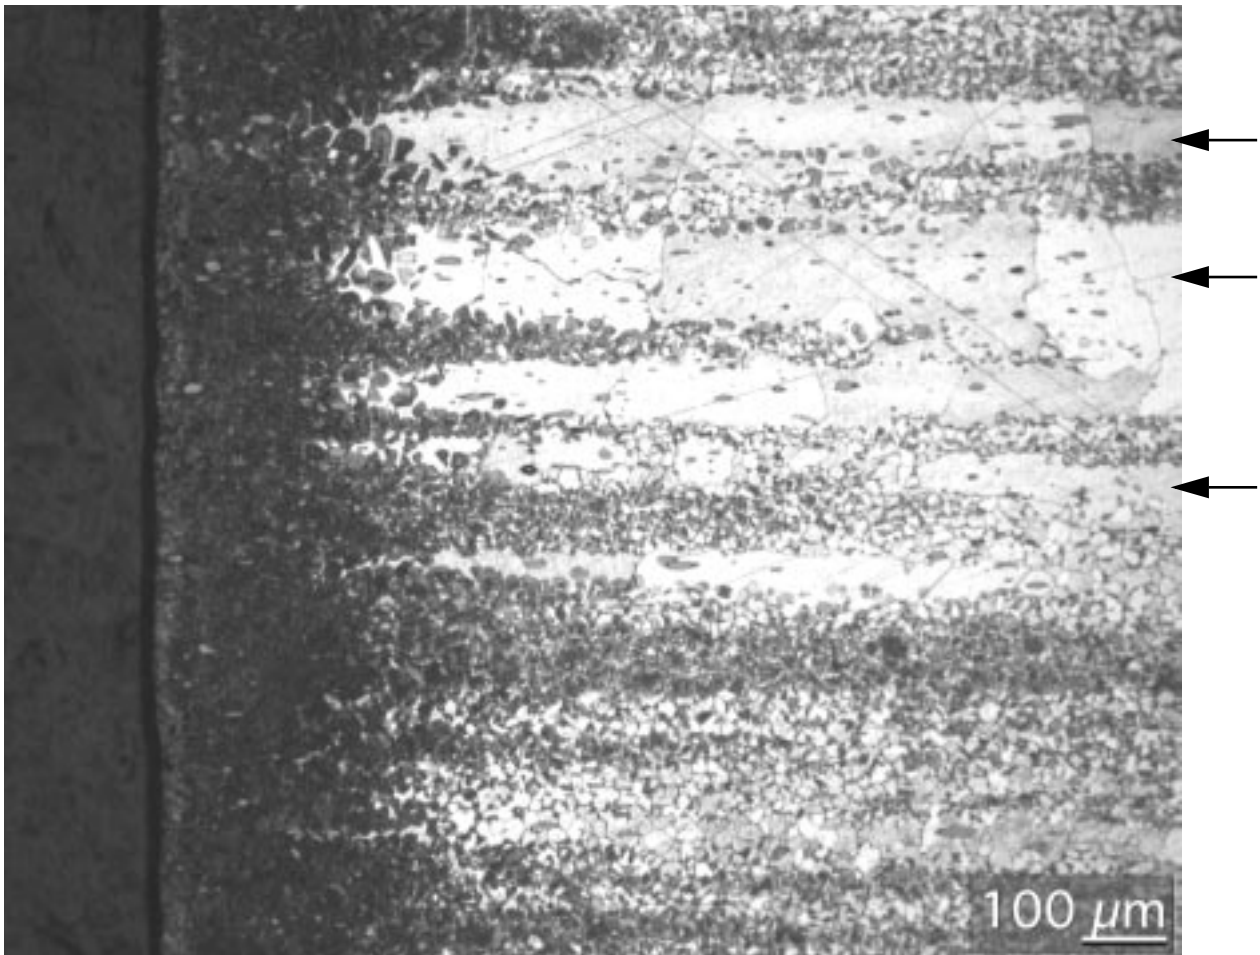
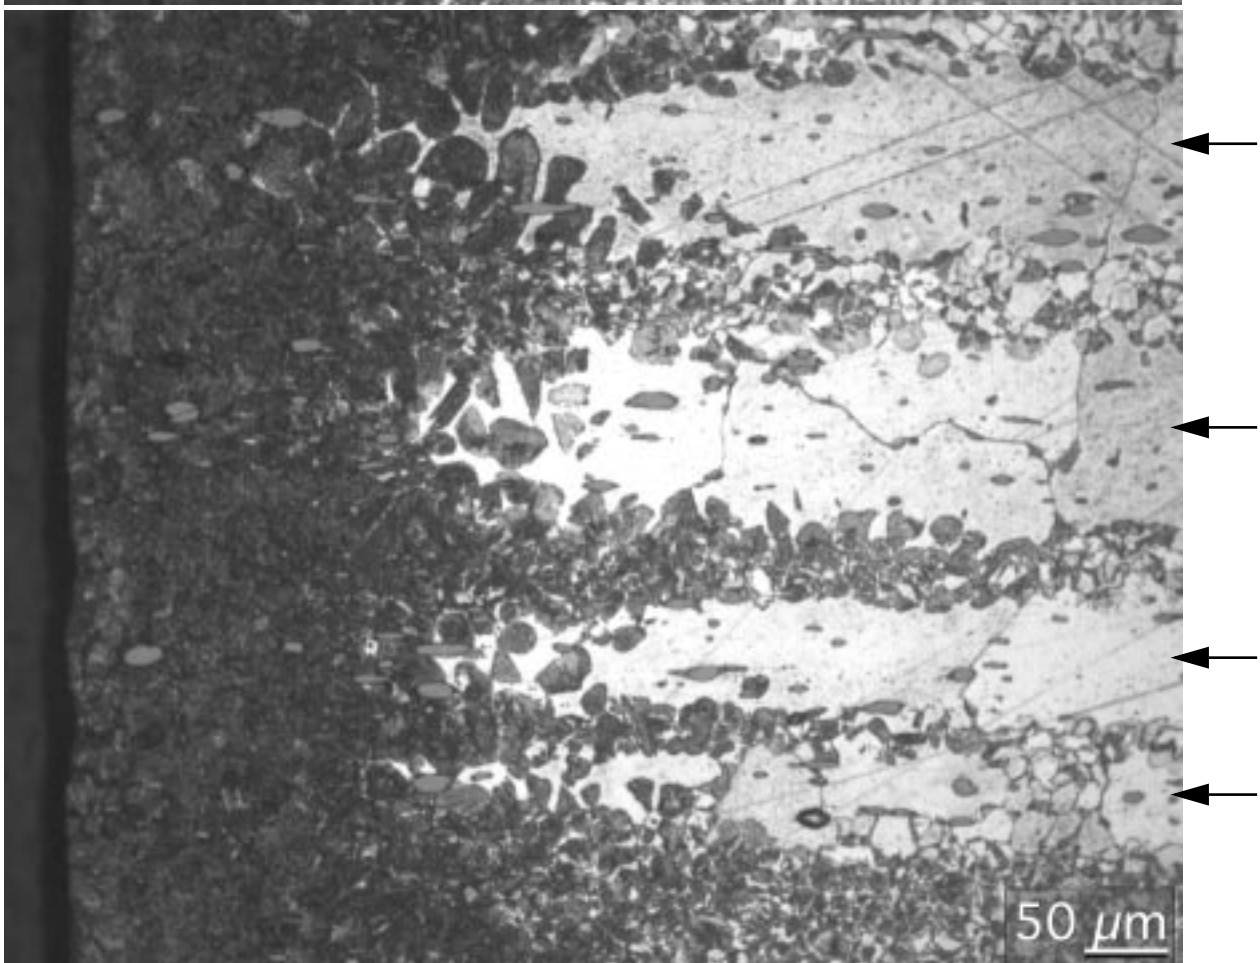
Fig 15. Micrograph of the spring seat (cylinder 2) near the surface. Arrows in Figs. point the ferrite bands with large grain size. Optical microscope.

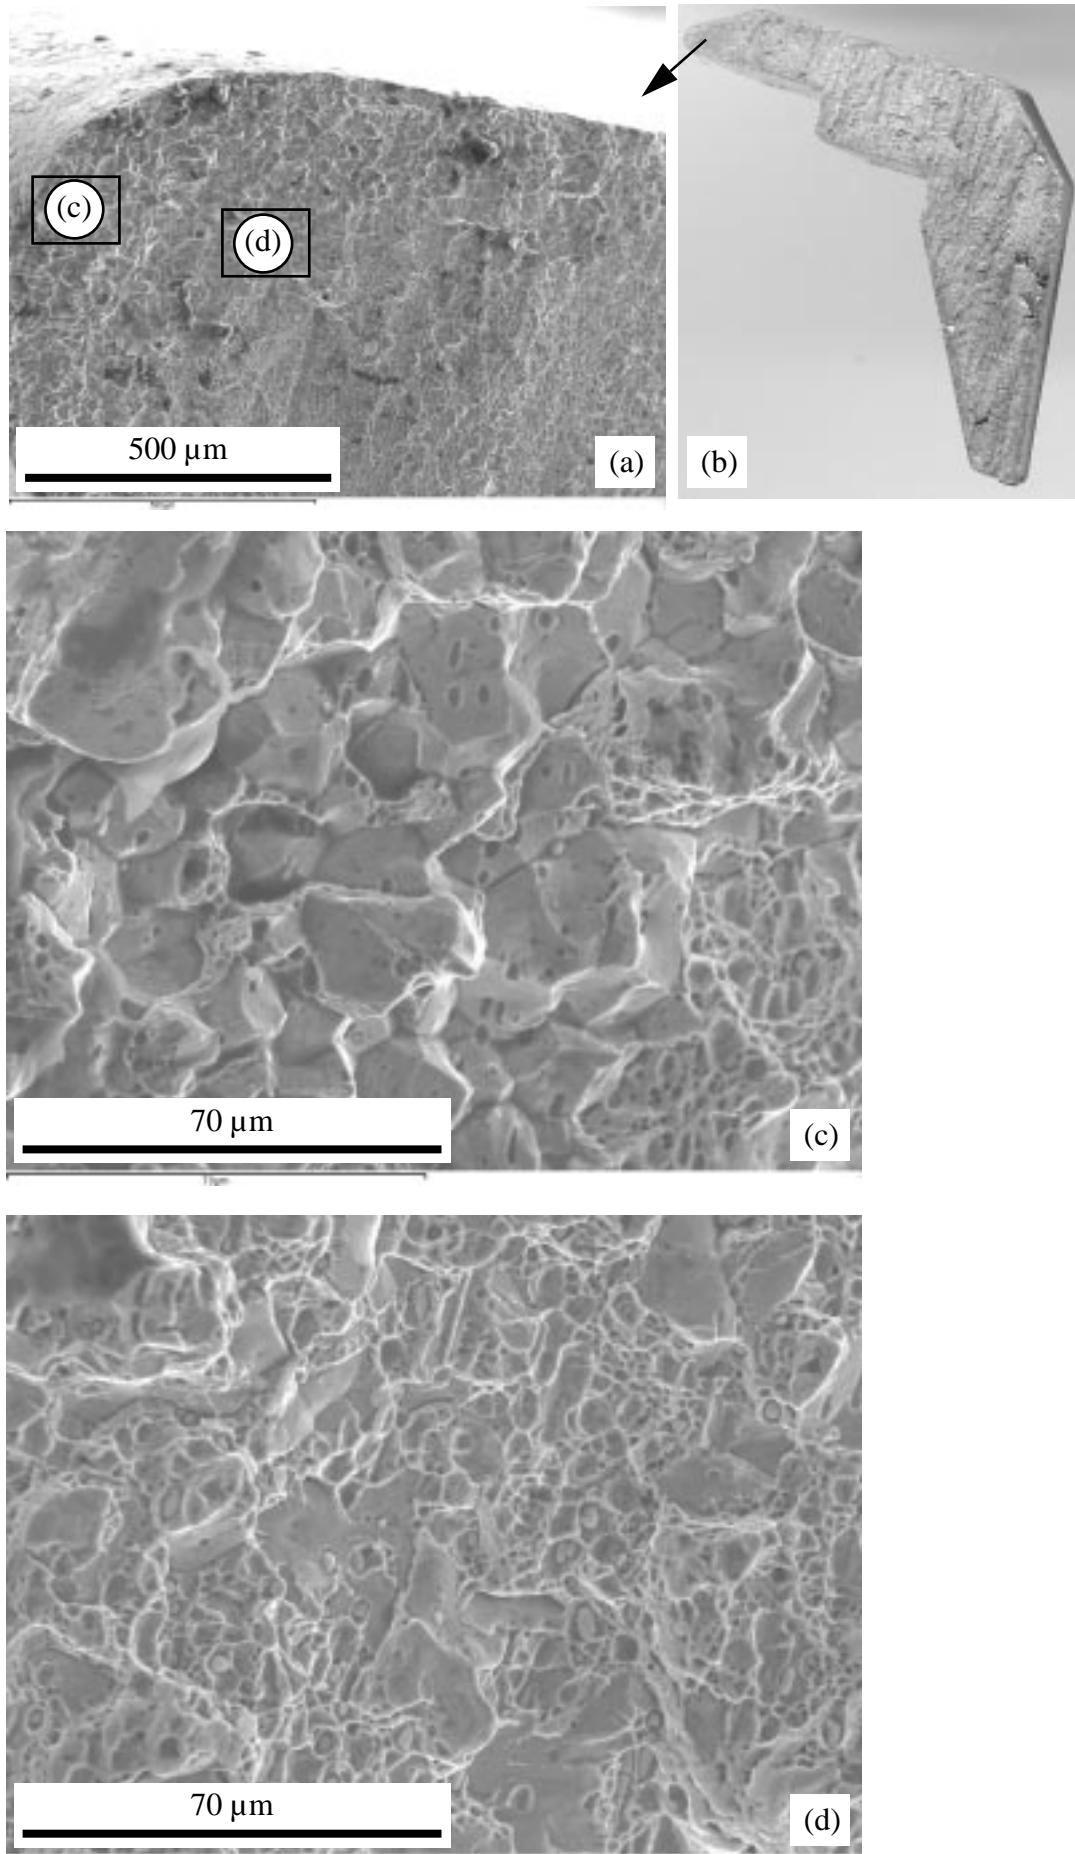
Fracture surfaces were studied using the opposite surfaces of the crack in the spring seat of the cylinder 4 (**Fig. 2g,f**). The fracture surface inspected visually had an oriented macrostructure corresponding to the banded microstructure mentioned earlier. According to the SEM studies, the fracture surface in the case hardened layer was mostly intergranular mode (**Figs. 16,18**). In the core, the fracture surface had both ductile and brittle features and it contained numerous MnS inclusions (**Fig. 17**). Any marks of fatigue was not observed.

Fig 16. Fracture surfaces of the crack in the spring seat of the cylinder 4 (fig. 2g). SEM.

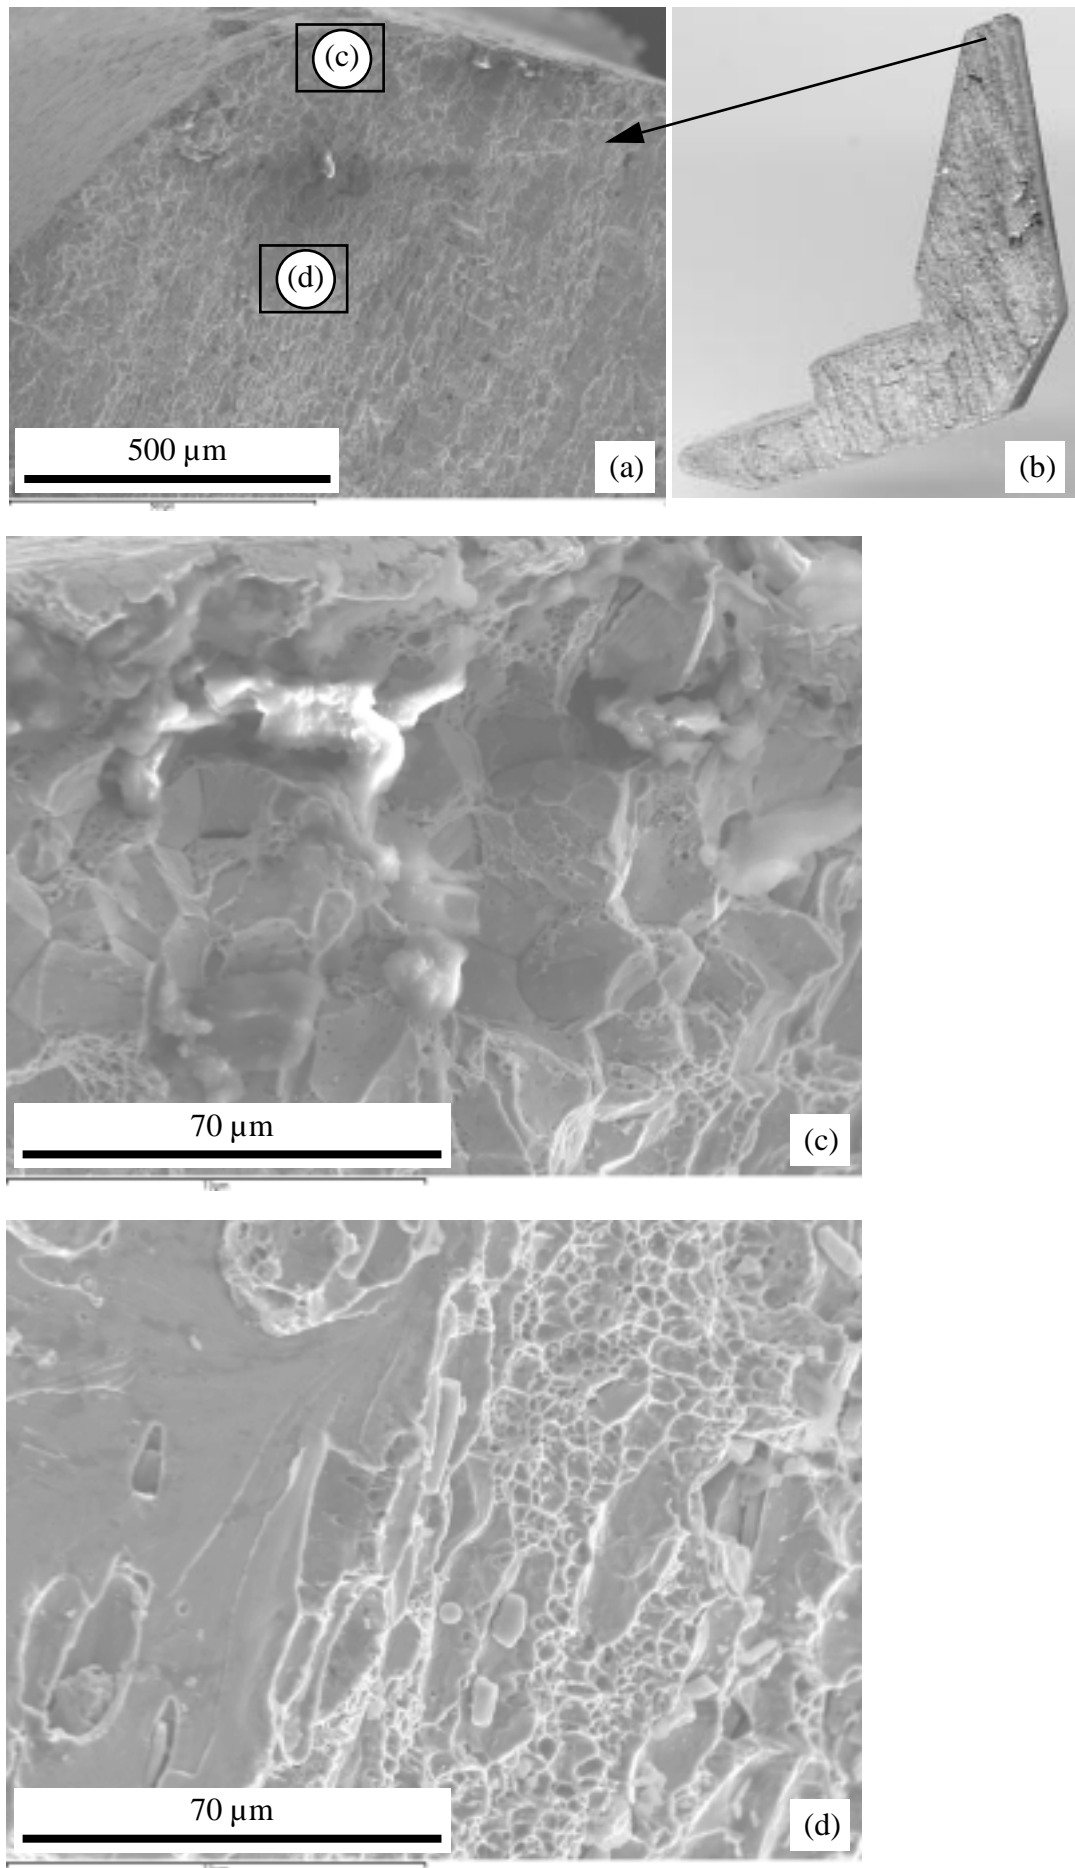
Fig 17. Fracture surfaces of the crack in the spring seat of the cylinder 4 (fig. 2g). SEM.

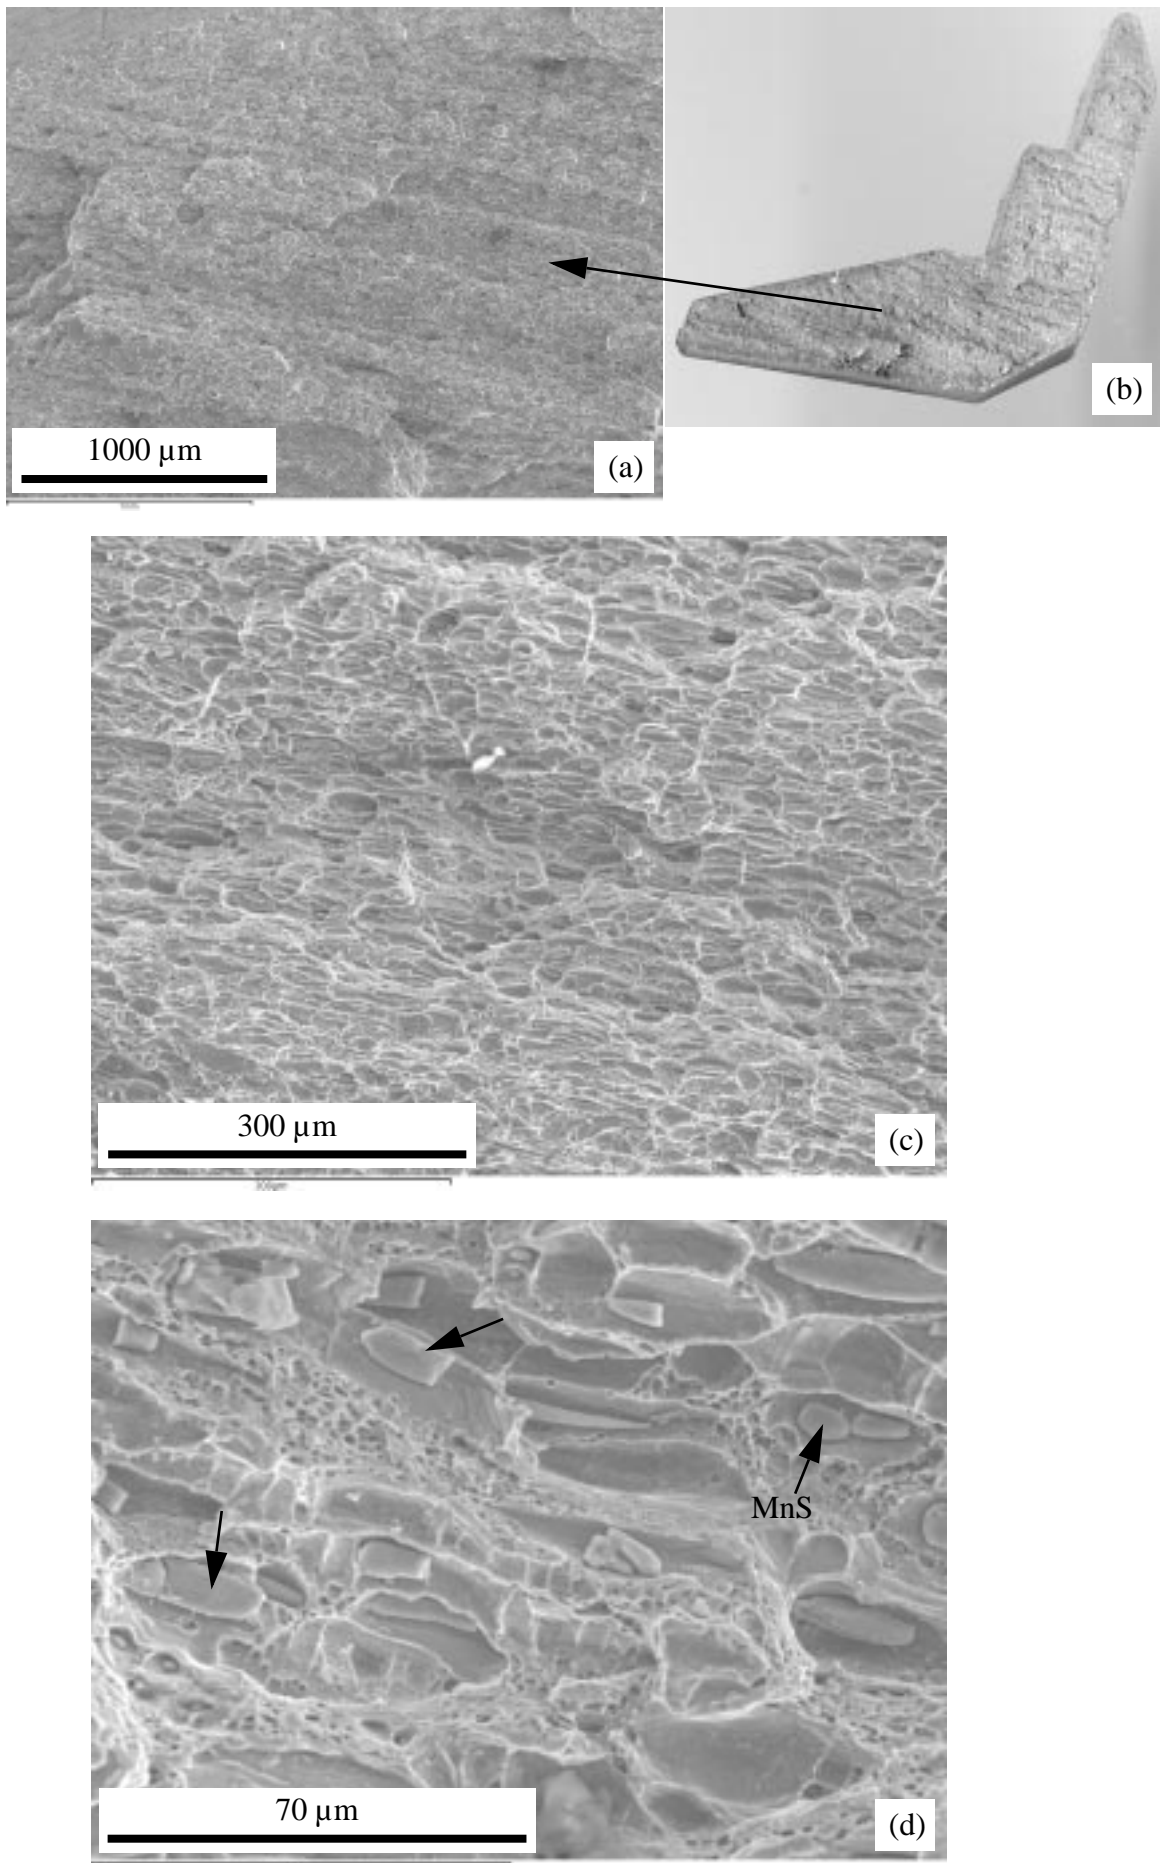
Fig 18. Fracture surfaces of the crack in the spring seat of the cylinder 4 (fig. 2g). SEM.
