Investigation report

C7/2005 L

Falling of passenger stairs at Rovaniemi airport on 14 December 2005

AIRBUS A321

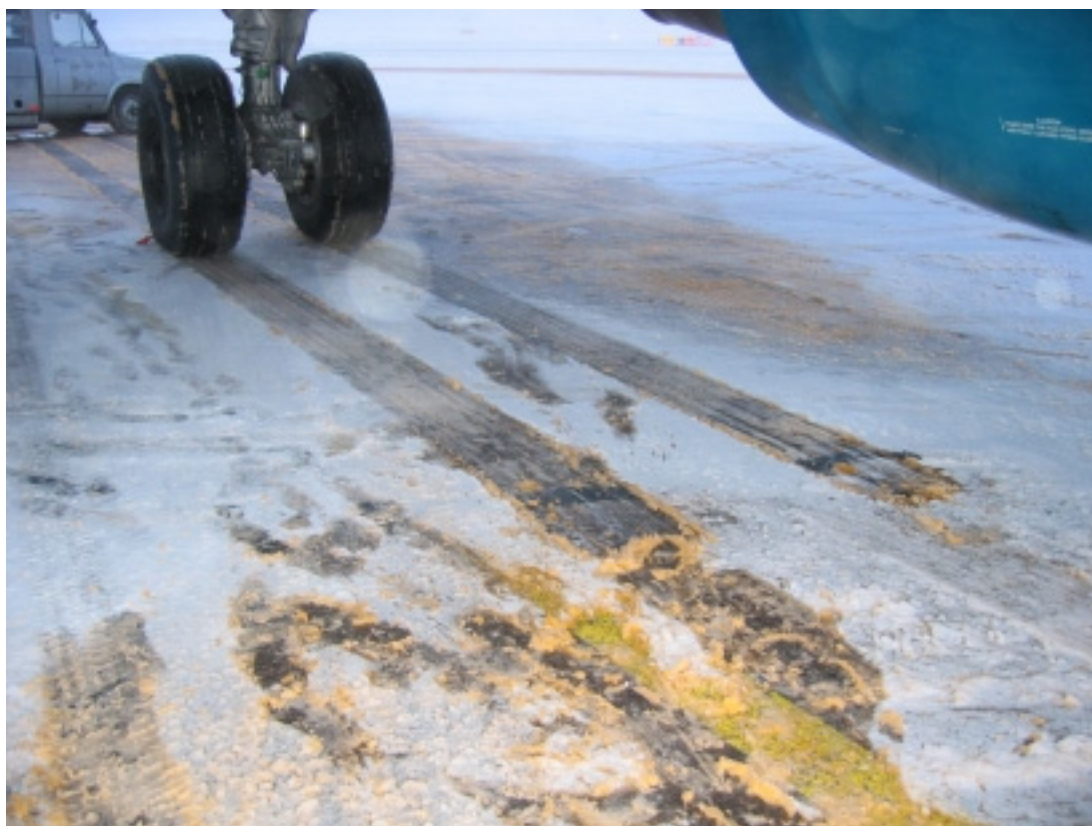
Picture 1. Track marks of the aircraft

As the aircraft was moving, the refuelling hose attached to the right wing tightened and tore off a coupling on the wing. The pressured fuel in the hose, about 40 litres, flowed out to the apron. The refuelling hose did not hit anyone working in the area, but one loader got fuel spray on him. The valve on the aircraft wing prevented fuel from running out of the tank. About 500 kg of fuel had been transferred from the refuelling truck to the aircraft before the fuel hose was torn off. The conveyor belt in front of the aft cargo door turned in a slant position as the aircraft moved, and its unpadded corner dented and scratched the aircraft skin plates. The hose of the water truck, situated on the rear left side of the aircraft, also tightened when the aircraft was moving, but the rest of the hose wound open from the reel and caused no damage. As the aircraft stopped, the left engine was about three meters from the water truck.

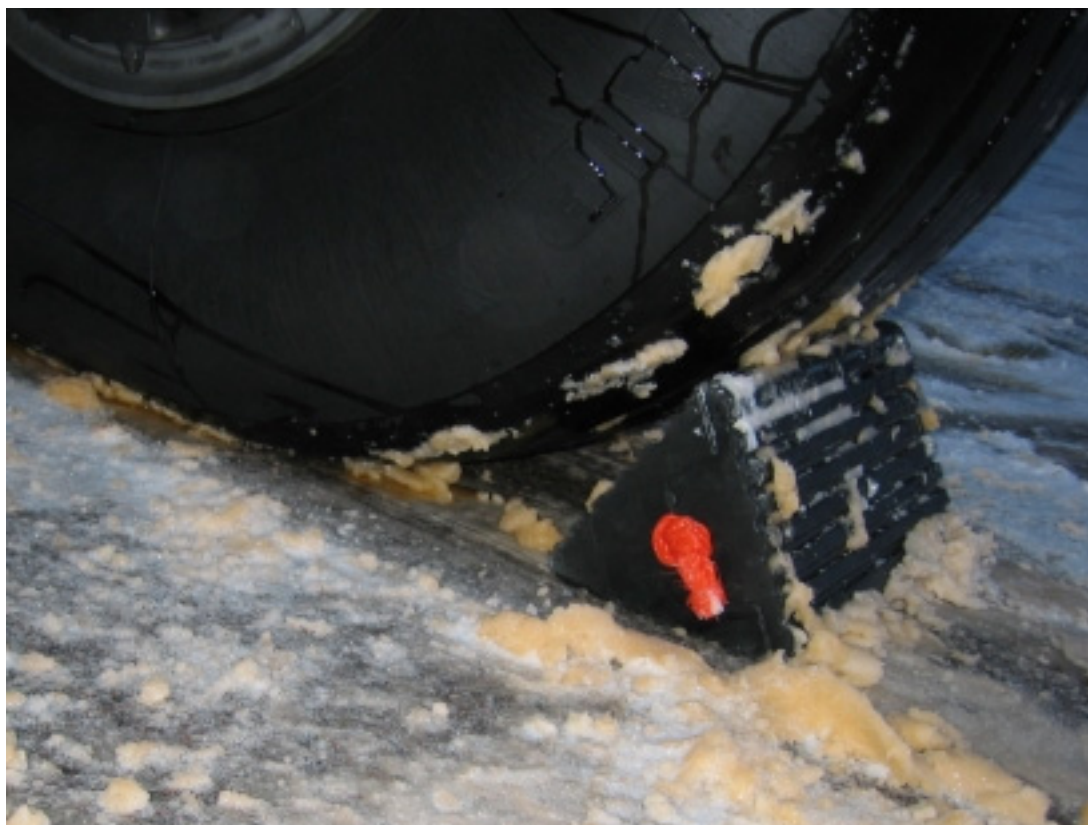
Picture 2. Wheel chock

When the loading staff tried to push the chocks behind the wheels while the aircraft was moving, the chocks did not become wedged under the main landing gear wheel because of their form and the slippery surface. At the handling agent's initiative, the wheel chocks

had been equipped with studs intended for car tyres in winter, to keep the chocks better in place in winter conditions. Only a small area of the upper part of the chock was in contact with the tyre.

The wheel chocks were made of rubber, left over from the manufacture of other rubber articles. This material was used because of lower production costs and because it responded well to the needs of the customer, Airpro Oy. No quality requirements have been defined for wheel chock materials. For this reason, they can be made of such rubber types that do not, according to the manufacturer's report, have the properties intended for winter conditions. Winter conditions make different requirements for the quality and composition of the rubber. If the material hardens, it becomes more slippery. If the shape of the object is changed as a result of wear, or if it is incorrectly shaped from the beginning, it glides easily away from its place behind the tyre. In addition, residue of de-icing fluid often found at the stands at Rovaniemi airport in winter reduces the grip of the chocks. The shape and dimensions of the chocks had been taken from a model. Due to the structure and shape of the chocks, the forces affecting them did not act in the correct direction, pushing them under the wheel to prevent the aircraft from moving backwards. If the wheel chocks were better shaped, they would be more effectively wedged and pressed between the tyre and the ground. Moreover, if appropriate requirements were defined for the rubber material to be used, it would be possible to develop a material which would more effectively prevent sliding on winter surfaces.

The ground handling agent had fitted studs to the wheel chocks so that they would better keep in place in winter conditions. However, due to the shape of the chock, its upper edge only touches the tyre on a small area. The slush at the stand also prevented the studs from gripping the ice when the chock stood freely on the ground. Therefore the studs used did not significantly improve the friction between wheel chocks and the ice layer in the conditions normally prevailing at Rovaniemi airport stands, since they did not reach to the hard ice surface through snow and slush. Because of the form of the chock aircraft wheel does not weight the chock dawn against the surface.

Airpro Oy should acquire such wheel chocks that, for their material and properties, are sufficient to keep the aircraft in place in the conditions prevailing at the airports where the company operates. Airpro Oy should also develop its ground handling equipment so that it is adequately protected to prevent damage to aircraft.

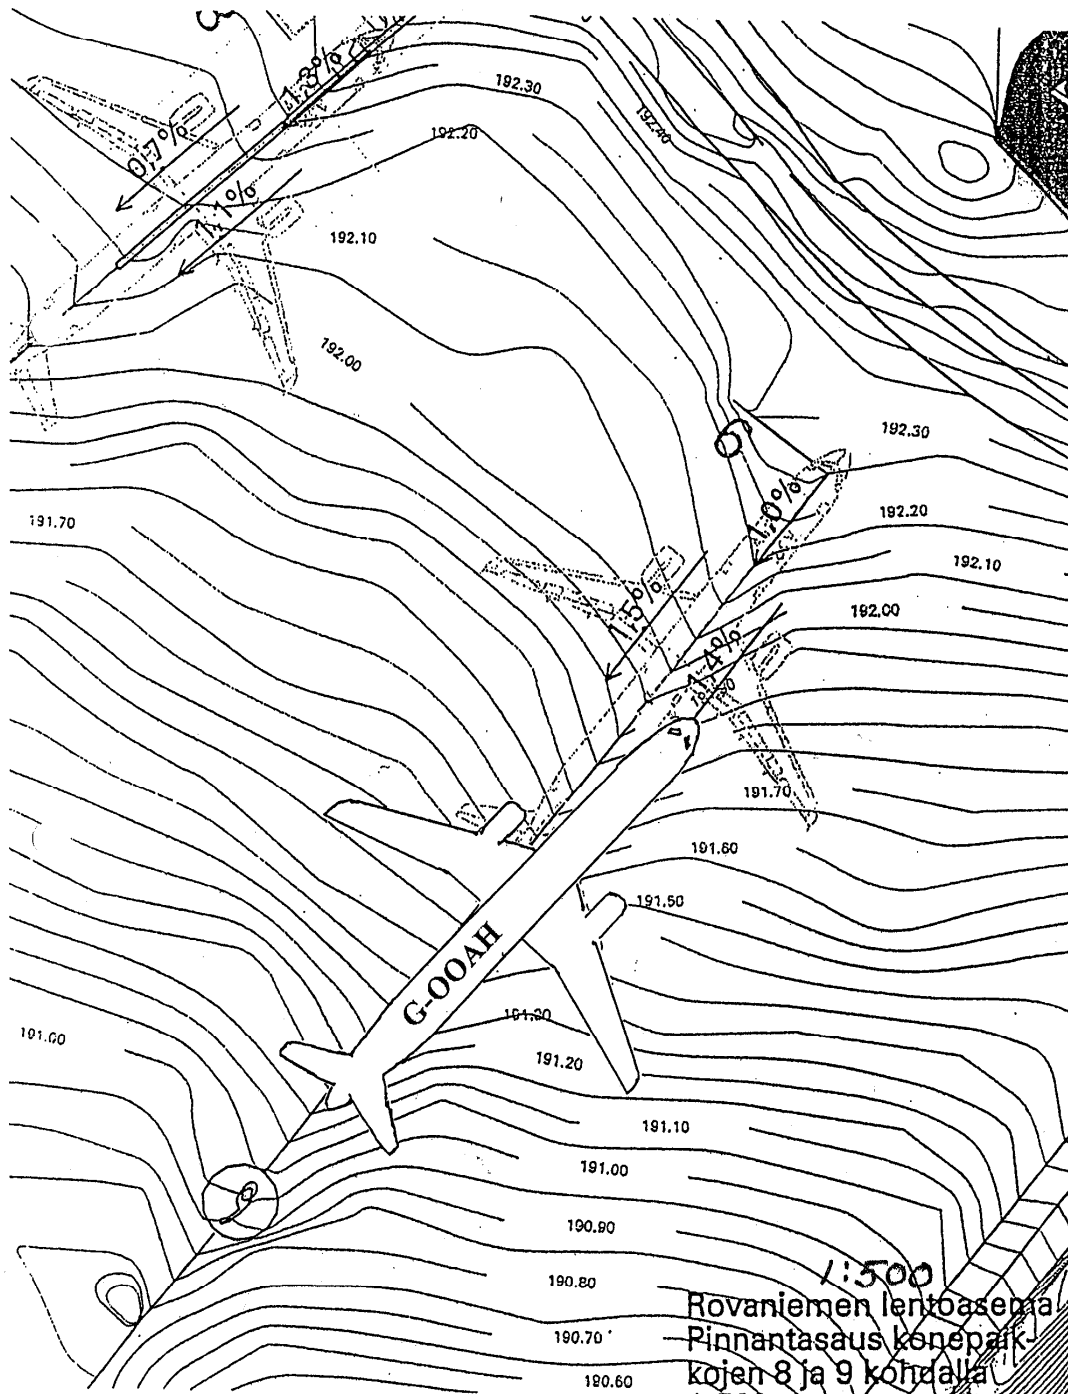
PIIRROSLIITE III

Liitty Rovaniemen kihlakunnan poliisilaitoksen ilmoitukseen 6670/S/33049/05,
onnettomuustutkinta Rovaniemen lentokentällä.
Koneen sijainti tapahtuman jälkeen pysäköintipaikassa 9.
