Investigation report

C 3/2006 L

Incident involving an airliner landing at Helsinki-Vantaa airport on 20 February 2006

OH-LEE

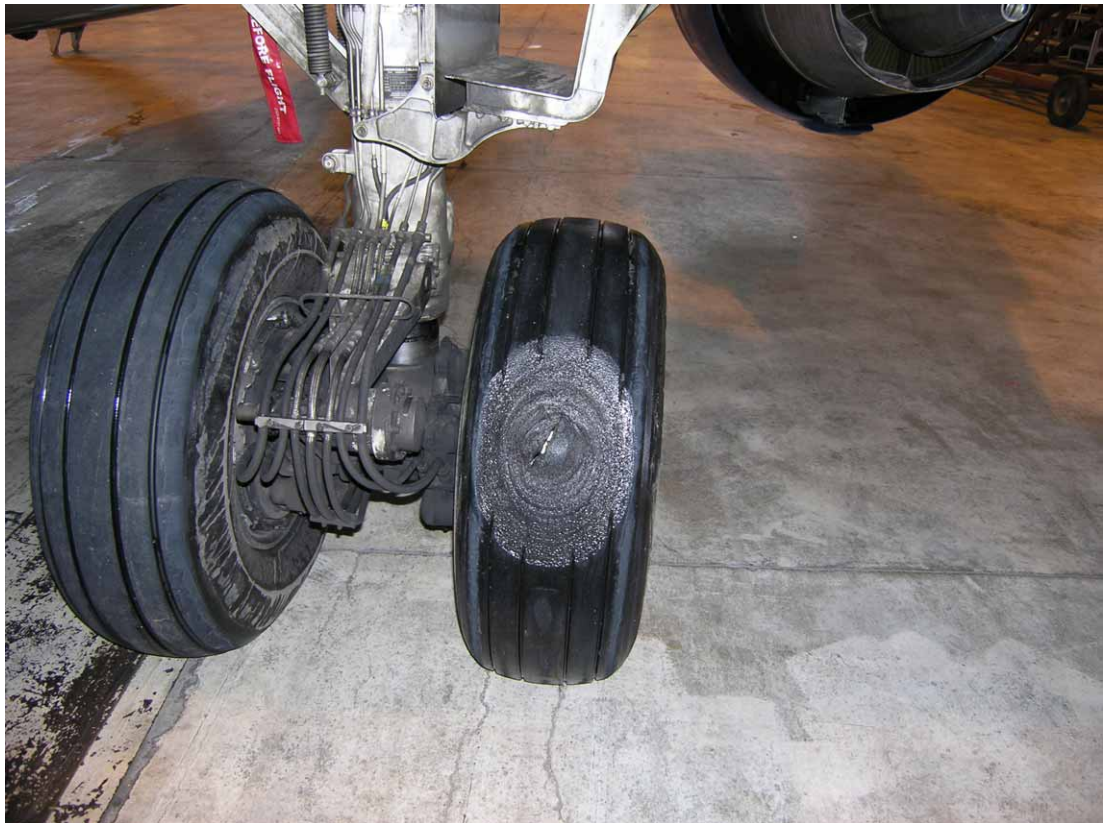
When the aircraft was inspected at the stand, it became clear that two main landing gear tyres had burst during landing. The pilots filed the mandatory Air Safety Report (ASR) of what had happened.

Figure 1. Right main landing gear tyres after the incident (Photo: Finnair Oyj)

The outermost tyres on the left and right main landing gear burst.

After the incident all four main landing gear tyres were changed, emergency/parking brake system settings were checked and the emergency/parking brake valve was changed. The maintenance was performed by following the type maintenance manual as well as the manufacturer's recommendations. Once maintenance was completed the aircraft returned to service.

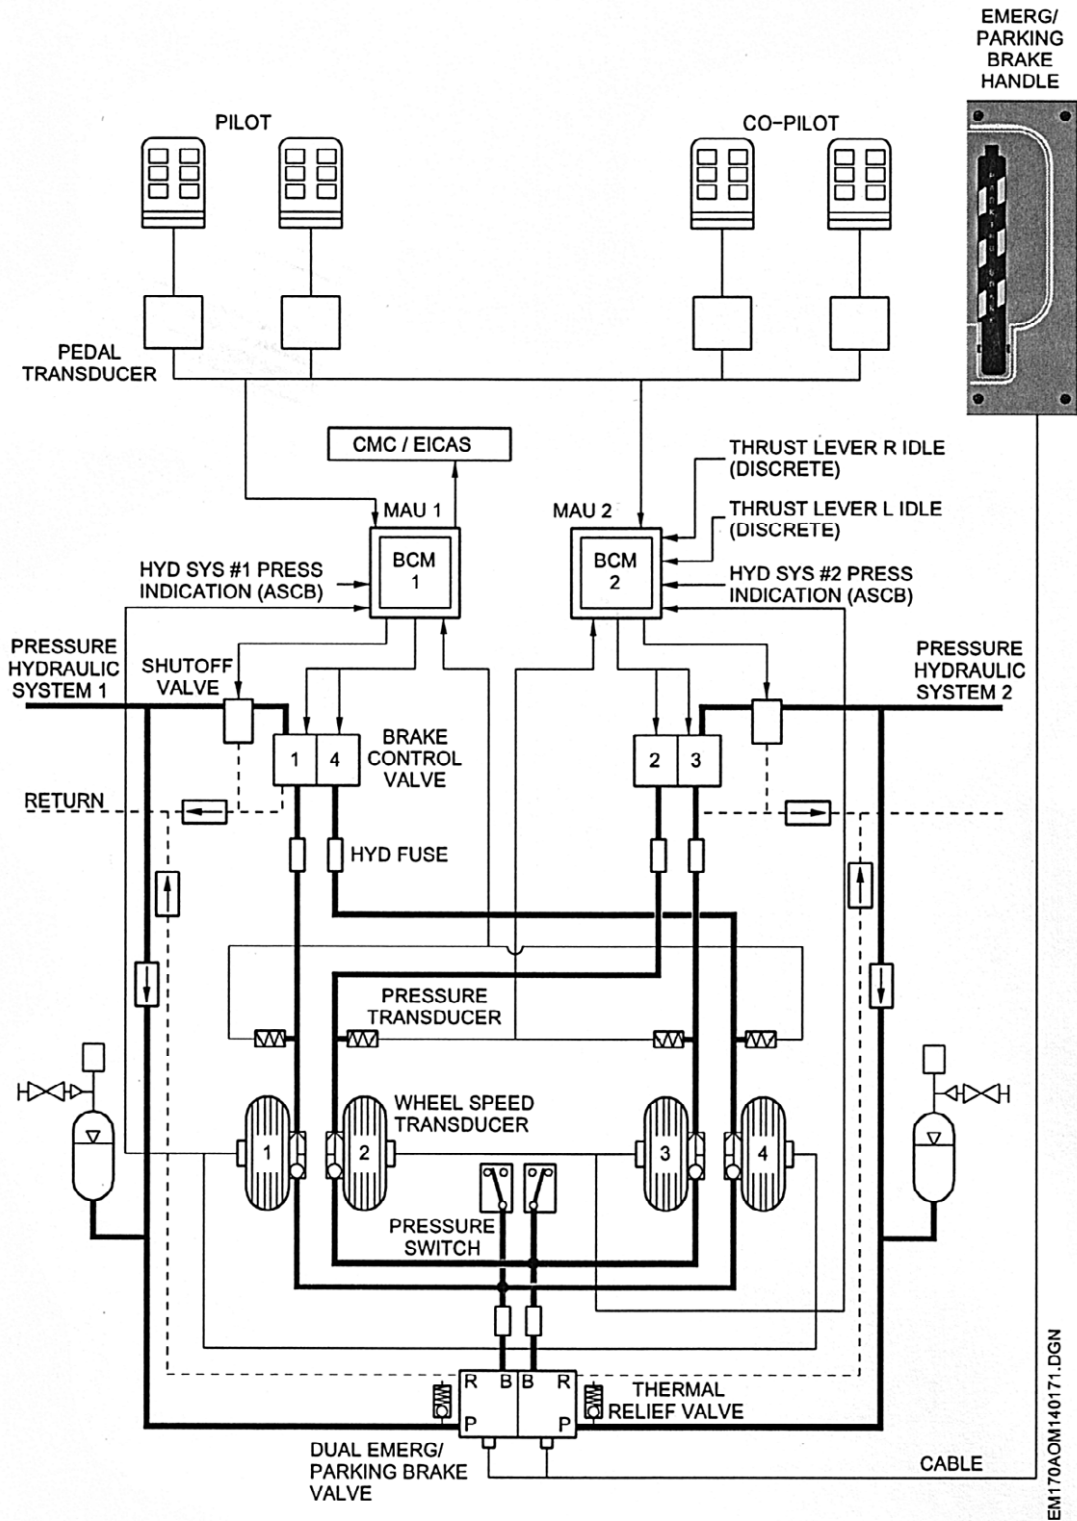
BRAKE SYSTEM SCHEMATIC

A fully mechanical emergency/parking brake system has been installed on the E-170 aircraft to act as the secondary brake system in emergencies as well as for parking the aircraft. The system is operated via the emergency/parking brake control lever on the cockpit pedestal, which mechanically adjusts brake pressure through a dual valve. In normal conditions the emergency/parking brake receives its hydraulic pressure from aircraft hydraulic systems 1 and 2. In addition, there are two pressure accumulators, separated from the main hydraulic lines with check valves. Should normal hydraulic pressure be unavailable, the accumulators provide sufficient pressure for six full brake applications. The emergency/parking brake system is a standalone system independent of the main brake system and does not require any electrical power. System operation is the same on the ground as aloft. The E-170's main brake system includes various protective mechanisms which, among other things, prevent brakes-on landings (touch down protection). However, the use of the emergency/parking brake overrides these mechanisms.

Two pressure sensors measure hydraulic pressure on the emergency/parking brake system. If at least one detects sufficient pressure, a small white text "ON" on the rectangular EMER/PRKG BRAKE telltale lamp comes on on the cockpit instrument panel.

Figure 2. The emergency/parking brake system schematic (Diagram: Finnair Oyj E-170 OM-B)

The direct causal factor in the incident was a malfunction of the emergency/parking brake system, allowing one of the two brake circuits to retain pressure even after the brake lever was released. The investigation could not determine a clear cause for the malfunctioning of the emergency/parking brake system.

The investigation commission recommends that the aircraft manufacturer redesign the emergency/parking brake system so that it be impossible for the emergency/parking brake to retain pressure when airborne and when the brake lever is disengaged and/or to publish a procedure according to which pilots can depressurise the emergency/parking brake system aloft without compromising flight safety.

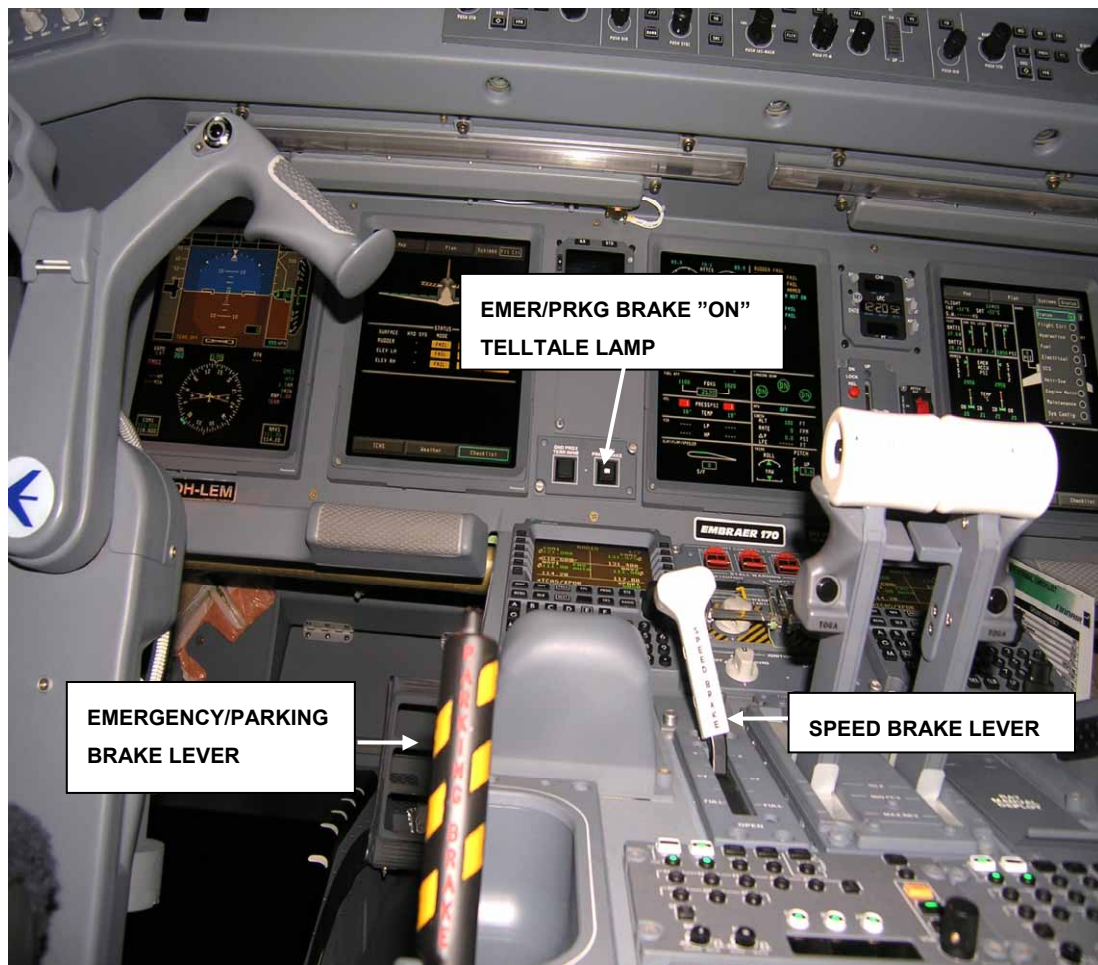
The captain of the aircraft explained that the speed brake lever on the MD-80 aircraft, which he had flown in the past, was located in the same place on the pedestal as the emergency/parking brake lever is on the E-170. It is the opinion of the investigation commission that the probable cause for using the wrong lever was the captain's relatively short practical experience in flying the E-170, compounded by a momentary workload increase due to the change of landing runway. His previous experiences on the MD-80 and ATR-72 aircraft could also have carried over and contributed to the use of the wrong lever.

Said light is white and quite small. On the ground the light indicates that the parking brake is on. If the emergency brake is used, the light indicates that brake pressure is available. According to the E-170 Operations Manual Part B (OM-B), white lights are used to report normal operation or normal system status to the cockpit. However, on buttons a white striped bar is used to indicate that the button is not in its normal position.

Figure 3. The emergency/parking brake lever, the telltale lamp and the speed brake lever (Photo: Finnair Oyj)

The investigation commission recommends that the aircraft manufacturer redesign the emergency/parking brake warning and indication system so as to provide sufficiently detailed information to pilots of system status and possible faults when airborne.
