Investigation report

C 4/2006 L

Engine failure and emergency landing at Joensuu airport on 24 March 2006

Cessna 172P (TAE 125 diesel engine)

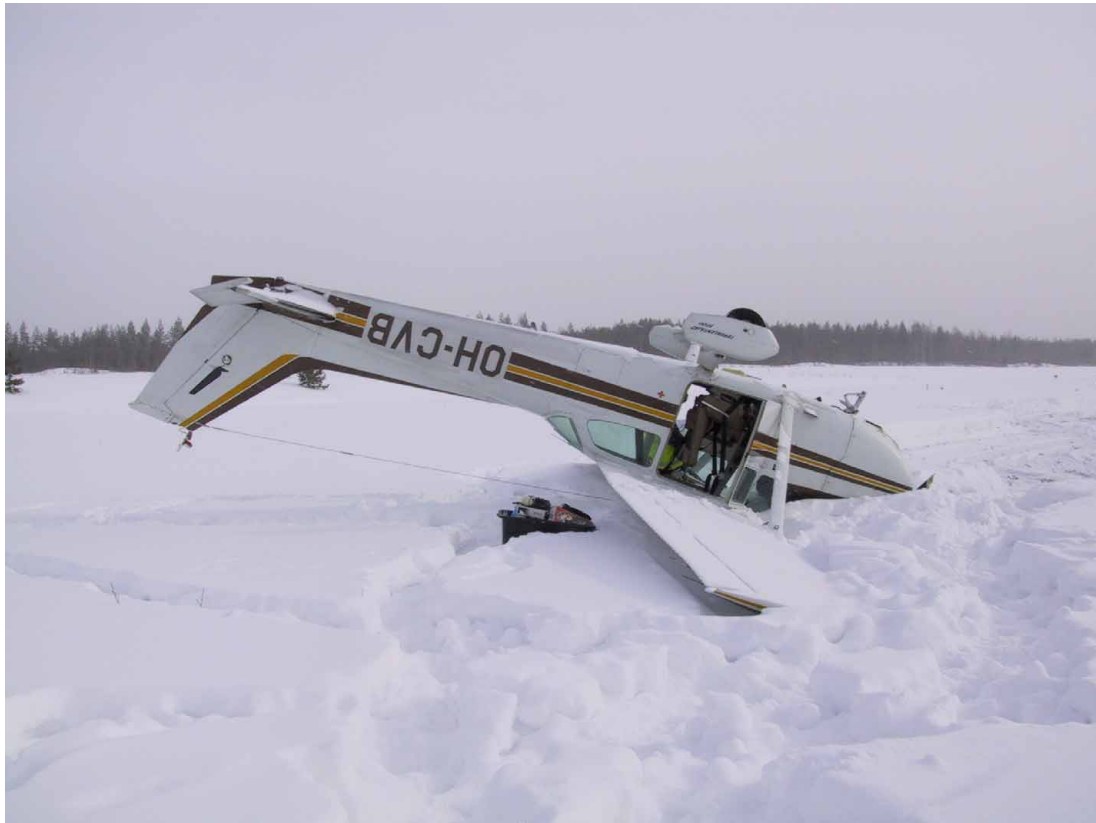
The pilot recalled that after the engine stopped he checked the position of the fuel selector and tested the operation of the power lever. The pilot reported the engine malfunction and his intention to make an emergency landing by radio to the control tower. The pilot steered right of the approach path to avoid collision with the runway 10 approach lights. As the nose wheel touched down in the snow the aircraft banked right, after which the right wingtip also touched the snow. The aircraft rolled over its nose and right wingtip coming to a halt upside down.

Figure 1. The aircraft after the emergency landing

All three blades of the propeller had broken off approximately 20 cm from the root. The spinner and back plates were dented. The lower engine cowling was dented and the composite air intake channels had minor damages. The leading edges of both wings were dented for a length of approximately 30 cm and the outermost wing ribs and wing-tips were torn. The auxiliary spars had buckled at the fuel tank position. The cockpit rear window was cracked. The vertical stabilizer tip was crushed, the beacon light had broken off and was hanging from its wiring. After the aircraft had warmed to room temperature in the aircraft hangar, fuel samples were taken from the wing fuel tanks and fuel filter. The fuel samples contained a few drops of water. The fuel was of the right colour and odour.

2. The investigation commission recommends that takeoffs with single-engine aircraft be commenced from the departure end of the runway, even in cases where the minimum takeoff distance requirement indicated in the aircraft manual is less than the runway length available.

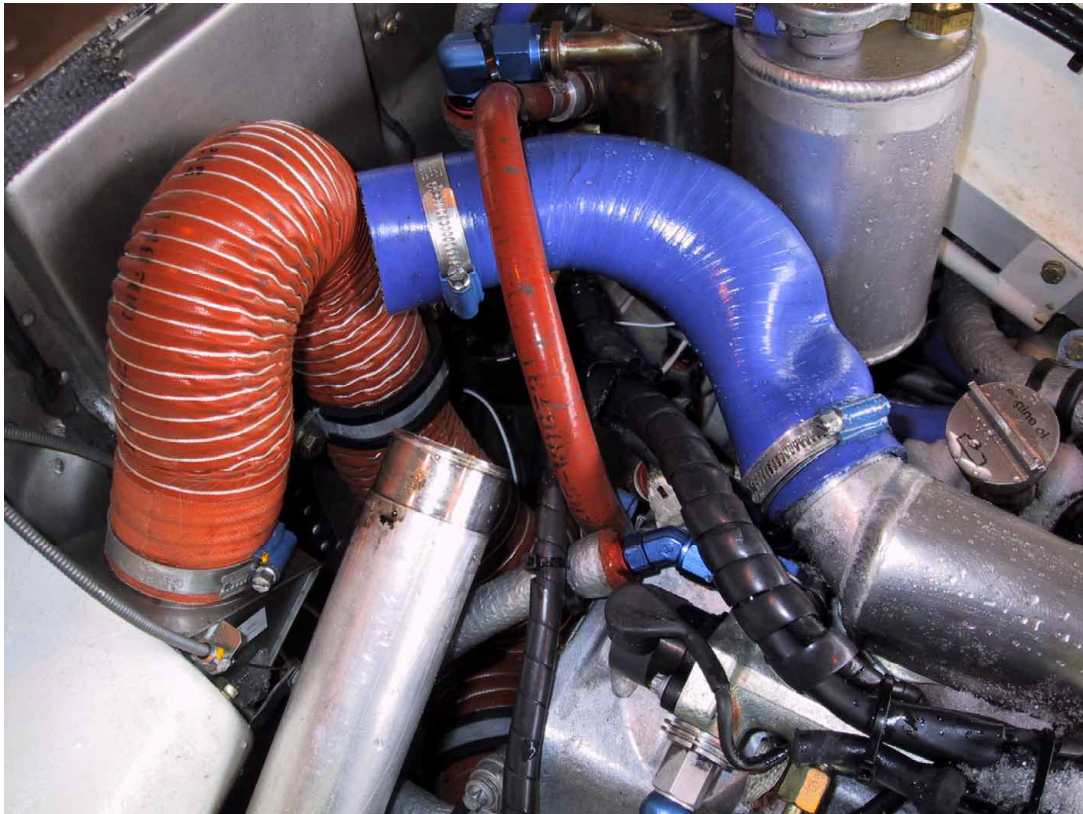
There was no damage to the engine compartment. The oil and fuel lines as well as the engine ancillary equipment, sensors and controllers were attached and no leaks were observed. The high pressure fuel pump, which had been replaced in the maintenance check, was removed and by rotating the pump shaft was found to transfer fuel. In the engine examination the long intake air tube situated between the intercooler and the intake manifold was found detached at the intercooler end. The loose end of the tube was

pointed towards the hose connecting the air filter to the turbocharger, and the tube had buckled at the intake manifold end. The attachment clamp was found resting on the tube. When tested, the tube was easily pushed back on to the metal tube coming from the intercooler, and it was possible to slip the attachment clamp back on to the tube using moderate finger strength.

Figure 2. The detached intake tube as it was found after opening the engine cowling

After opening during takeoff, the detached end of the tube turned towards the hose connecting the air filter to the turbocharger. The tube collapsed due to suction and became completely blocked. Consequently the engine was not supplied with intake air and it stopped quickly. After bending to the side the tube buckled, contributing to the blocking up of the tube. A drop in manifold pressure could be observed from the FADEC engine data sent to the engine manufacturer.

3. The Certificate of Airworthiness and Certificate of Registration of the aircraft were valid.
4. The intake air tube attachment clamp that had been loosened during the maintenance check had not been tightened and this was not detected in the inspection made by the second mechanic.

1. The investigation commission recommends that the engine manufacturer and maintenance personnel should seal the tube clamps using paint marking or safety-wire, enabling an easy visual detection of opened attachments in the final maintenance inspection.

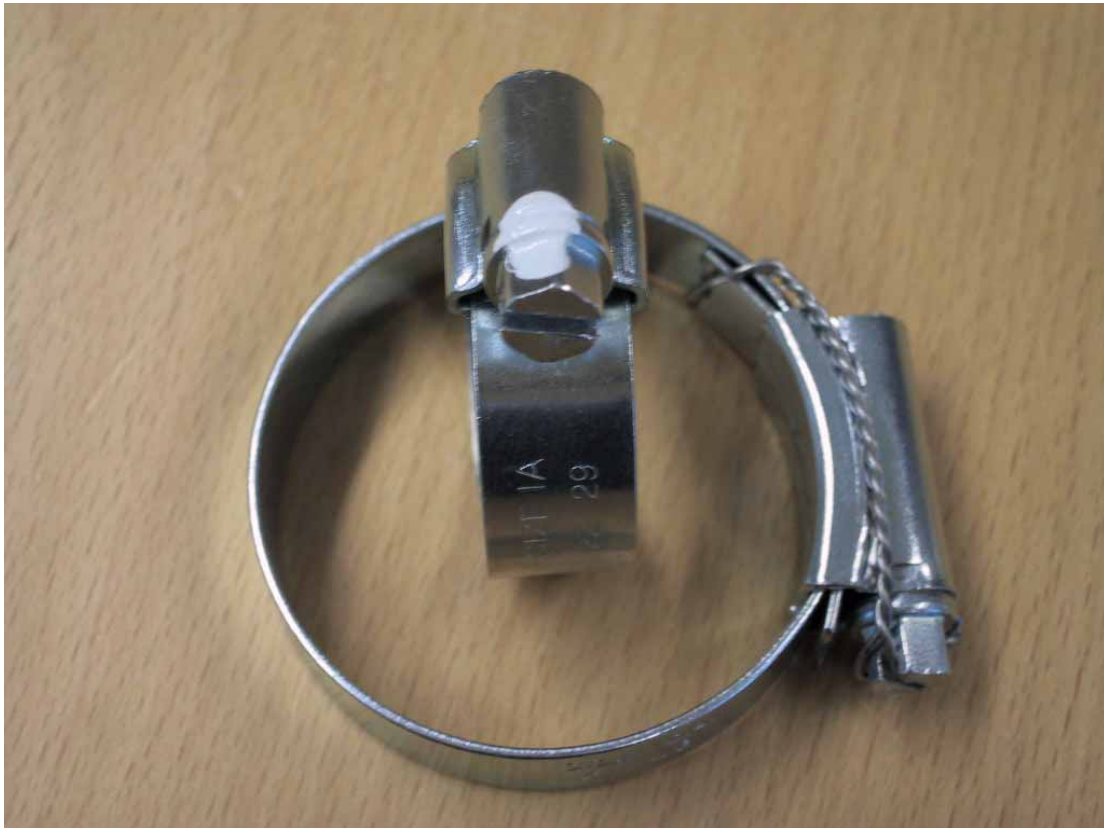
The attachment clamps were installed by the engine manufacturer. A clamp of this type may be left loose without it being visually detectable. Even though such clamps do not loosen with time, it is the view of the investigation commission that the attachment clamps should be sealed with an inspection paint marking or safety-wire. Sealing the attachment is an aid in the detection of possible loose attachments. According to the engine maintenance checklist, attachment clamps should be checked by visual inspection. There is no specific instruction to check the tightness of attachment clamps.

Figure 3. Examples of sealing methods using paint marking and safety-wire
