Investigation report

C4/2007L

Microlight emergency landing in Petsmo on 24 June 2007

F-JZUH

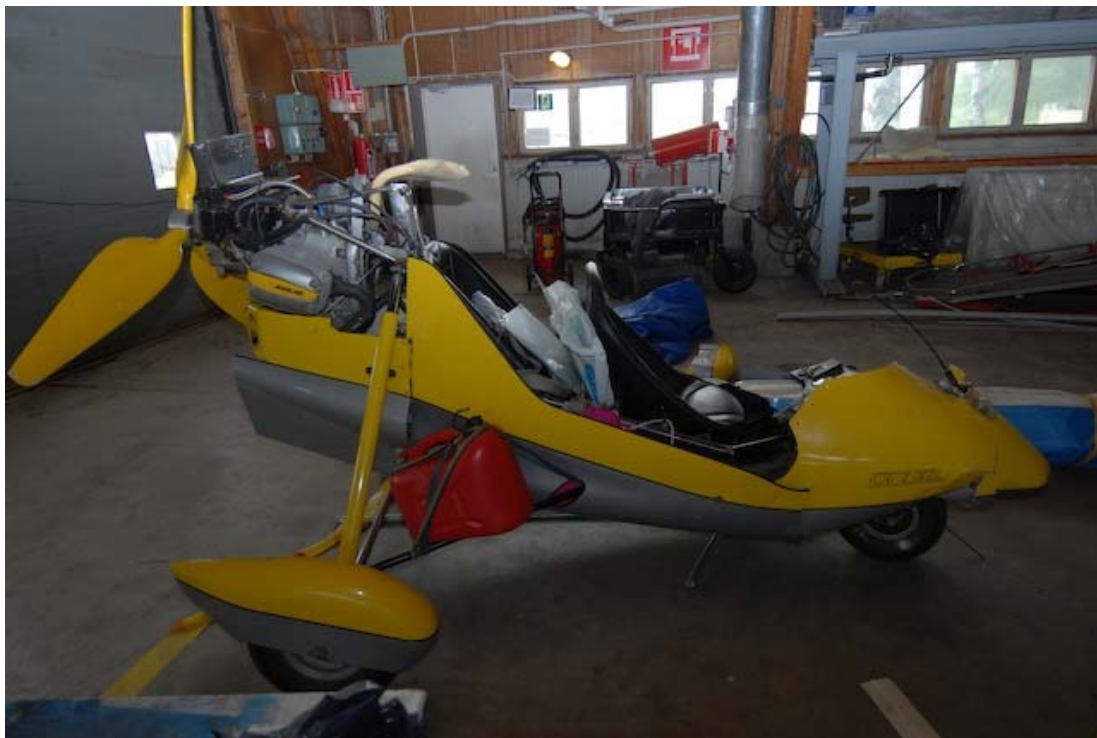
Figure 1. The pod (fuselage) after the accident

The steel keel tube under the pilot bent approximately 15 degrees to the right. The steel mast snapped at the height of the passenger's head. The tube joining the front of the pod and the mast had broken at its front joint. The fibreglass front cowling was damaged. The compass had dislodged and the GPS was found 30 m from the wreckage.

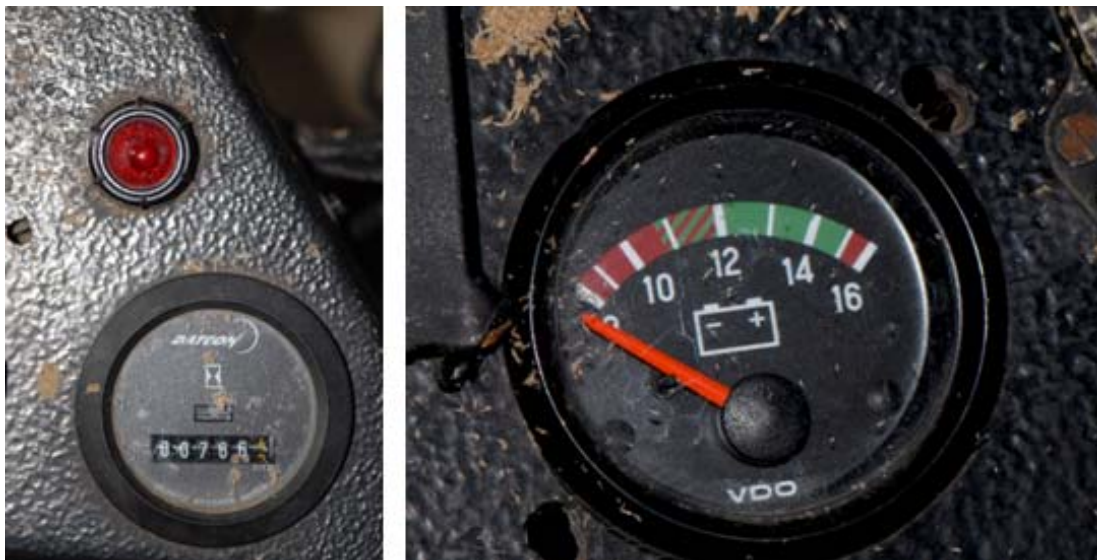
Figures 2 and 3. Generator warning light and Volt meter

If the generator fails while the engine is still running, there are two ways to detect this: the generator warning light comes on and the Volt meter indicator drops to indicate the remaining battery voltage. The pilot of the accident flight did not detect either of the above. Instead, he continued the flight until the engine began to sputter.

When it comes to warning lights and the electrical system the pilot knew that two red lights always come on before the engine is started and that the lights go off when the engine is running. He did not know that the left warning light on the instrument panel was the oil pressure light and the right one the generator warning light. Neither did he know how long the engine runs on battery power alone. There are no warning light placards on the instrument panel. The pilot did not notice that the warning light came on. It is possible that sunlight reduced visibility of the warning light.

6. There were no warning light reference plates on the instrument panel (contributing causal factor).
7. The pilot did not notice that the warning light came on (contributing causal factor).

As regards flight safety, it is essential that the pilot be sufficiently familiarized/trained on the aircraft's systems and emergency procedures at the very onset of flight training.

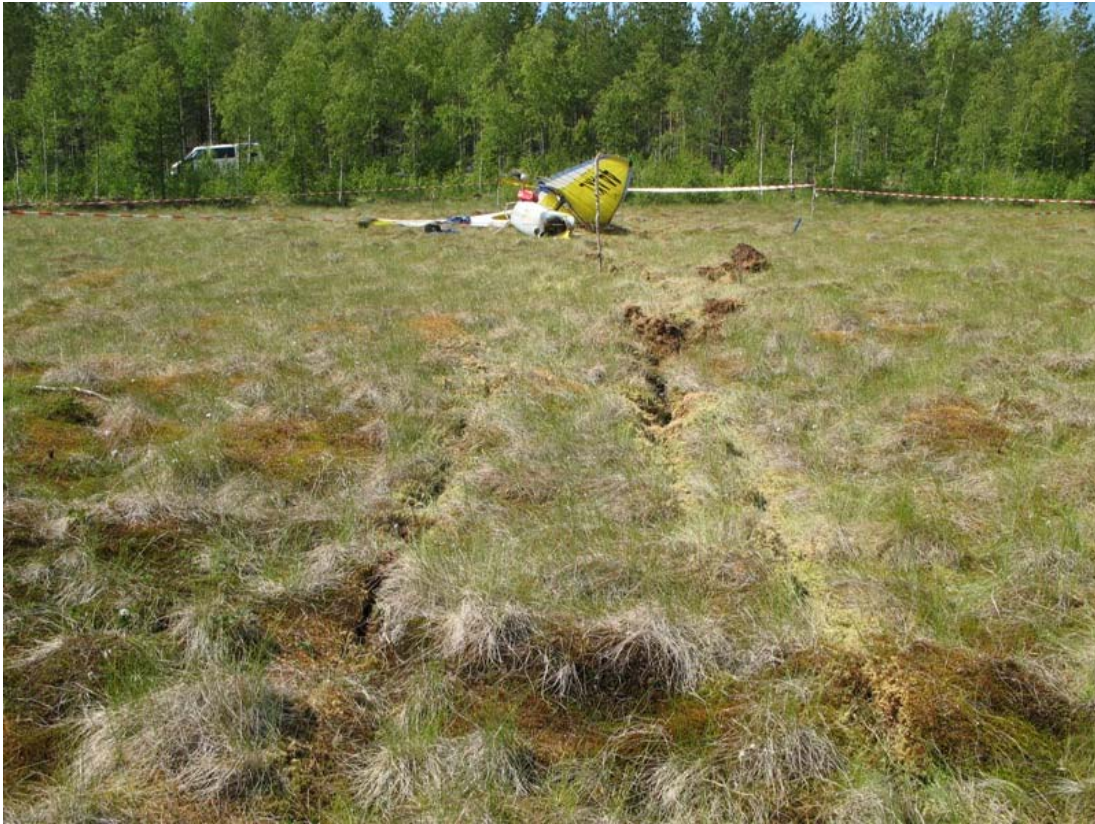
Judging by marks on the pod and on the ground the aircraft touched down on its rear wheels, at which time also the belly of the pod made contact with the ground. As the nose wheel hit the surface, it ploughed into the marsh for the distance of approximately 2 m. As a result of this, the pod tumbled twice.

Figure 3. Accident site and markings on the ground
