Investigation report

C9/2007L

An unauthorized approach to an engaged runway at Pori aerodrome on 7 November 2007

BOEING 737-800

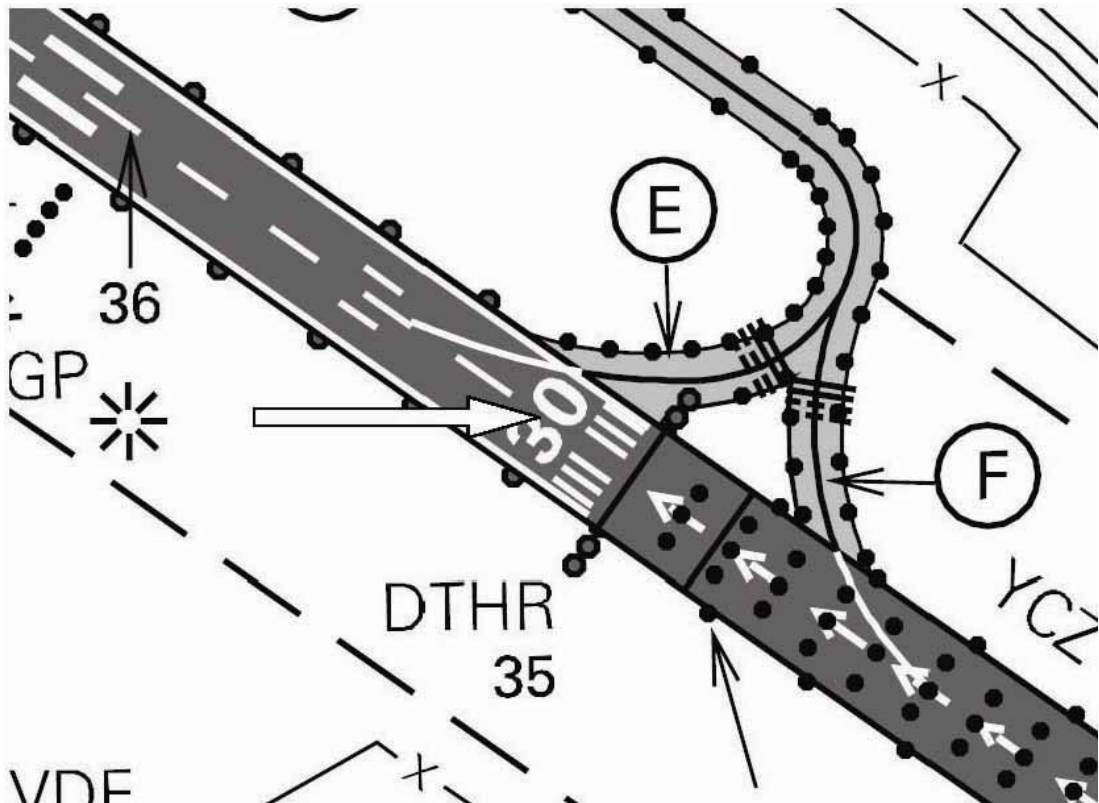
The Pori airport does not have an automatic RVR measuring system. RVR for runway 12/30 is measured by assessing it visually. Pending permission from the air traffic controller, specially trained airport maintenance staff assess the RVR from the Runway Observation Position (ROP). On RWY 30 the ROP is on the runway centreline, 60 m from threshold (figure 2). The observer counts the number of high-intensity runway lights he can see from the ROP. The air traffic controller then converts this information into RVR.

Figure 2. The Runway Observation Position, © Finavia, Permission 4/590/2007

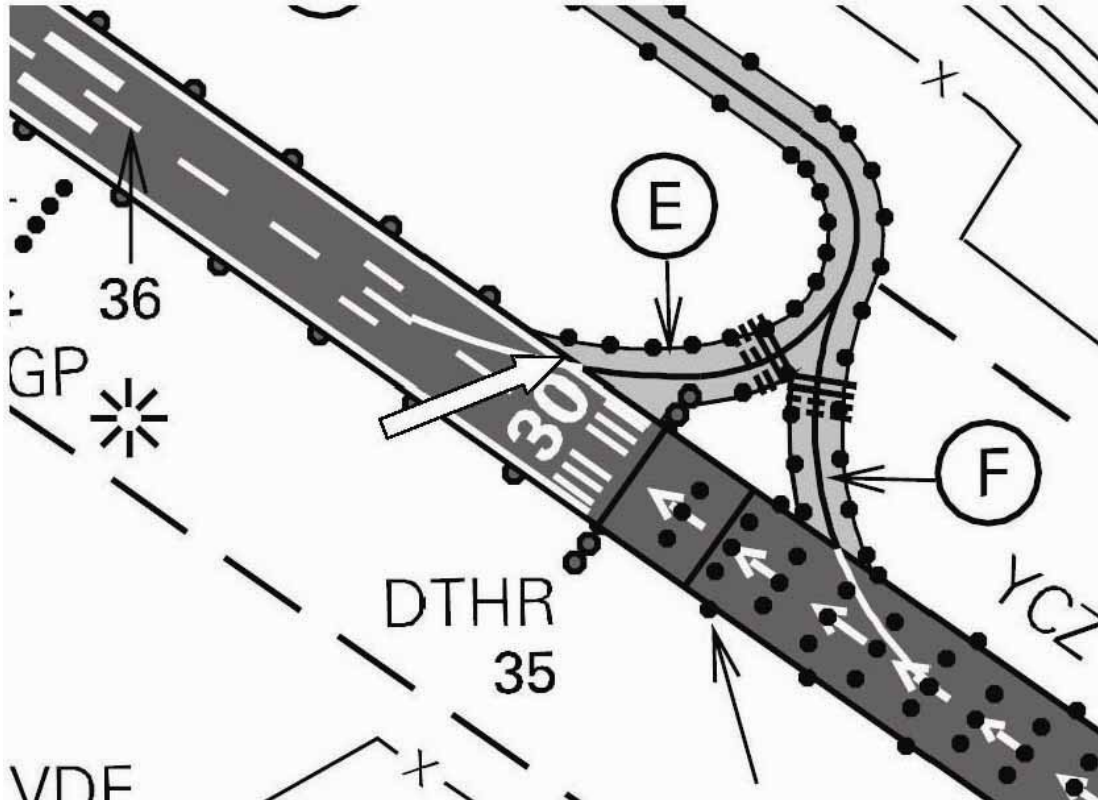
Even though the RVR observer sped off of the Runway Observation Position (ROP), his vehicle was still partially inside the runway edge when PGT442 passed overhead. As per his account, the driver spotted PGT442 in his rearview mirror as it flew over the ROP. He estimated that the wing tip of the aircraft cleared his vehicle by approximately 15 m. The driver's statement and the DFDR-based estimation of the distance between the vehicle and the aircraft at the moment when they passed each other are conflicting.

Figure 3. Position of the vehicle at the moment when PGT442 passed it, © Finavia, Permission 4/590/2007
