Investigation report

D16/2007L

Infringement of radar separation minima in Helsinki TMA on September 5, 2007

FIN166 and SAS1712

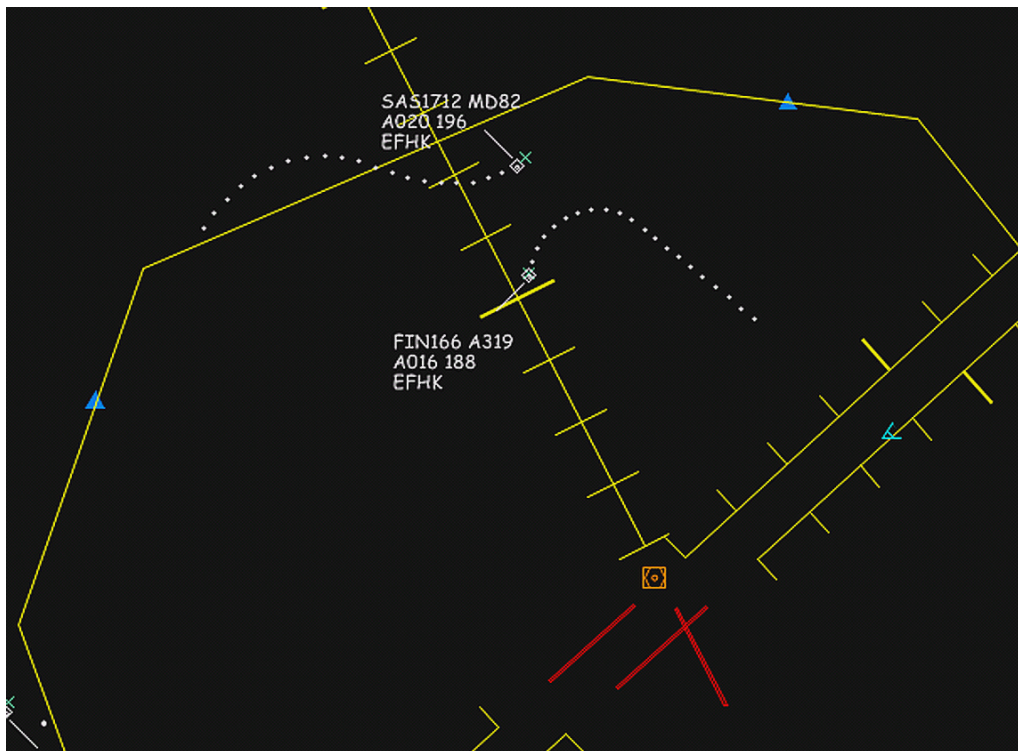
left...this is too close”), which the controller accepted. After a while SAS1712 announced that they would have to fly a circle to the left to gain sufficient distance from the aircraft ahead (“we are gonna have to make a three sixty...this is less than half a mile...”), which the controller also accepted. While SAS1712 continued turning to the left, safe separation was re-established. The shortest horizontal distance between FIN166 and SAS1712 was less than 1.5 NM, while the minimum allowed separation is 3.0 NM. At the time when the separation was lost, the air-speed of SAS1712 was about 230 KT.

At the time of the incident, FIN166 was turning to the left base leg for runway 15 at 1900 FT (feet), and SAS1712 was turning to final for the same runway at 2100 FT. The vertical distance between the aircraft was about 200 FT, which means that the minimum vertical separation of 1000 FT was not maintained either.

Picture 1. Recorded radar image of FIN166 and SAS1712 flight tracks on final for runway 15.
