## Investigation report

B3/2008L

# In-flight structural failure at Taipalsaari on 15 August 2008

Piper PA-28R-200 Arrow II

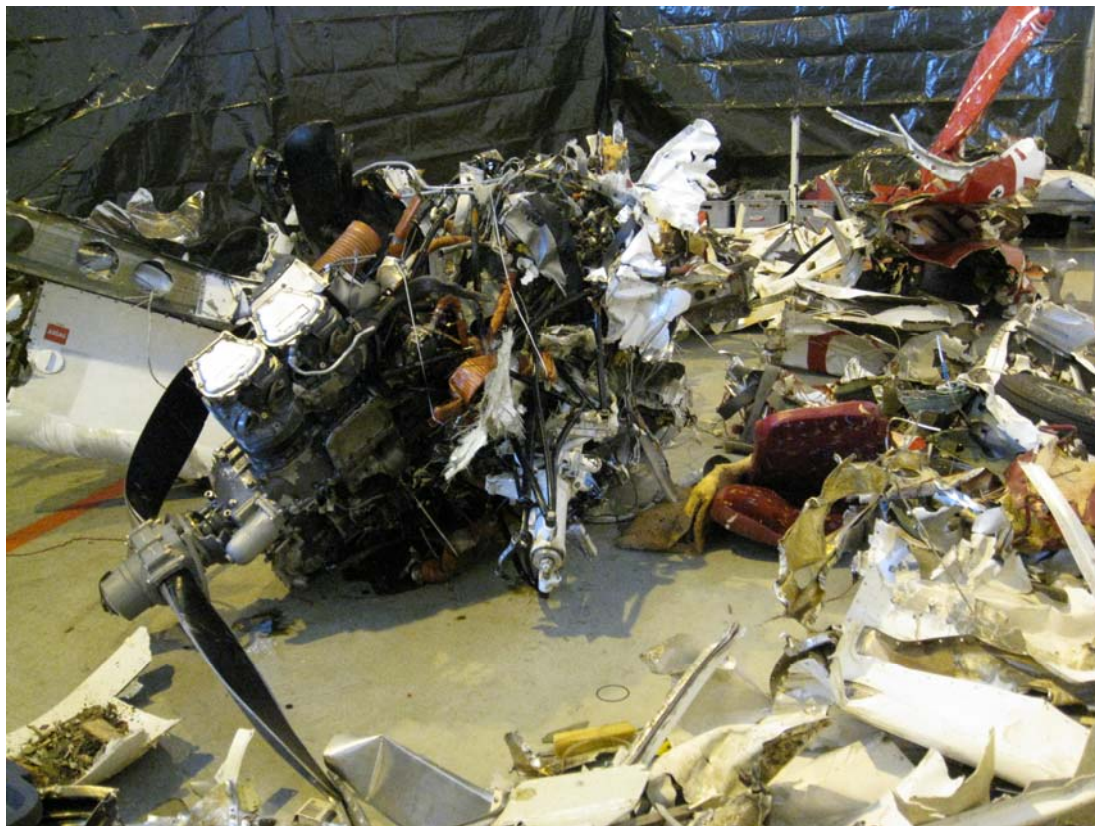
The fuselage and the cockpit were destroyed beyond all recognition. The broken seats were strewn about, having torn loose from their mounting brackets. The front seat belts as well as the right rear seat belt had stretched and the belt buckles were broken by the force of the impact. All of the seat belts were still connected to their mounting brackets. It was impossible to make any reliable observations on the engine controls and switch positions.

The inboard wing sections were still connected to what was left of the fuselage. Both wing spars had broken off at approximately 215 cm from the side of the fuselage. The parts that were still connected to the spars included the remains of the fuel tanks, the main landing gear, parts of the trailing edge flaps and small pieces of skin panel. The rest of the wings (approximately 225 cm in length) were missing.

Figure 3. Wreckage found at the site of impact

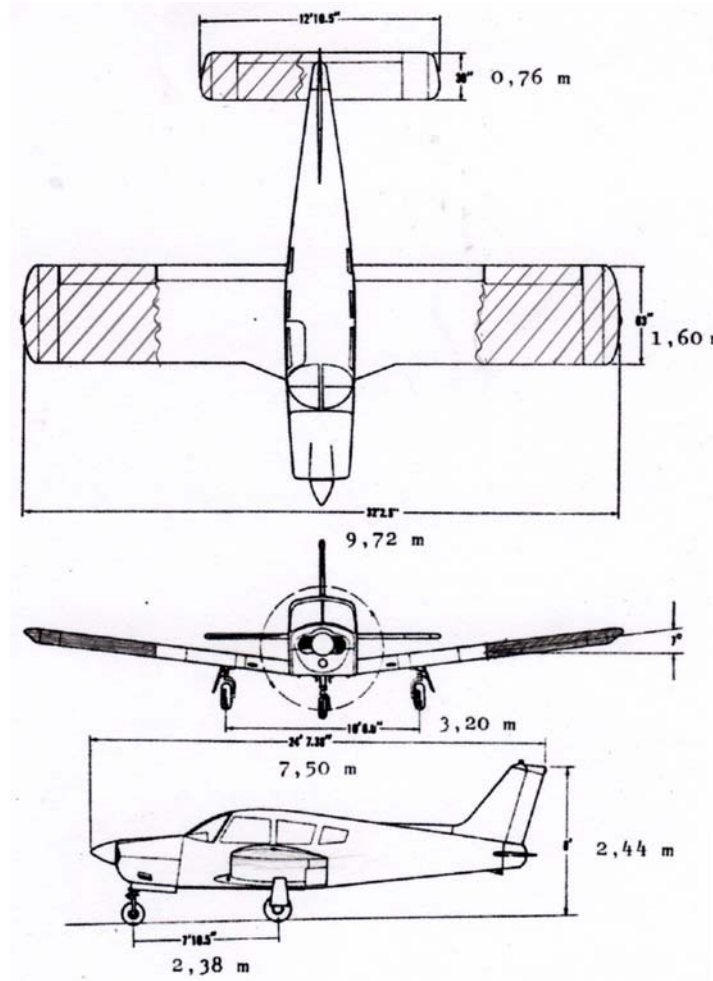
The rudder and the vertical stabiliser were intact as was the left stabilator. The right stabilator and its trim flap were missing. The Piper Arrow has a combined elevator/stabilator, a so-called full-flying tail.

Figure 4. Stripes denote sections of structure that separated in flight

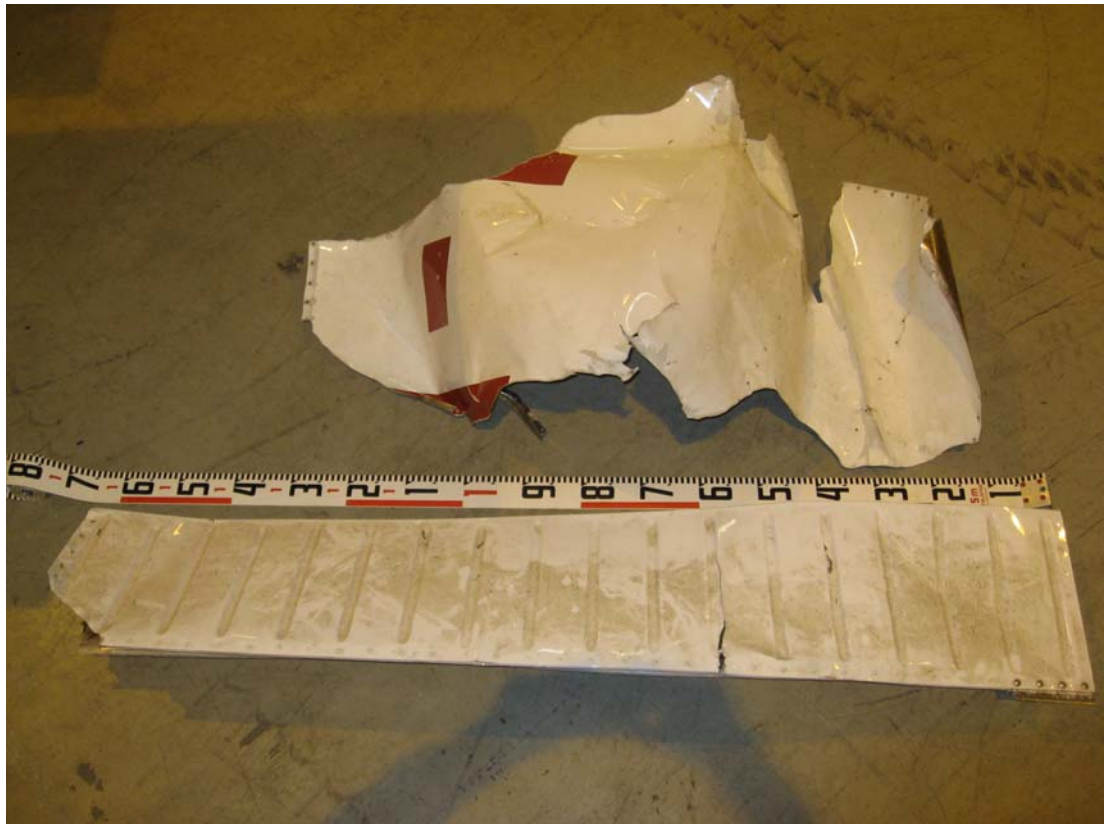
An approximately 0.5 m<sup>2</sup> sized piece of skin panel from the lower surface of the left wing as well as the right aileron were found in the searches. The skin panel piece had torn off at the location where the wing broke off. The piece was badly dented and it had numerous cracks.

The aileron was slightly bent along its length. Its outboard piano hinge and outermost rib as well as the balance attached to the rib were missing. The inboard hinge was attached and had come off the wing when the rivets broke.

Figure 5. Parts that fell off the aircraft in flight and were discovered in searches.

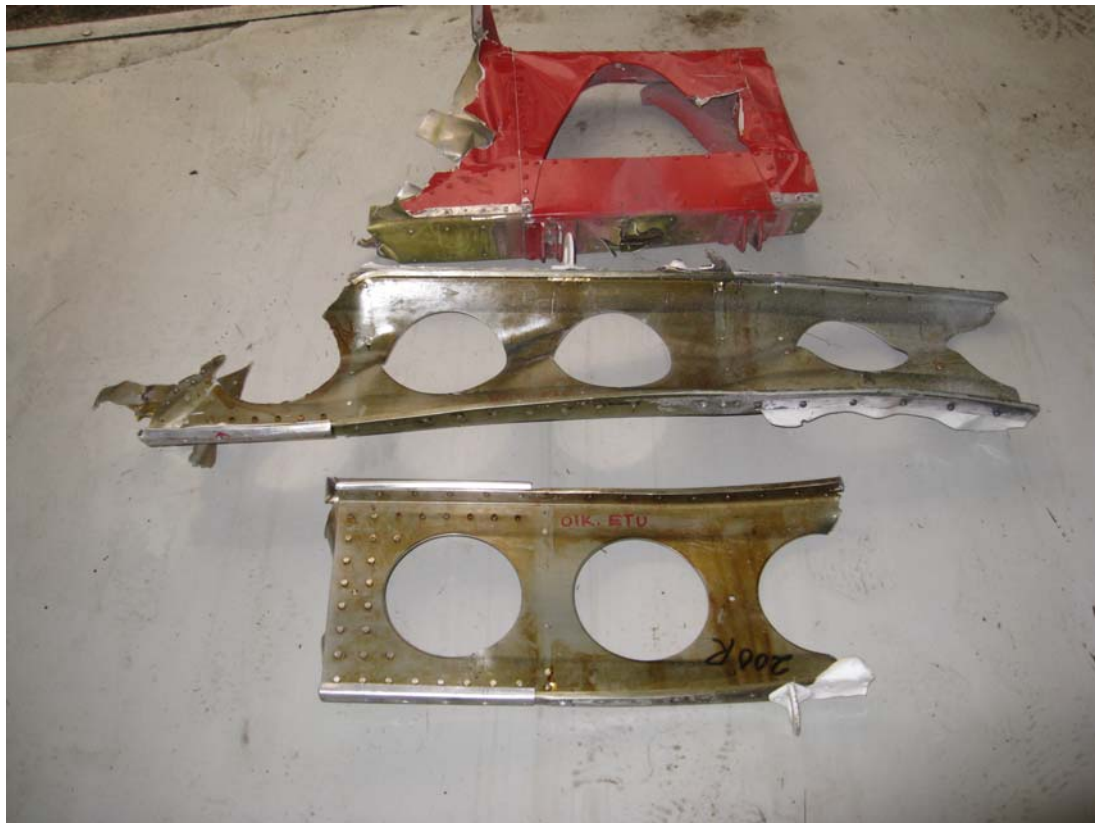
The sample from the right wing was mainly bent forwards. In addition to the forward bend, minor deformations had occurred in the wing spar. Some of them were so local that they were probably caused by the collision with the water. Apart from said deformations, the machined wing spar was intact. A crack had occurred next to the end of the aluminium spar along the approximately 1.3 mm thick sheet aluminium alloy spar. Next to the crack, the thickness of the inboard spar root plate is approximately 2.6 mm. In the middle of the fractured root plate there was a secondary crack that ran through a rivet hole, pointing upwards at an oblique angle. The area above this crack was bent backwards. The length of the section where the inboard spar is riveted to the outboard spar is 205 mm.

Signs of some upward deflection were present on the upper and lower edges of the left wing spar. In addition, the lower edge was bent forwards. The area between the machined spar's holes had buckled in a manner which points to shear stress caused by an upwards bend. The fracture had occurred on the machined spar as well as the 1.3 mm thick sheet aluminium alloy spar. The edges of cracks that were on the machined spar were bent upwards and contained secondary fractures.

The right side of the stabilator was torn off. The U-shaped rear spar was bent backwards for approximately 15 cm and the forward box spar's fracture surface edges were bent forwards. The cracked plate was deflected upwards and contained secondary fractures.

No signs of metal fatigue or material defects were found when fracture surfaces were examined visually or by stereo microscope. Neither did the fracture surfaces display any signs of altering or inconsistent fracture mechanisms. Most of the fracture surfaces, especially those on the thinnest components, were at a 45° angle from the surface of the plate. This is typical of a shear fracture. Some fracture surfaces showed marks caused by post-fracture blows or abrasion. An example of such post-fracture damage is the fracture surface on the bottom of the inboard left spar root.

Figure 6. Parts inspected by VTT. Top: part of the stabilator. Middle: part of the left wing spar. Bottom: part of the right wing spar (all of the parts' fracture surfaces were at the left end).

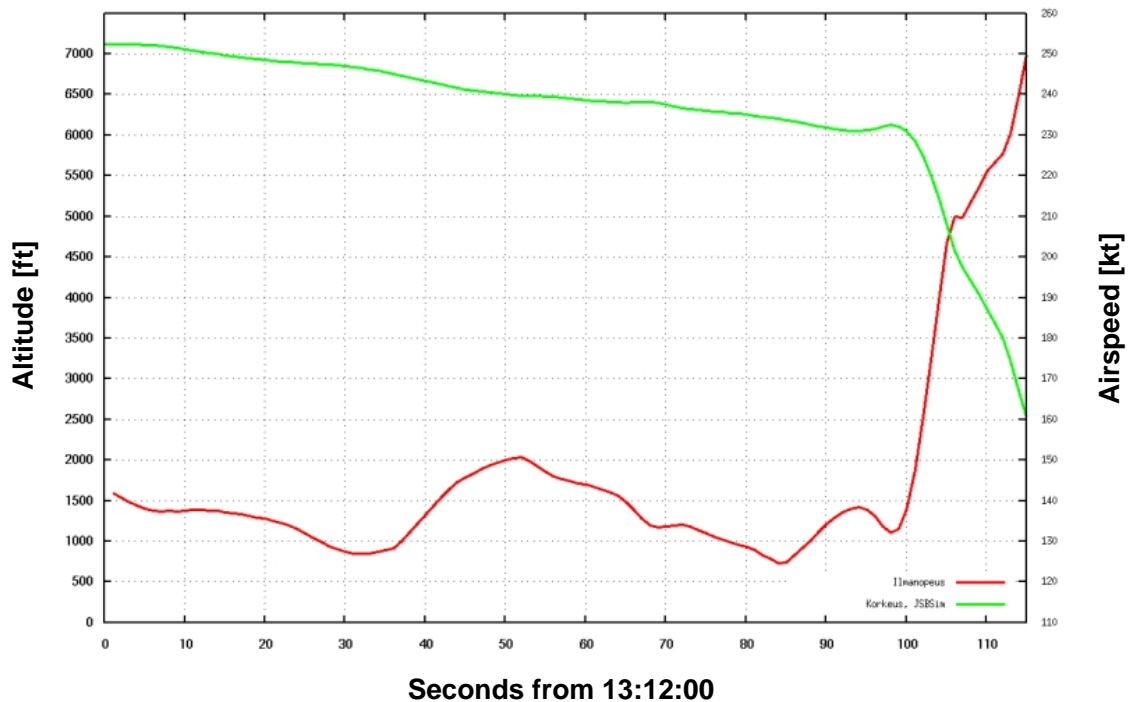
The two final minutes of the aircraft's flight path were analysed in more detail. In the beginning of the observation period the aircraft was flying at 7000 ft. All radars painted a more or less uniform picture, within tolerances, of the aircraft's flight path and manoeuvring from 13:12:00 to 13:13:20. The aircraft was in a shallow descent, possibly manoeuvring.

Figure 8. Change in airspeed and altitude as per radar returns.

After this interval the number and reliability of radar returns gradually declined along with the decreasing altitude. SSR data were used as the aircraft's altitude information. The point in time when the wings broke off, as well as the probable left spiral dive that followed, was determined by radar contacts

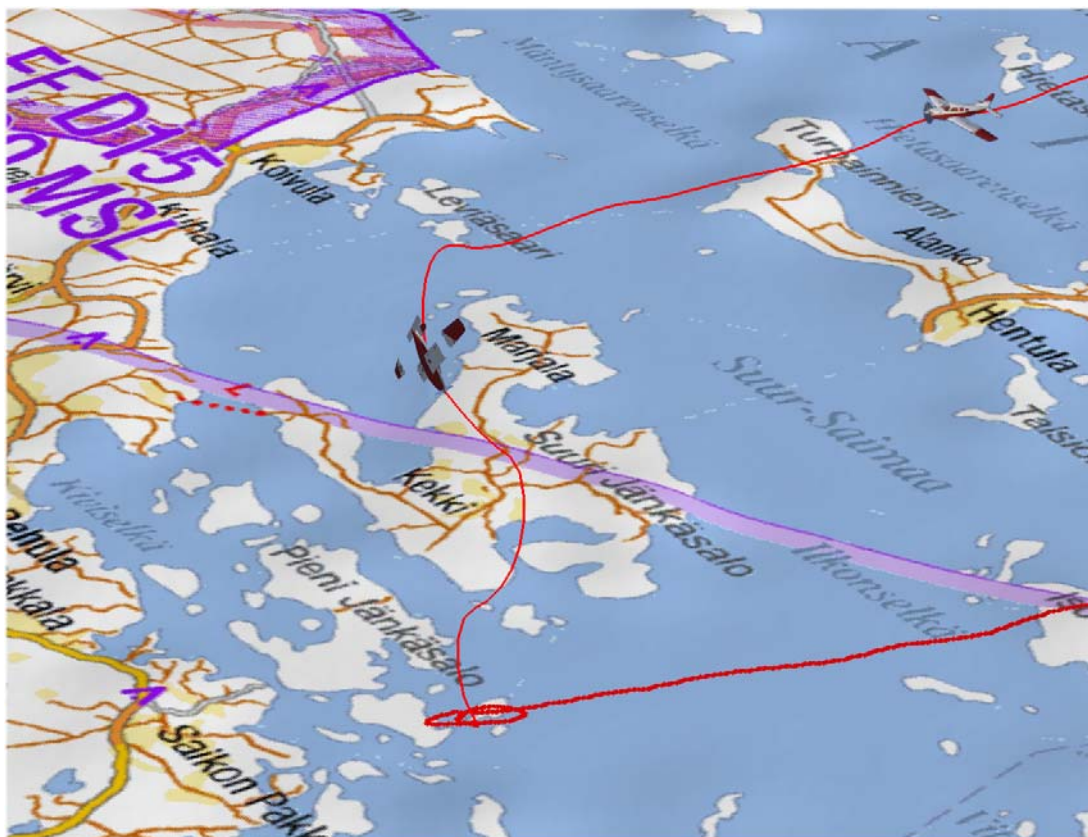
The investigation commission believes that the initial adverse condition was set off by banking the aircraft approximately 90 degrees to the left at 125-135 kt and by applying left rudder. This corresponds to the upset recovery procedure the flight instructor had a student pilot perform on his previous VTL4 flight. During the previous instance the aircraft approached its maximum permissible airspeed. Judging by radar returns, the aircraft went into a dive and its heading changed approximately 160 degrees to the left during the recovery. The wings broke off during the recovery at 5000-4500 ft; the airspeed was over 200 kt. The aircraft went into a left spiral dive which continued until the collision with the water. Airspeed was approximately 240 kt (ca. 445 km/h) at impact.

Figure 9. Flight path simulation of the final two minutes (the lower line represents the flight's 2D projection over the surface of the lake)
