Investigation report

C1/2008L

Airliner wingtip collision with the Lappeenranta airport baggage shelter on 12 February 2008

OK-CCD

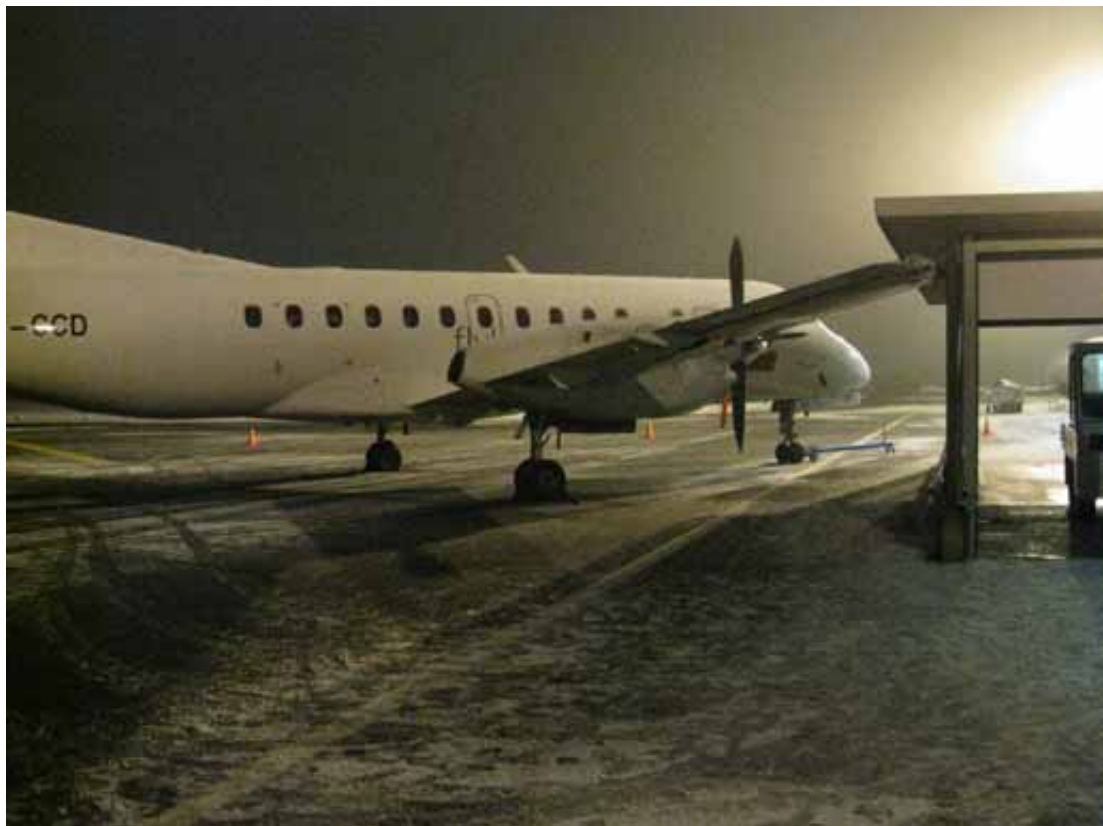
Figure 1. The aircraft at a standstill after the collision

The right wingtip was torn and a lighting fixture was broken.

The corner beam of the baggage shelter's roof was scratched and a terminal window was slightly bent inwards.

The right wingtip of the aircraft collided with the corner beam of the baggage shelter's roof. The wingtip, including navigation lights in it, broke. No other damage was detected elsewhere on the wing structure.

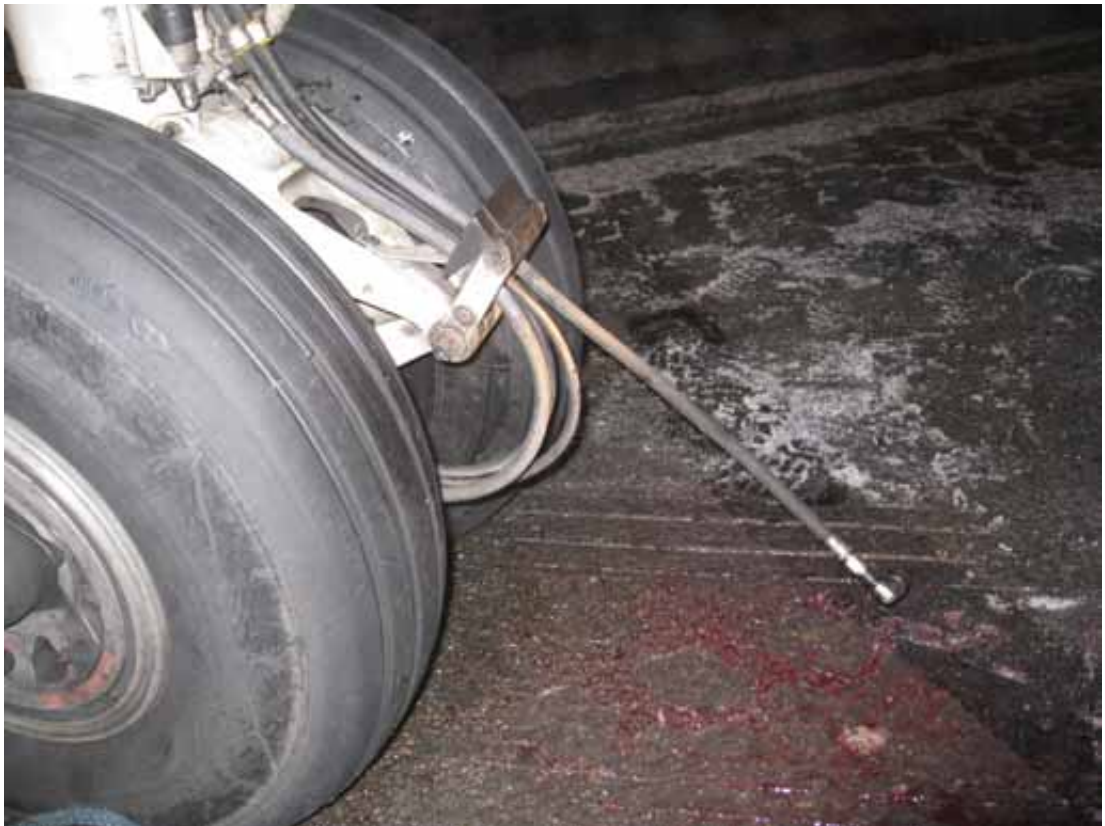
The brake line swivel of the left main gear's inner wheel was broken and the severed end of the line was on the ground behind the wheel. The hydraulic fluid had leaked onto the ground and the hydraulic system was empty.

Figure 2. The brake line broken at the swivel as well as a pool of hydraulic fluid on the ground

Examination with a scanning electron microscope showed that the appearance of the main fracture surface area was dimpled, typical of ductile fracture. At a considerable portion of this ductile fracture surface area the dimples were orientated typically to a ductile shear fracture. The main part of both fracture surfaces was in an angle of about 45° compared to the tube axis and had a homogenous and matt appearance. The fracture surface contained an impact indentation with arched grooves corresponding to the appearance of the machined surface of the nut part. Examination also found that...this zone...contained radial ridges indicating numerous crack origins at the outer surface of the swivel as well as narrow parallel striations typical of fatigue fracture.

Discussion of the results states the following: *The examinations performed showed that the fracture surface of the examined swivel contains a narrow zone with an appearance typical of fatigue fracture. This finding indicates that a gradually growing fatigue crack has existed in the examined swivel. The origin of the fluctuated stresses causing the fatigue crack cannot be clarified on the basis of the investigations performed. The examinations did not either reveal signs of manufacturing defects or any other deviating features at the origin area of the fatigue crack. On the basis of the maximum crack depth (about 0.1 mm) and the width of the observed fatigue striation (about 0.5 µm) the minimum number of loading cycles during the crack growth stage has been about 200, but the real number may be even several orders of magnitude higher. During the final fracturing the depth of the fatigue crack has been small, the maximum depth being about 0.1 mm.*

Fracturing of the swivel has occurred suddenly as a ductile fracture. Since the fatigue crack was small and so the strength of the component has been reduced only to a very small amount, the fracturing must have been caused by high loadings during exceptional conditions and not during normal service. It is, however, apparent that without the occurred failure the fatigue crack would have continued the gradual propagation during service.

The inner wheel brake line swivel on the left main gear broke when it hit the aforementioned taxiway lighting fixture. Traces of similar yellow paint with which the broken taxiway lighting fixture was painted were found on the underside of the brake cylinders, close to where the swivel was attached, as well as on the swivel itself and on the threaded brake line coupling.

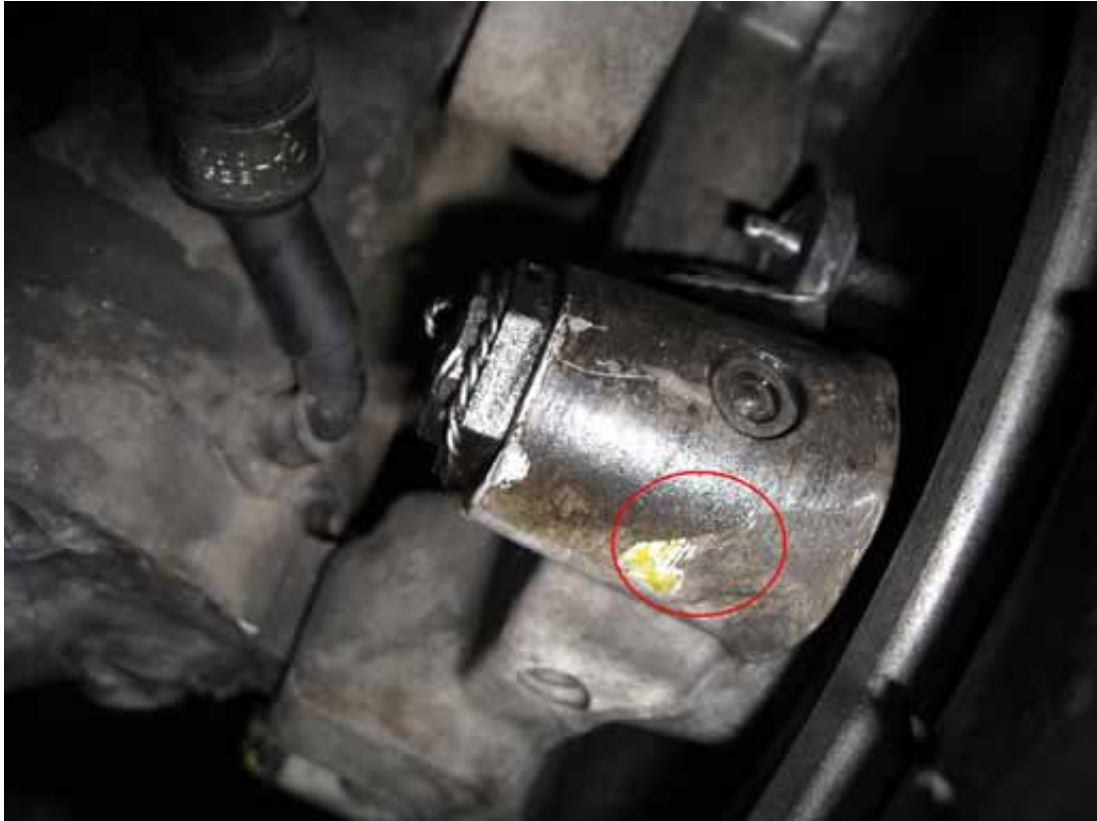
Traces of yellow paint were detected on the underside of the brake assembly, close to where the swivel was attached and on the swivel itself as well as on the threaded brake line coupling.

Figure 3. Yellow paint underside of the brake assembly

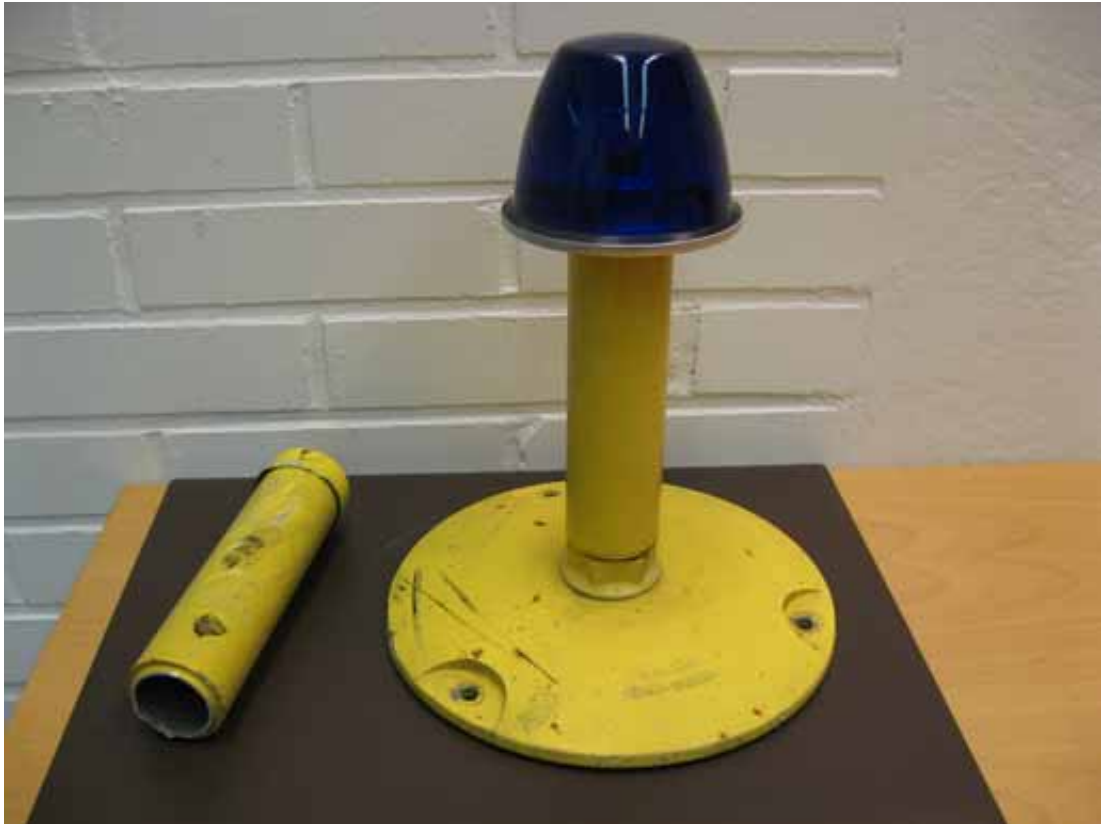
The morning after the incident Helsinki-Vantaa airport maintenance personnel found a broken taxiway lighting fixture at the throat to taxiway WK. The yellow shaft of the fixture was scratched and had black rubber marks on it.

Figure 4. A taxiway lighting fixture and its broken shaft (left)

The previous flight of the occurrence aircraft had been flown from Lappeenranta to Helsinki-Vantaa. After the landing the aircraft exited RWY 04L via taxiway (TWY) WK. The morning after the incident occurred Helsinki-Vantaa airport maintenance personnel inspected the area and found a broken taxiway lighting fixture at the throat to taxiway WK. The yellow shaft of this fixture was scratched and it had black rubber marks on it. Airport maintenance personnel say that they find toppled taxiway lighting fixtures in this area from time to time. Investigation revealed that the area preceding TWY WK can be difficult to taxi, especially, at night or in poor visibility.
