Investigation report

C4/2008L

Terrain clearance infringement in Helsinki Terminal Control Area on 26 March 2008

BOEING 737-300

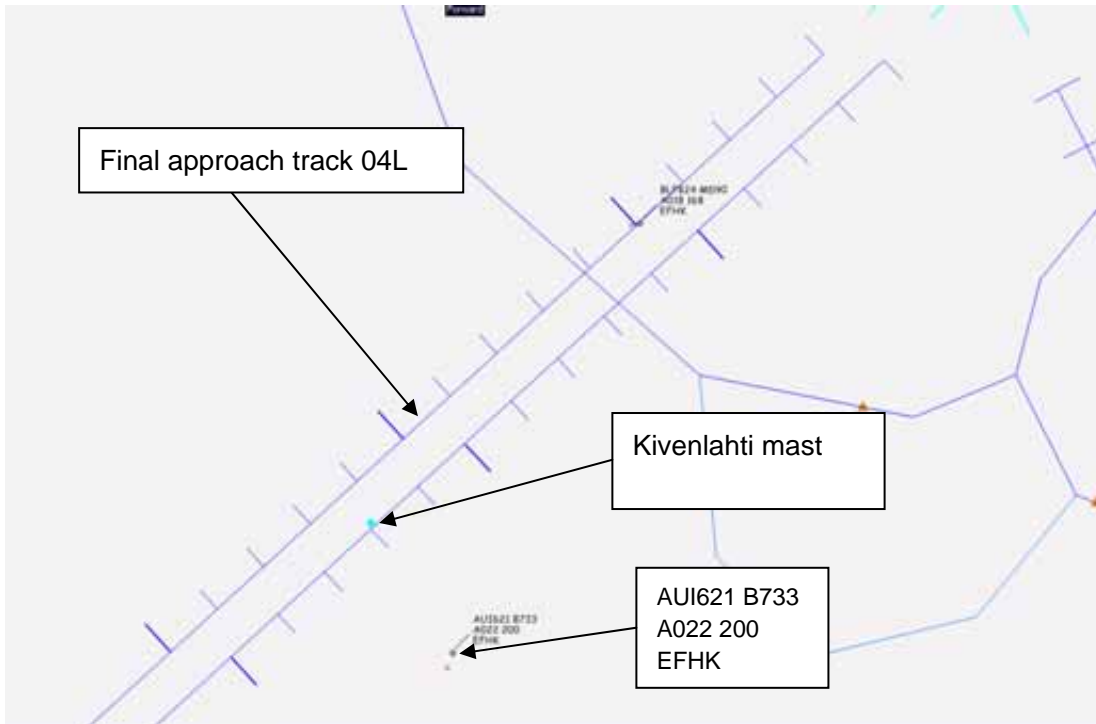
Figure 1: AUI621 descends below its clearance altitude

According to the ATC radar recording and the aircraft's Flight Data Monitoring (FDM) information the aircraft descended to a minimum of 1400-1500 FT MSL. As per the radar recording, AUI621 passed the 1227 FT (MSL) tall Kivenlahti telecommunications mast at a distance of less than 0.7 NM. The required minimum terrain clearance for the mast is 1000 FT, which is complied with when aircraft maintain 2300 FT. Moreover, 2300 FT is also the Minimum Sector Altitude (MSA) in this airspace segment.

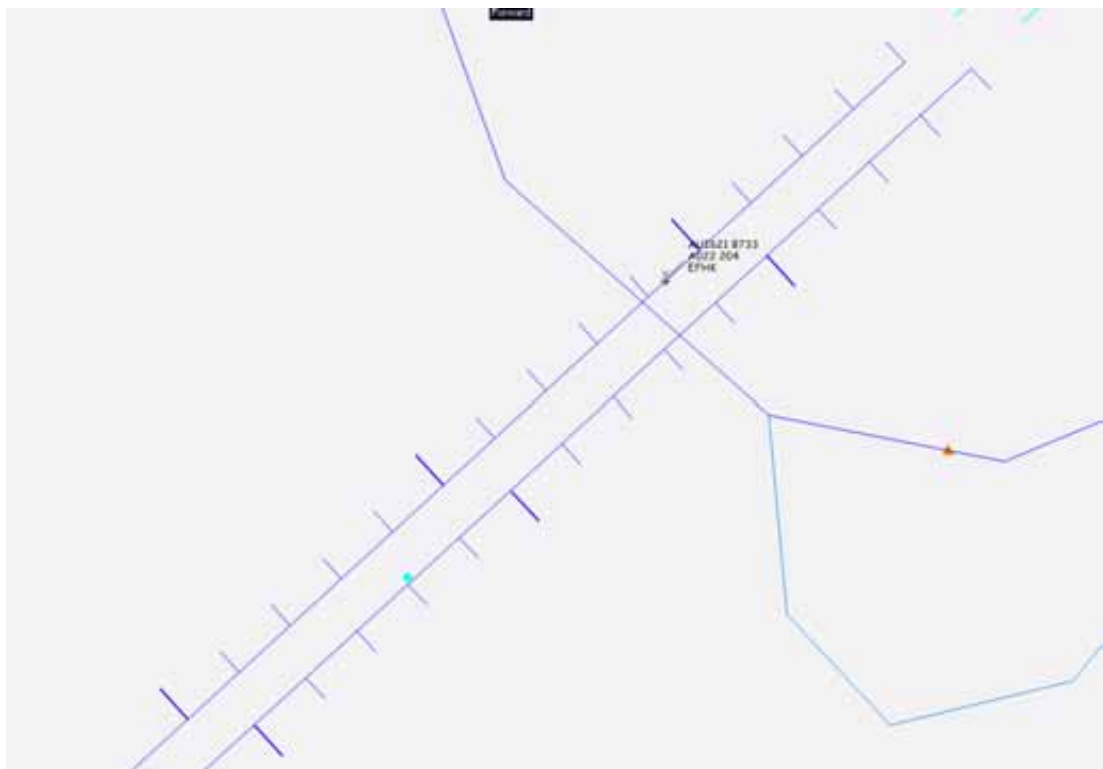
After AUI621 read back the order to instantaneously return to 2300 FT the air traffic controller told it to turn right, heading 010, and cleared it for an ILS approach RWY 04L. The pilots read back the clearance. The aircraft drifted a little to the left of the final approach track, only to return and become established on the localizer and the glide path approximately 5.5 NM from the threshold of runway 04L. Following this the air traffic controller handed AUI621 over to the tower frequency.

Figure 3: AUI621 established on the final approach track
