## Investigation report

B4/2009L

# Hard landing for helicopter in Porvoo on 7 May 2009

Bell 412EP

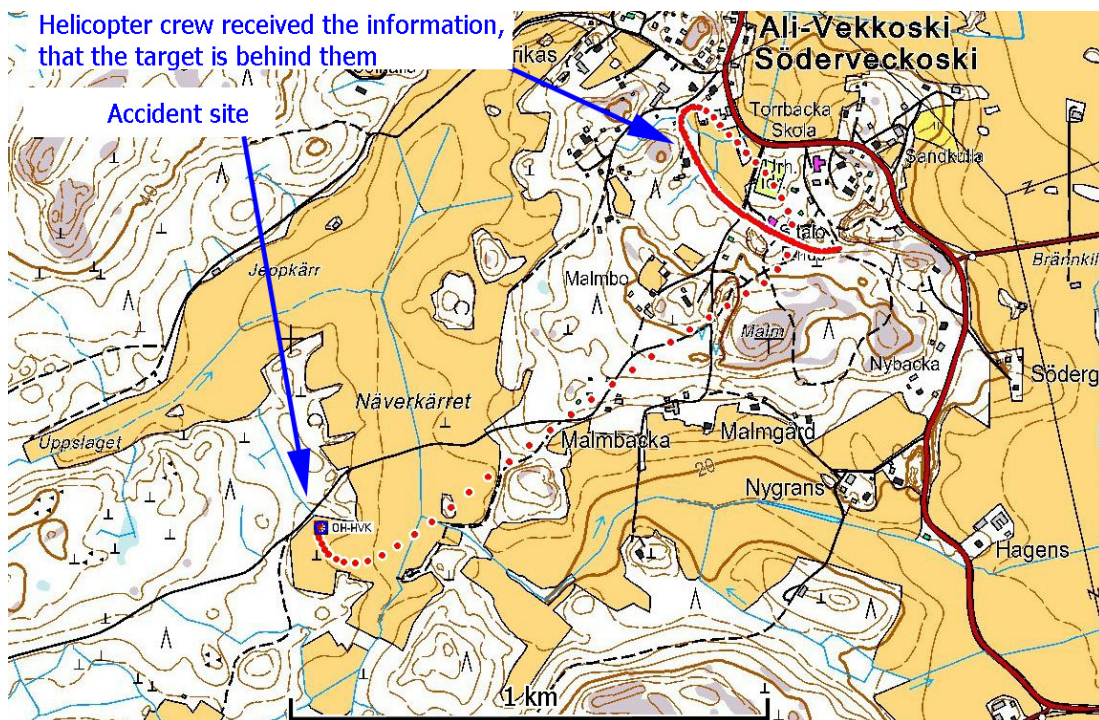
Figure 1. The track of the final phase of the flight and the accident site. Each red dot represents a one second interval. (©The Finnish Border Guard) (Map: KTJ/Ministry of Justice/MMJ)

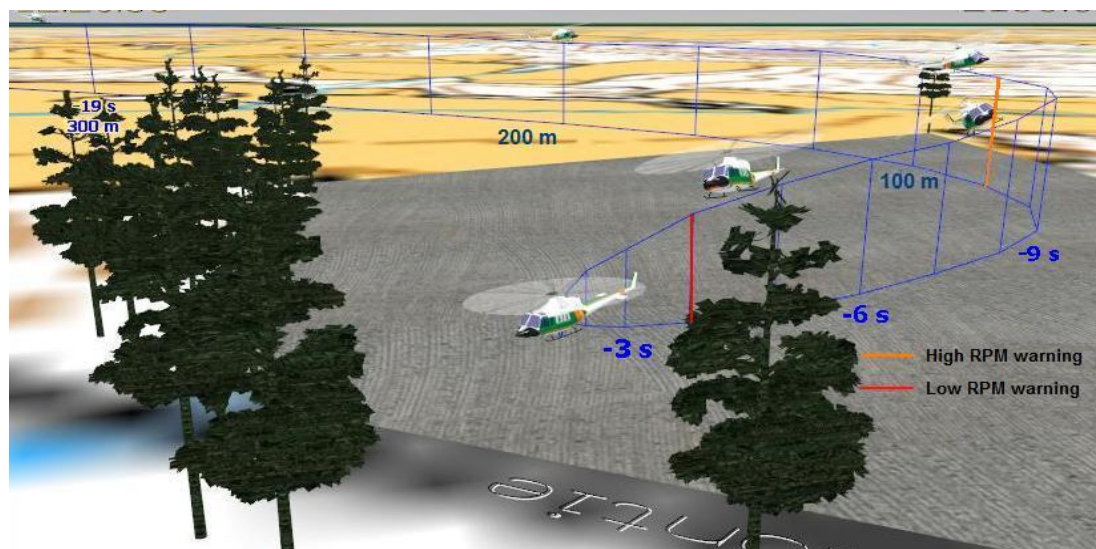
At approximately 100 m from the landing site the airspeed was 90 kts and the altitude approximately 200 ft. The collective lever was in the full down position. The main rotor RPM increased during the deceleration. Approximately two seconds after the start of the turn they received a high RPM warning (104.5%), indicated in the ‘Master Caution’ legends shown in figures 3 and 4. The co-pilot reported this to the PIC by calling ‘RPM’, which the PIC acknowledged. The main rotor RPM rose to 105.5%. The collective was nearly in the full down position. Simultaneously, the transmission freewheeling clutches disengaged for approximately five seconds.

Figure 2. The final phase of the flight. The blue vertical lines represent an interval of one second. The distances are direct distances to the landing site. Because of the data recording rate the helicopter’s position is slightly inaccurate. The graph was generated from an animation. (© Finnish Defence Forces)

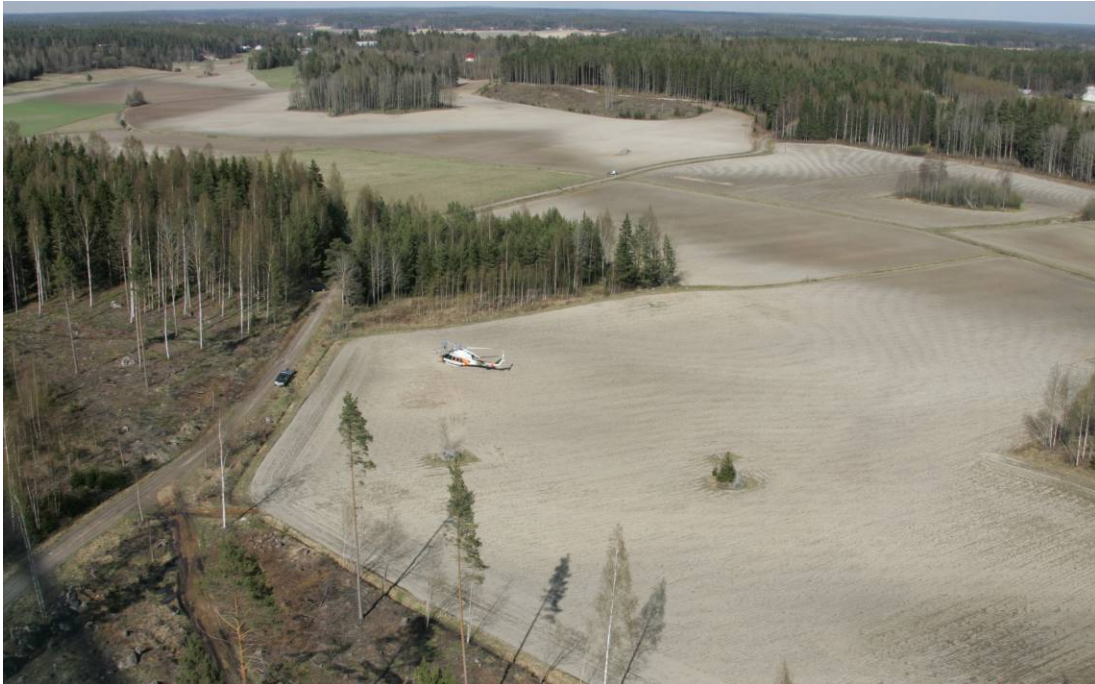
The helicopter collided with the ground at 12:21 (figure 5).

Figure 5. The accident site and the surroundings. (Photo: Border Guard)

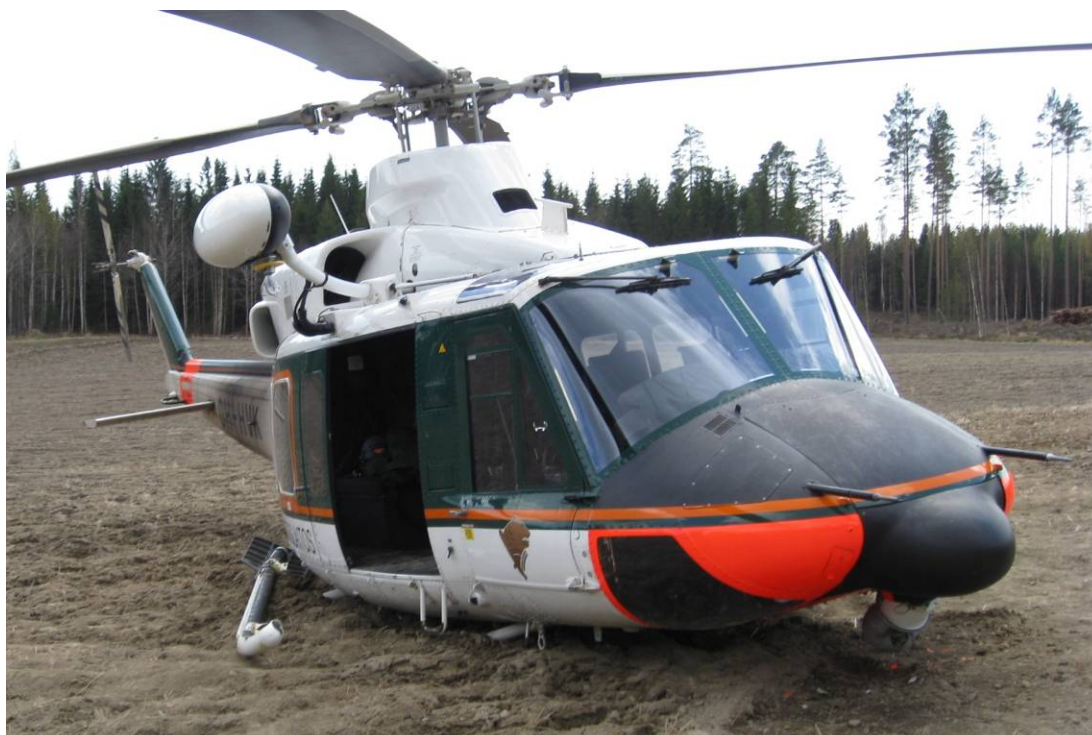
After touchdown the flightcrew noted that the landing gear was damaged and that the helicopter sat on the ground on its belly (figure 6). Since the crew did not notice anything else out of the ordinary, they shut the helicopter down as per the normal procedure. No serious injuries occurred.

Figure 6. The helicopter on its belly at the accident site.

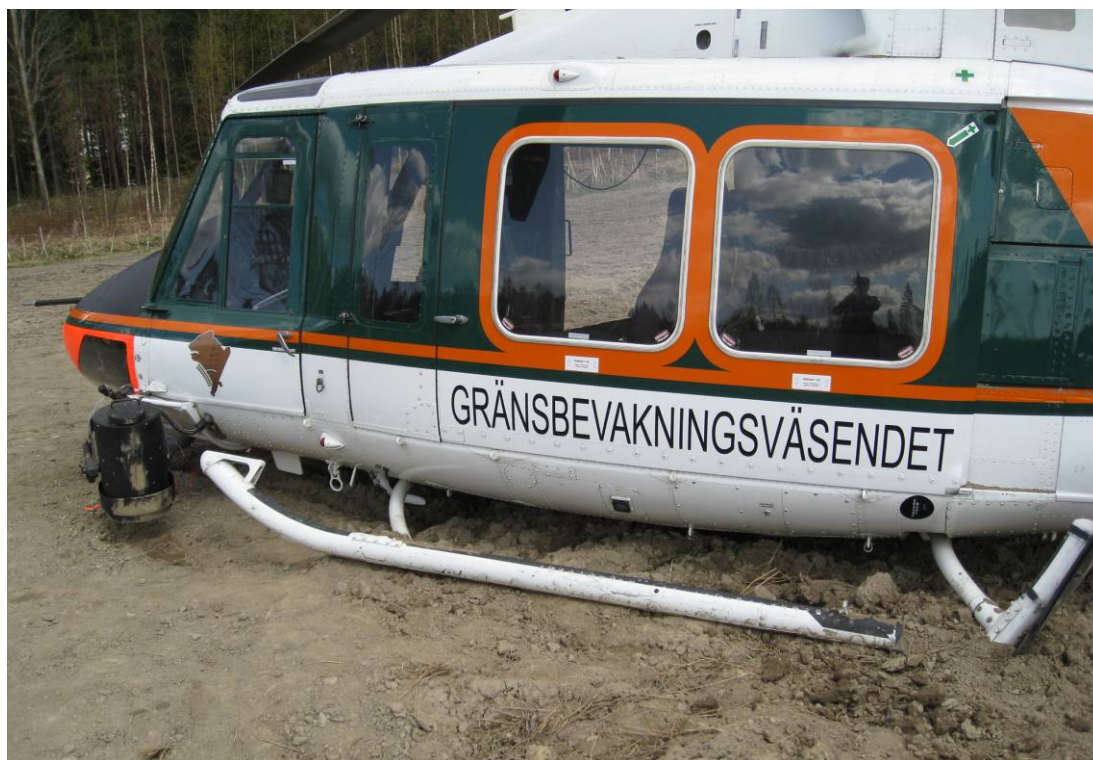
The helicopter ended up on the ground on its belly (figures 8 and 9). The wearpads at the aft ends of the landing gear left clear skid marks on the ploughed field (figure 9). The marks were approximately two metres long. The aft ends of the skid tubes were bent upwards. The left skid tube was almost completely severed from the cross tubes which, themselves, were bent backwards. The right skid tube broke off and lay next to the fuselage. The FLIR camera below the nose was bent backwards and its fittings had damaged the sub-floor sandwich structure. The larger searchlight on the left side had hit the surface of the field and was bent backwards. The smaller searchlight at the aft end of the fuselage did not make any contact with the ground.

Figure 8. Damage on the left side.

There were deep dents and tears in the fore and aft structures of the landing gear well. Landing gear fitting points were ruptured and bent. The landing gear well bulkhead structure was bent and dented. There were some dents in the sub-floor structure.

**The skid tube** was bent upwards on the aft left side. It was broken to the front of the cross tube. The right aft cross tube was completely severed from the skid tube. The fore cross tube was broken off from the skid tube on both sides. The landing gear was broken beyond repair.

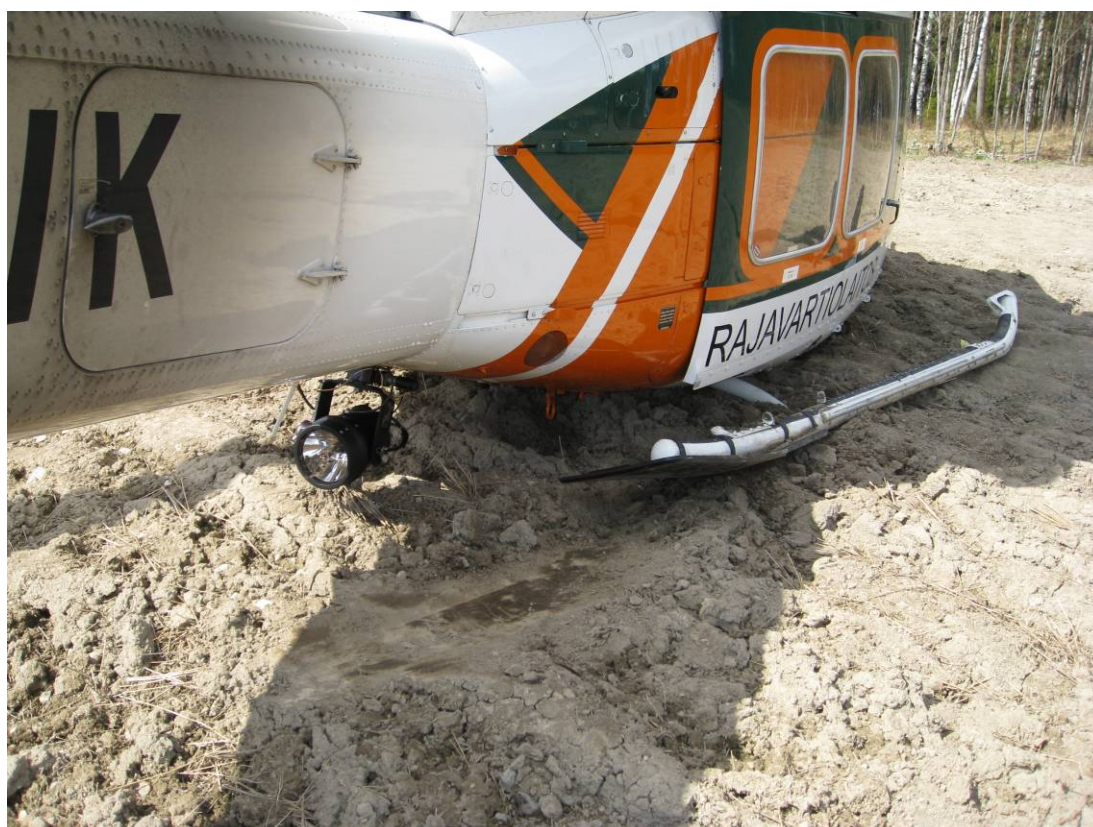
Figure 9. Damage on the right side. The photo shows the skid mark.

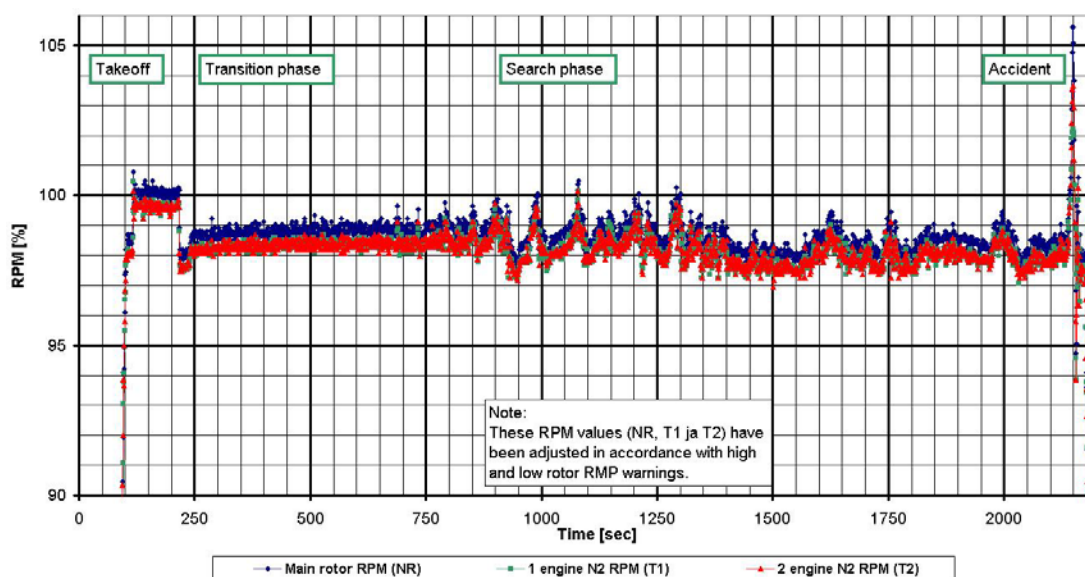
On the accident flight the main rotor (NR) RPM was not set at 103%, the CAT A approach setting that the Rotorcraft Flight Manual (RFM) allows. According to DFDR data (figure 12) the RPM was set at 98.5%, which means that not all of the rotor's thrust was being used. The low rotor RPM (below 95%) during the landing, and hence weaker rotor downwash, exposed the main rotor to a vortex ring state.

Figure 12. Main rotor RPM during the accident flight.

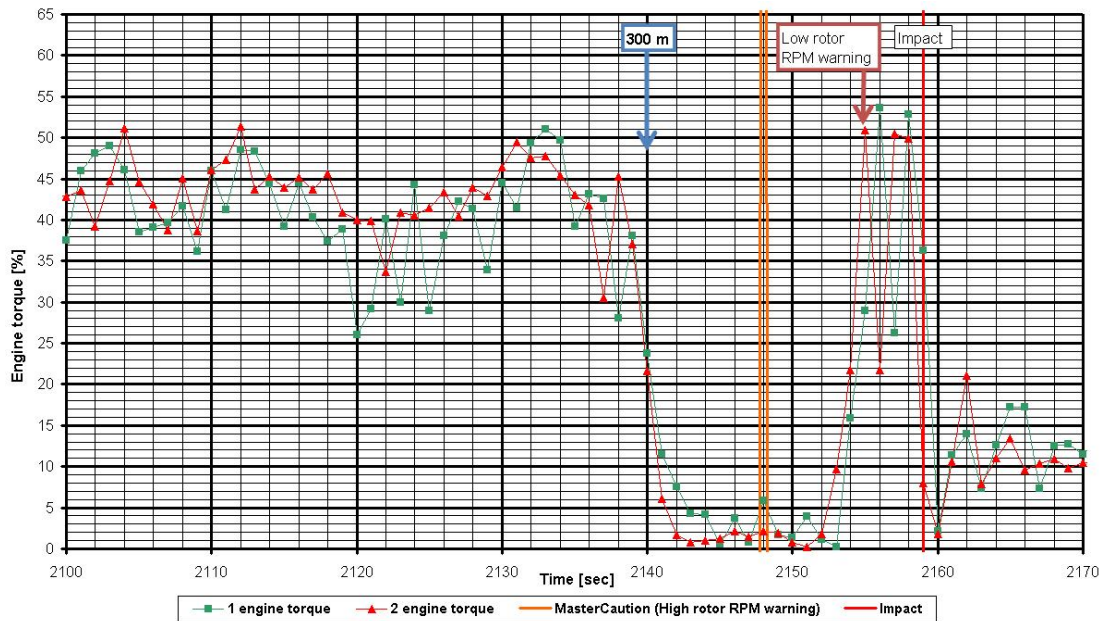
- The torque difference between the engines after the collective's raising was paused, as shown in figure 13, is the result of the pause itself as well as considerable changes in main rotor drag caused by the vortex ring state.

Figure 13. Engine torque during the final minute of the flight.

The investigation commission believes that the torque difference was not abnormally high before the low RPM warning sounded and when the raising of the collective was paused, nor did it have any bearing on the accident.

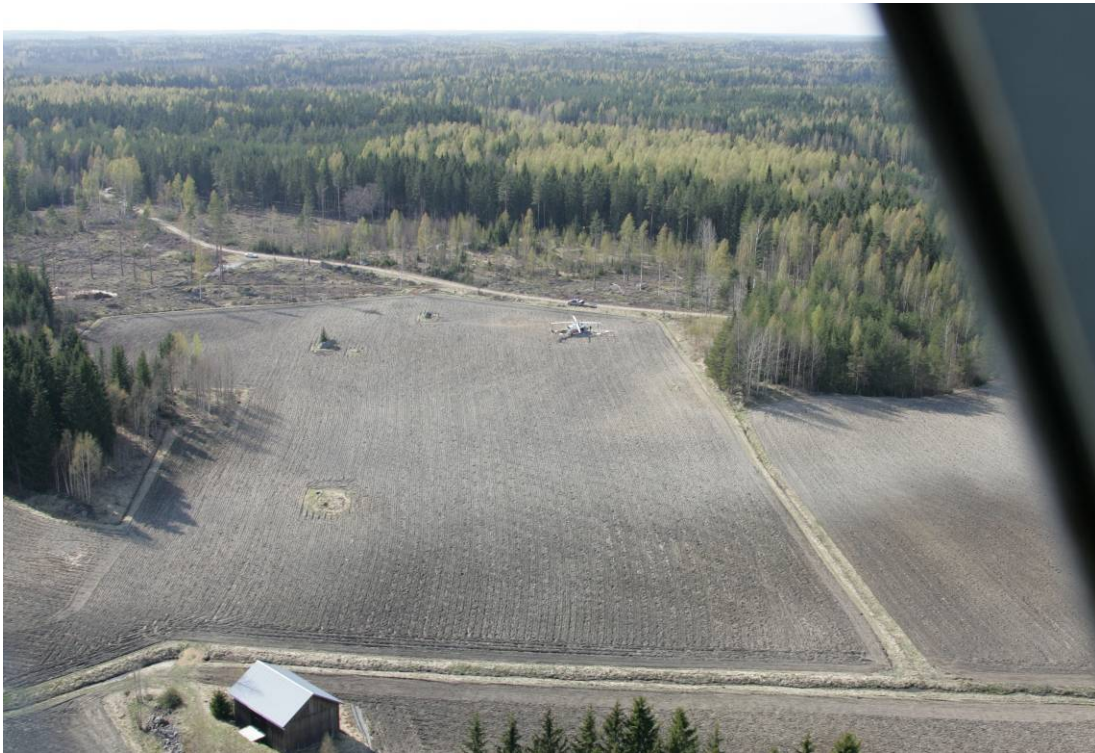
The approach occurred over a field which gradually rose towards the landing site. The ploughed field's surface had dried and become lighter in the spring sunshine. The dry, light surface reflected the rays of the sun more intensely than its surroundings. This made it more difficult to detect the contour of the surface and the details, especially from a higher altitude (Cf. figure 5). The road at the northern edge of the field was clearly visible against the backdrop of the clearing. This kind of clearly noticeable visual shape or outline may prompt the observer to believe that its surroundings, too, follow the same shape or outline. During the flight re-enactment the pilots noticed that they could not distinguish the gently undulating surface of the field from a higher altitude. The contours of the surface were only discernible when the helicopter was flying down on the deck.

Nevertheless, the landing site and its perceptual environment were suitable for a helicopter terrain landing. The aforementioned visual environment would have permitted a safe landing. The approach speed may have contributed to the insufficient perception of visual cues from the terrain and the surroundings.

Figure 14. View of the landing area. The helicopter's flight path traversed the field from the bottom right of the photo turning along the left side of the field towards the landing site. (Photo: Border Guard)
