## Investigation report

C1/2009L

# Helicopter collision with the ground at Pyhäselkä on 5 February 2009

OH-HWH

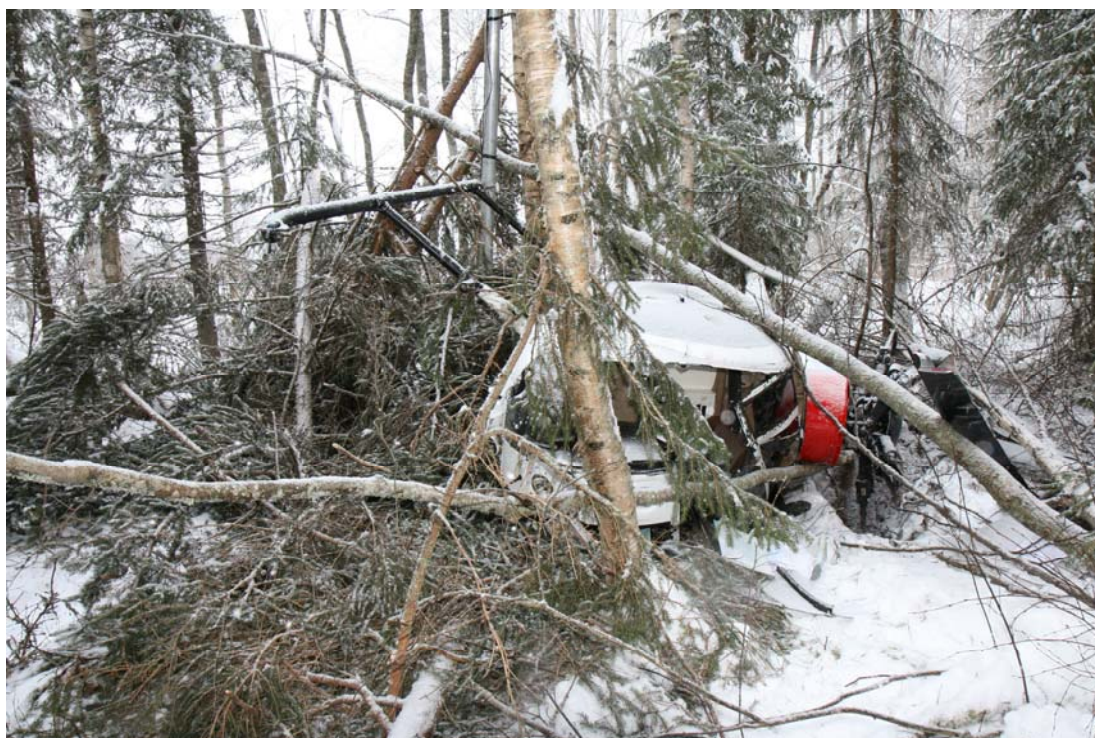
As the helicopter made contact with the ground it turned to the right towards the power line and tipped over onto its left side. All of the main rotor blades broke off close to the hub when they hit the ground. The suspension bar was bent into an arc between the helicopter and the topping saw. When the helicopter tipped over the pilot's head was pinned between the ground and the helicopter's structures. However, he managed to get his head loose. Due to the attitude of the helicopter and an injury to his left hand he was unable to turn the engine off from the collective lever. He could not turn off the Fuel Shut-off Valve because of how tight it was and because his hands were slippery. The engine was left on and as the rotating mast kept turning the stubs of the main rotor the blades dug a hole into the ground. After the pilot unbuckled his safety harness he left the cockpit through the broken windshield.

Figure 1. The helicopter following the accident.

The left landing gear skid was bent under the helicopter. The lower left front part of the helicopter frame and the top part of the left door frame were crushed inwards as a result of the collision with the ground. The windshield and the overhead window were broken. All of the main propeller blades had broken off close to the rotor hub and were heaped in a pile next to the rotor mast, but otherwise almost whole. The tail rotor had torn off of its gearbox when it hit the trees and broken loose. The tail rotor blades were intact. The tail boom was twisted counter-clockwise and bent downwards approximately one metre from the tip of the boom.

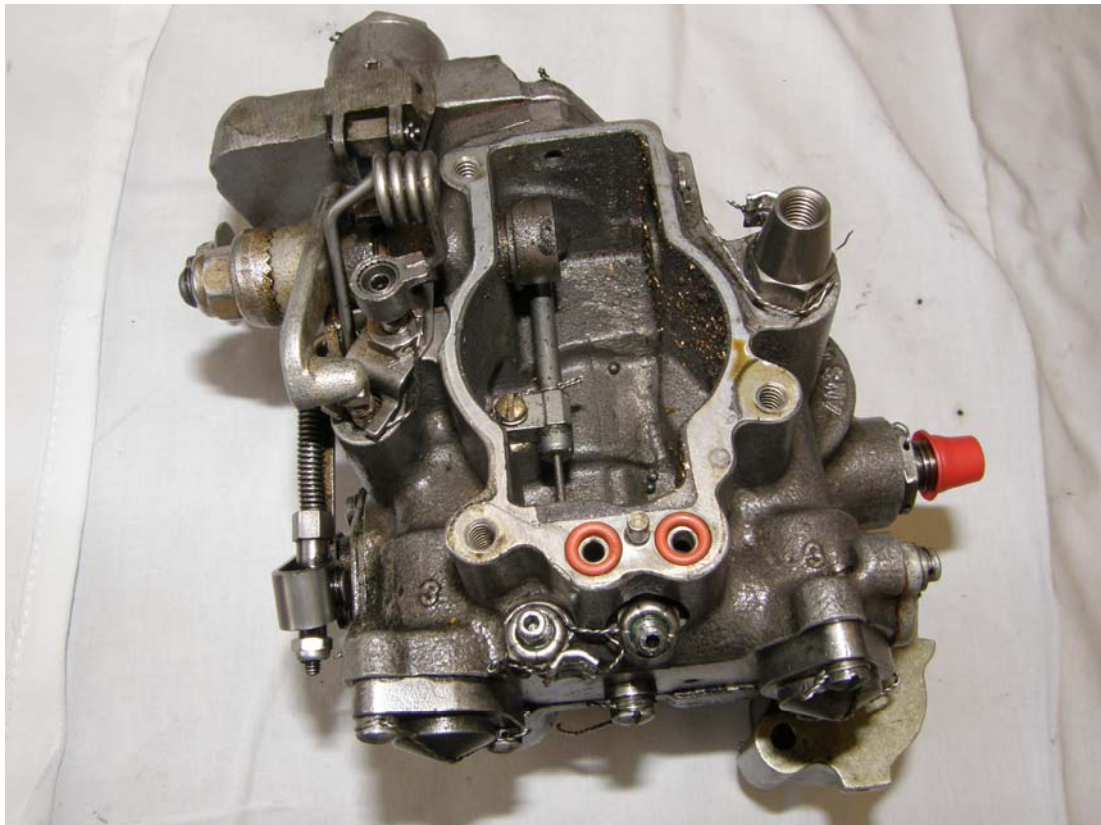
The FCU was removed from the engine and the maintenance manual's air leak check was performed on the FCU alone. The leak came through the breather hole below the FCU. The purpose of this hole is to facilitate the venting of any possible fuel and oil deposits within the FCU. The breather hole uses the same space as the FCU's flyweights. Air also vents through this hole when the FCU is in operation.

The FCU was opened and partly disassembled. At this time it was detected that the spool bearing of the bushing at the end of the FCU's flyweight driveshaft was broken. Bearing balls were scattered inside the FCU and a disconnected, thin bearing shield was also found loose inside it. The bronze coating around the flyweights had peeled off. Metal chips were discovered in the FCU casing. Due to the mechanical failure the bushing had moved up and tilted to one side, which in turn jammed the Px line open. Since the pressure inside the line directly affects engine fuel control, the malfunction rendered the fuel control system inoperative and made it impossible for the pilot to control engine power.

Figure 2. The Fuel Control Unit opened.

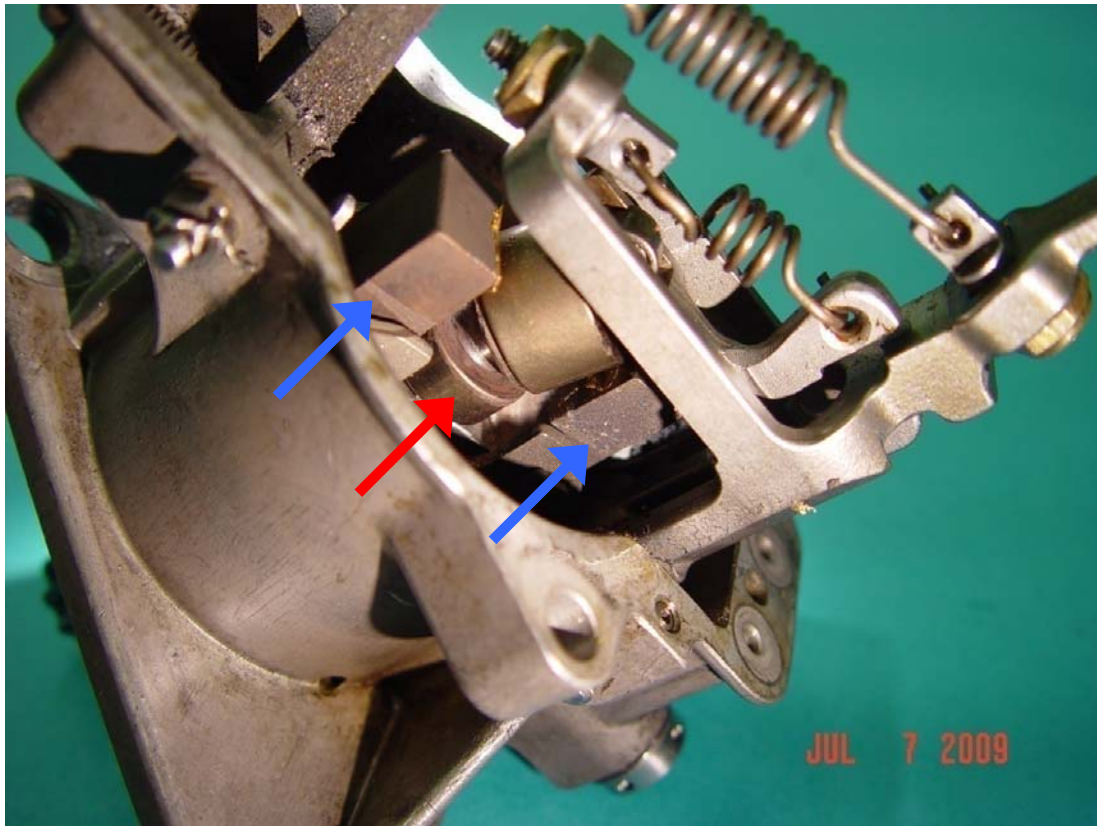
The inspection of the FCU aimed at establishing the factors which resulted in the failure of the spool bearing. The investigation into the condition of the components of the bearing concluded that the bearing failed due to insufficient lubrication of the spool bearing. This conclusion was arrived at on the basis of surface wear, fragmentation, surface corrosion and thermal discoloration. The investigation was unable to identify the specific root cause or causes of the insufficient lubrication. It was concluded that the grease that was used as lubricant met its specific requirements (ES-1962). Energy Dispersive Spectroscopy was employed to establish that the materials used in bearing components met their requirements.

Figure 3. The Fuel Control Unit from the inside (photo: Honeywell). The flyweights are indicated by the blue arrows and the bushing as well as the broken spool bearing are indicated by the red arrow.

Technical investigations (HE and RRC) found that the cause of the defect was the failure of the FCU's spool bearing due to insufficient lubrication. Three possible root causes were given for the insufficient lubrication: degradation of lubrication (attributed to shelf life), failure of the bearing shield (that retains the lubrication) due to a flaw or impact damage, and wear due to continuous fuel scheduling variations due to operations maneuvers. The investigation commission also believes that a manufacturing fault could have been one of the causes, in which case the bearing would have received too little lubricant. None of the aforementioned root causes can definitively be confirmed or eliminated.

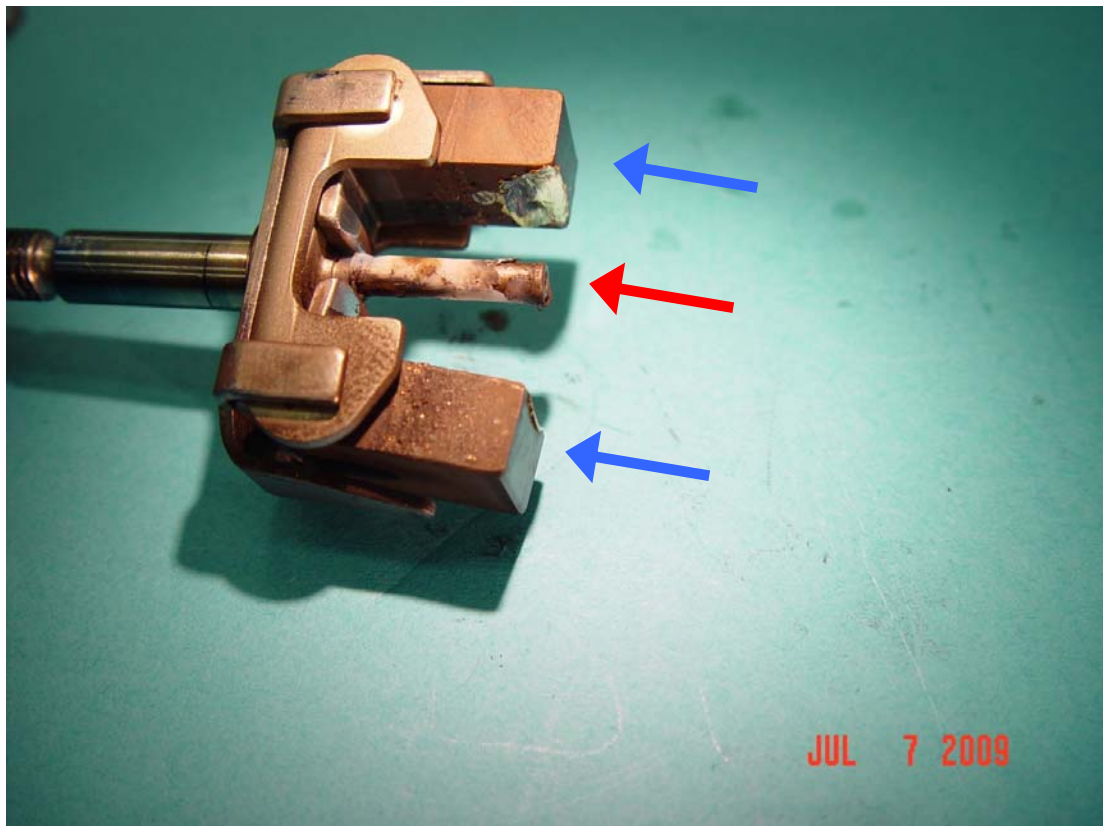
Figure 4. The FCU driveshaft and flyweights (photo: Honeywell). The damaged flyweights are indicated by the blue arrows and the melted Teflon coating by the red arrow.
