## Investigation report

C2/2009L

# Serious incident at Helsinki-Vantaa Airport due to tread separation and hydraulic failure, 22 June 2009

Airbus A340

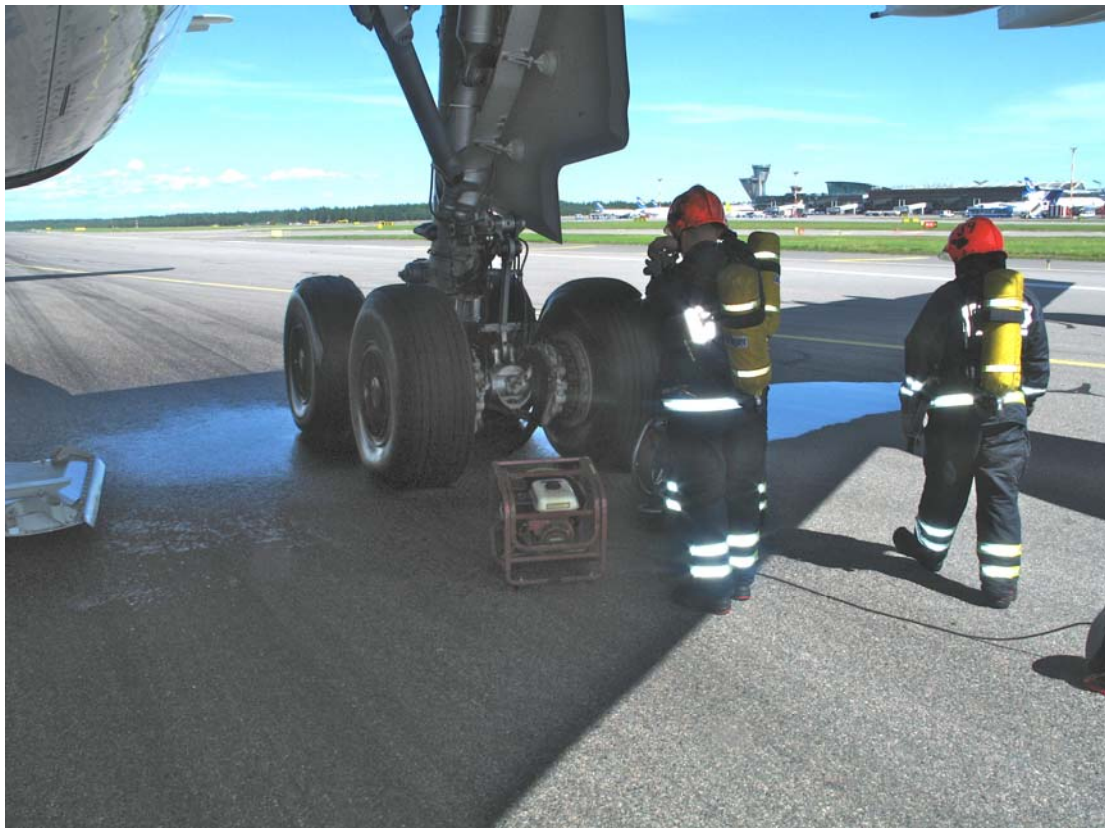
Tread pieces had impacted the green system's hydraulic lines in the wheel well, causing an approximately 10 mm rupture on one line and a dent on the other. During the flight, the green system depleted to the minimum level in approximately 4 hours. Tread pieces also hit the brake line coupling of tyre number 2, right in front of the damaged tyre. The coupling broke, causing a hydraulic leak as braking was commenced. The investigation could not establish whether the coupling broke at takeoff or at landing. After the aircraft came to a standstill, the blue system drained onto the landing gear and the runway.

Figure 1. Hydraulic fluid on the runway

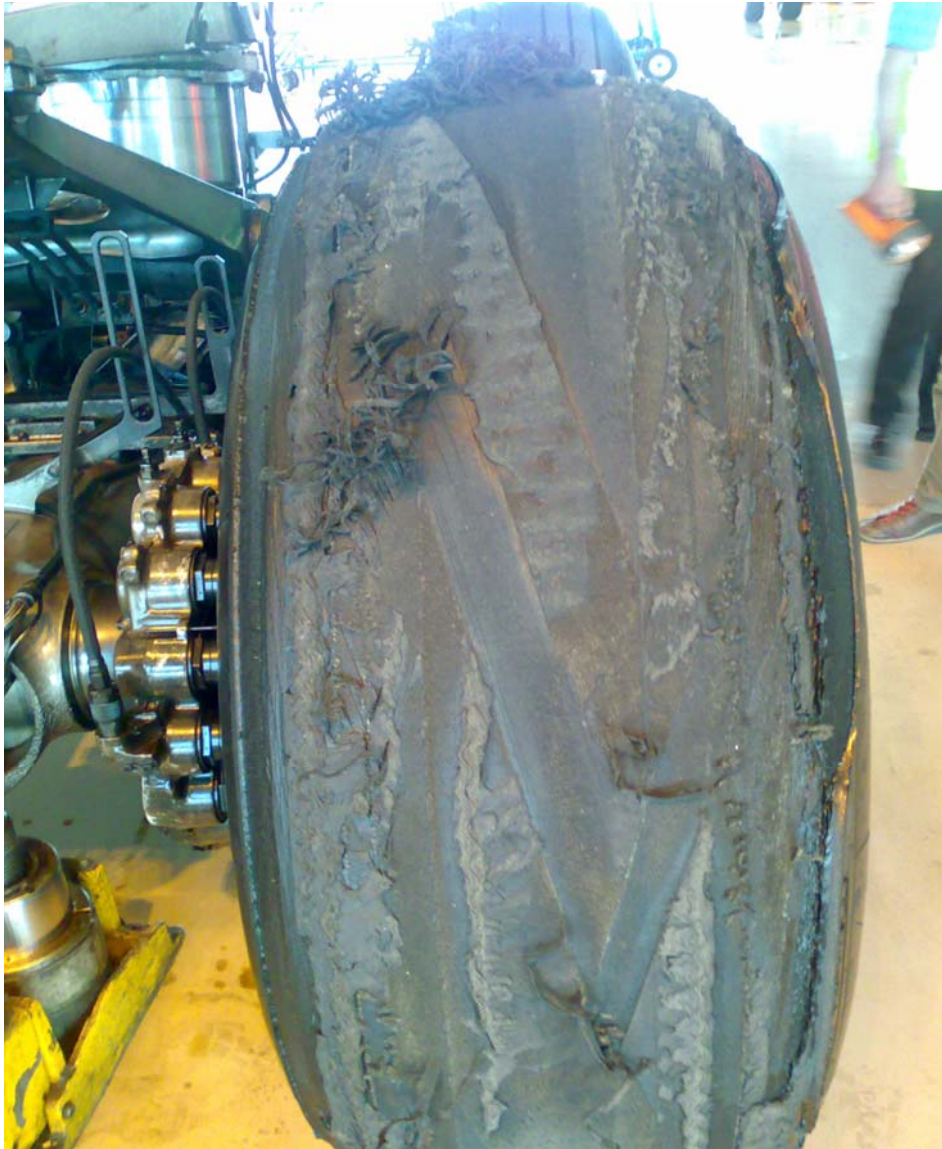
Figure 2. The damaged tyre

Due to a nail that was found in the tyre the damaged tyre was removed from OH-LQB on 14.9.2008. The tyre was retreaded at Bridgestone S.S. in Belgium. However, the retreading company was not informed of the pinhole, nor was it detected during the inspection. Prior to its removal the tyre had made 202 landings. After the retreading, the tyre was put on the OH-LQE on 11.3.2009. The tyre was again removed on 22.6.2009, at which time it had made 186 landings. Finnair's tyre repair shop says that, due to wear, an A340 tyre is replaced after approximately 400 landings.

The investigation commission believes that the tread separation was caused by a build-up of pressure between the tyre tread and the casing. The tread had gradually been detaching and then completely ripped off at takeoff in Shanghai. Rubber discoloration caused by overheating was detected during the inspection. It is possible that overheating degraded the integrity of the tread and the belt plies, accelerating the delamination.

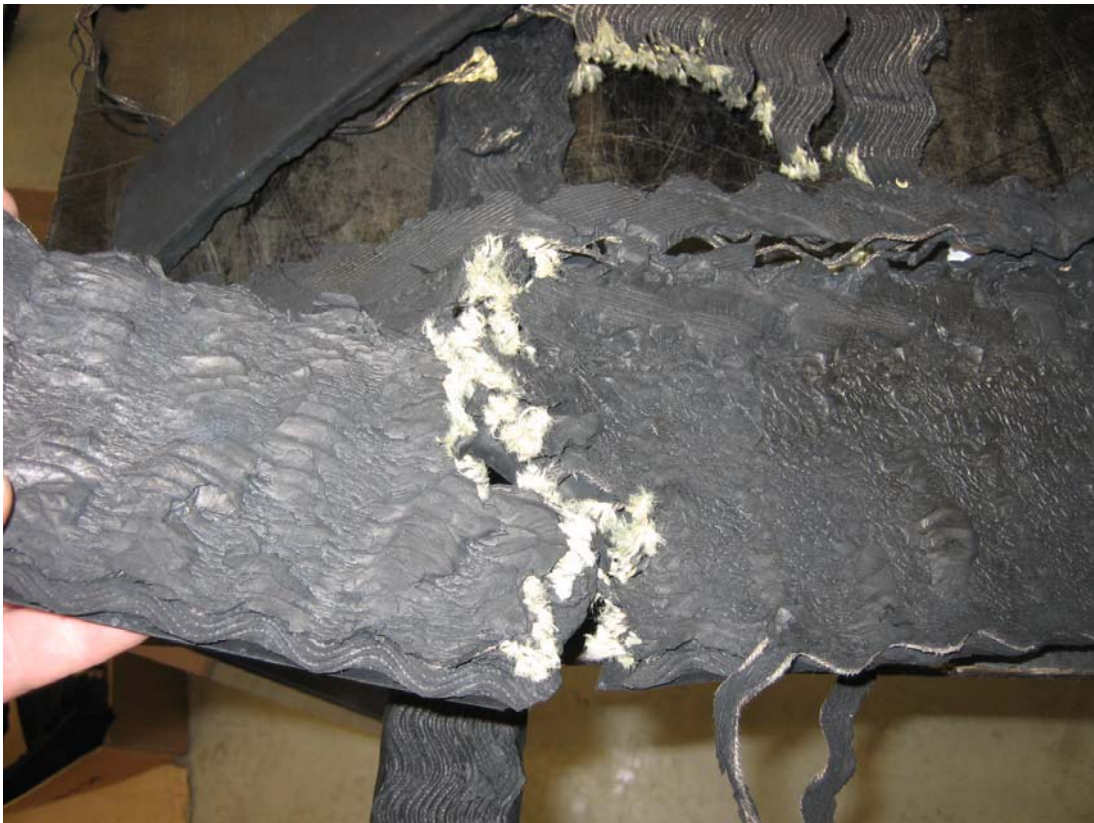
The Finnair brake and tyre repair shop inspected the damage to the tyre. The entire tread, broken to pieces, as well as sections of casing belt plies had detached. There is an aramid cord protector between the tread and the belt plies. The belt plies are made of nylon fibre. The largest piece of detached tread weighed 1.9 kg.

Figure 3. The detached tread and aramid fibre (white material)

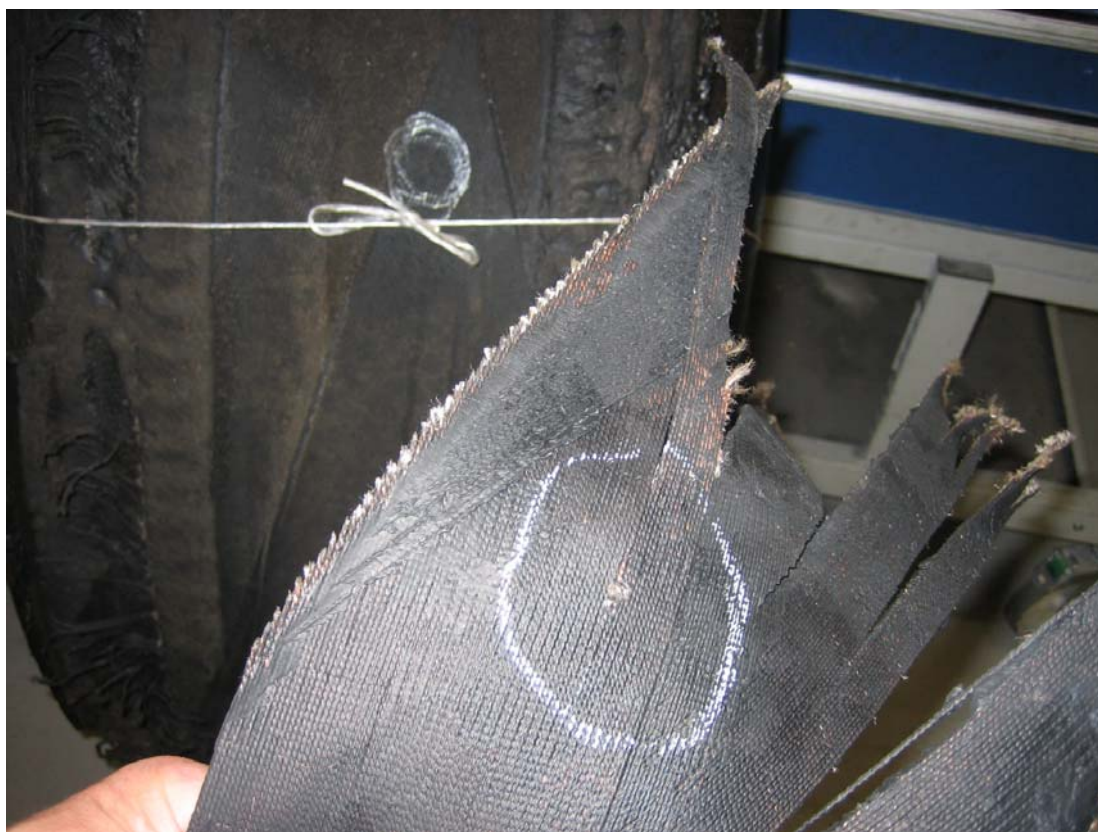
When the tyre was analysed a small pinhole was detected on the innerliner at the site of the leak. No other damage was found on the innerliner.

Figure 4 The FOD hole on the tyre as well as on the casing belt ply.

- Both external sidewalls were in normal condition;
- The tread had fully detached from the casing, varying at the interface between the 1<sup>st</sup> and 2<sup>nd</sup> belt plies;
- The FOD hole in the tyre could not readily be seen with the naked eye. However, it protruded into the complete casing ply section and perforated the innerliner;
- The hole was not present in the newly applied tread. Therefore, it was present in the tyre at the time of the last retreading process.

The report proposed that pressure began to gradually build up between the tyre tread and the casing through the hole. A small separation at the under-tread level continued to grow until the tread finally detached from the casing at takeoff in Shanghai. In static conditions the leak rate through the hole was low. However, it is likely that it greatly increased in dynamic conditions during taxiing, takeoffs and landings. Eventually, pressure began to build up between the tyre tread and casing, causing the tread to gradually detach. The retreading company considered this incidence a very isolated case.

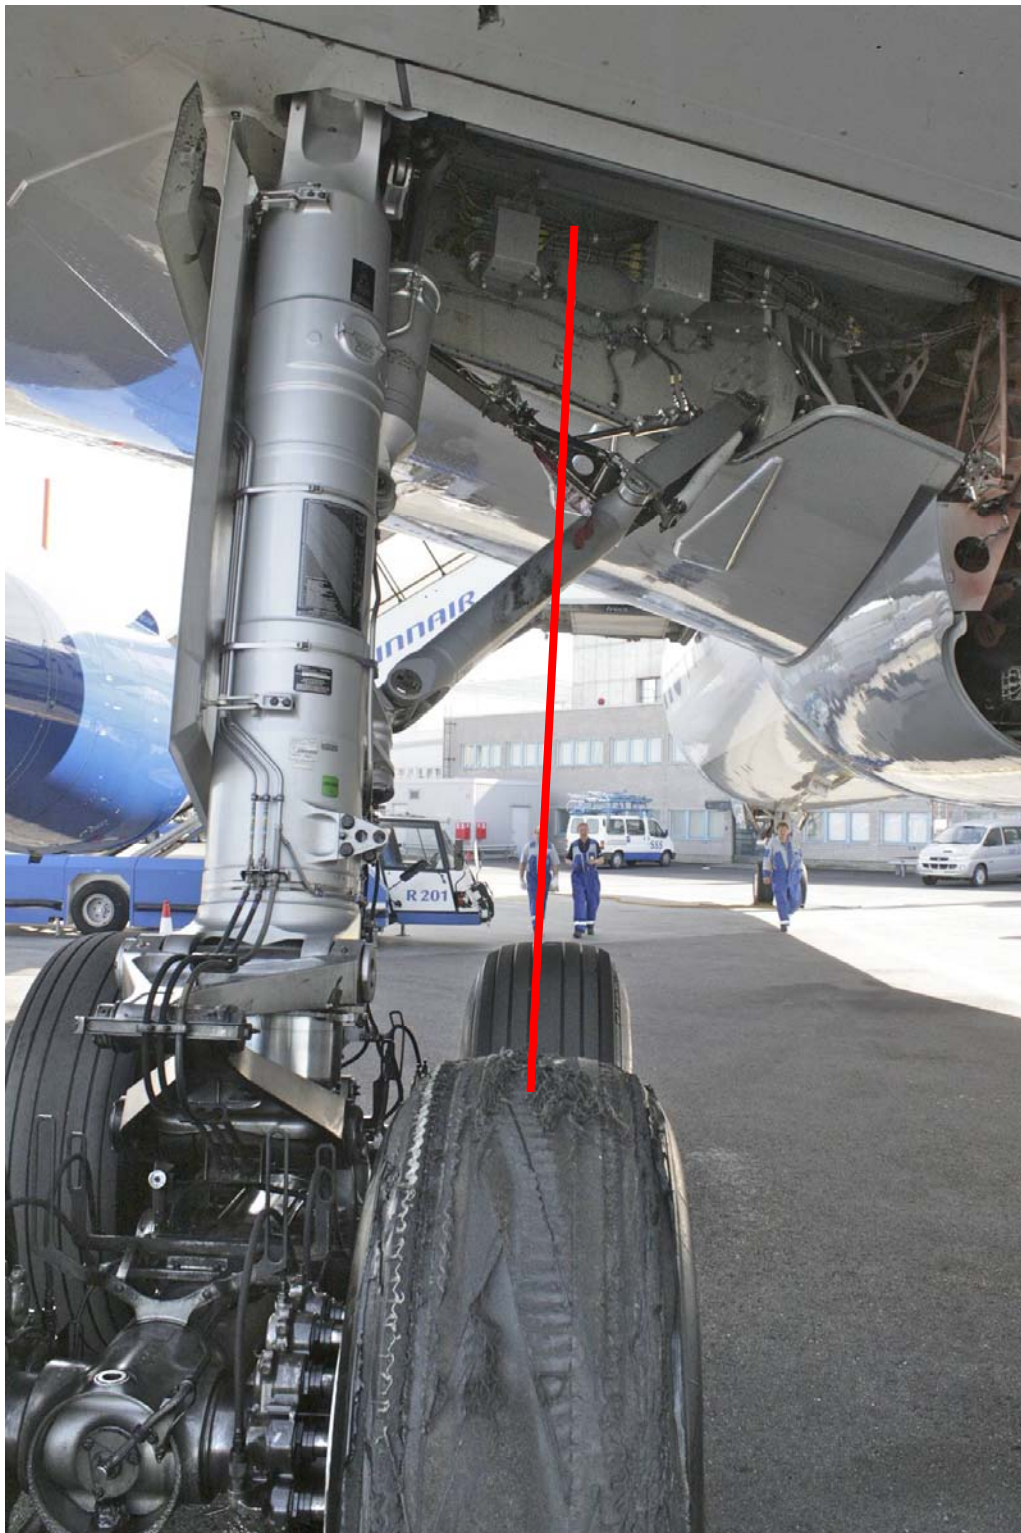
Inspections revealed that both lines of the green hydraulic systems, fastened to the rear spar of the left wing in the wheel well, were damaged. The hydraulic lines are fully exposed in the wheel well. The lines in question alternate as supply and return lines, depending on the direction of travel of the landing gear. The upper (large) line shown in figure 7 is pressurised during landing gear extension and the lower (small) line is pressurised when the landing gear is retracted. Hydraulic pressure in the supply line is 3000 psi. Return line pressure is below 1450 psi. When the landing gear was retracted and all landing gear doors closed and locked, both hydraulic lines reverted to the return side. There was an approximately 10 mm long rupture on the lower line (Fig 7) and the line was leaking. The green system leaked at 3000 psi through the rupture until the landing gear doors closed.

Figure 5. The detached tread's impact trajectory on hydraulic lines and electrical wiring shrouds

The investigation commission recommended that Airbus Industries evaluate the need for and possibilities of shielding hydraulic and electric systems in wheel wells.

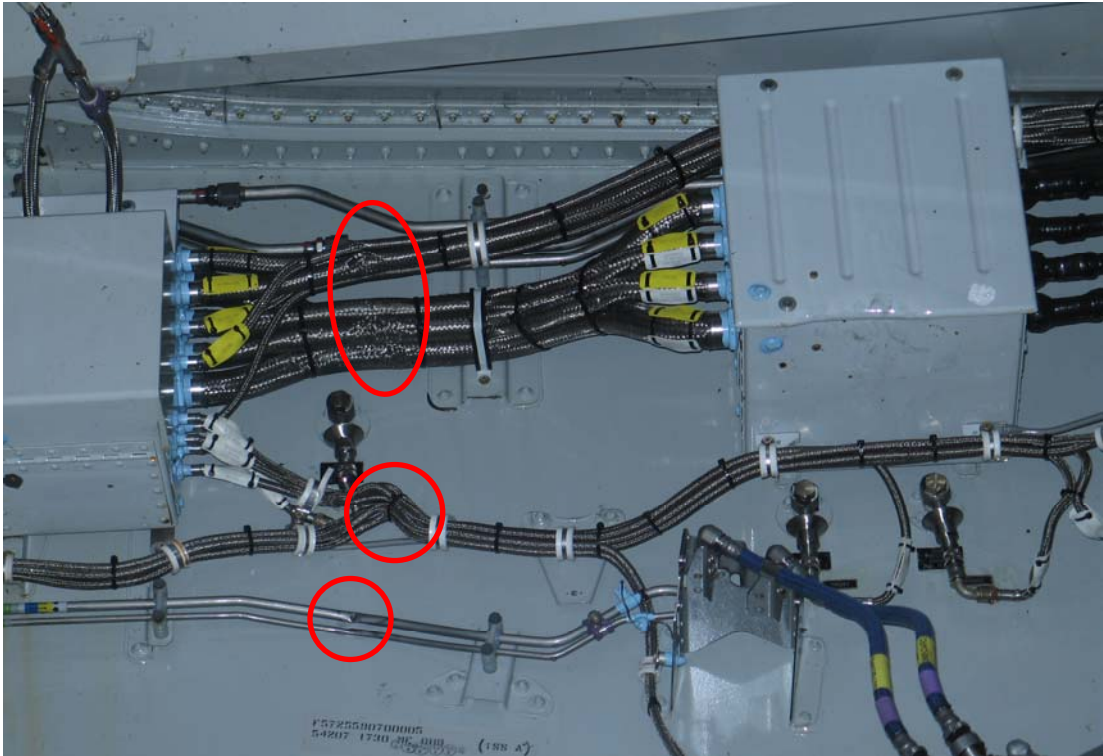
Figure 6. Damage to the hydraulic lines and electrical wiring shrouds in the wheel well

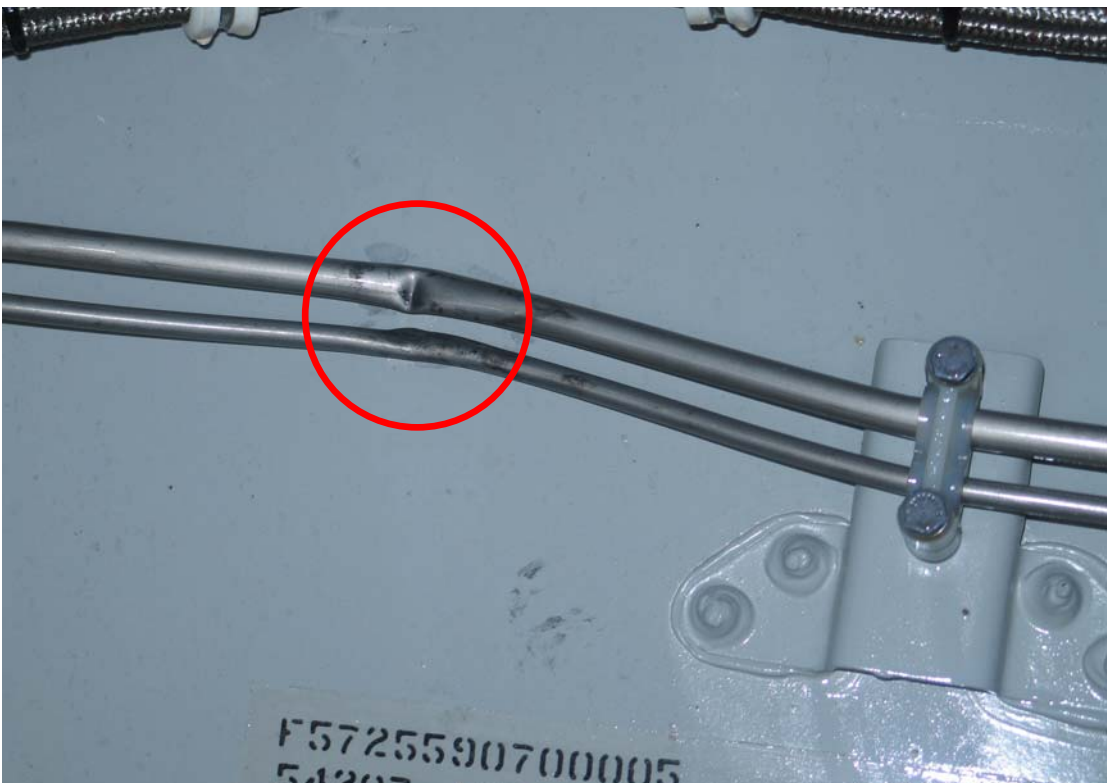
There was a dent on the upper line (Fig. 7), next to the spot where the other line was ruptured, but it did not leak. When the system was tested, the dented spot sprang a leak at approximately 2200 psi. The line did not leak during the flight.

Figure 7. Damaged hydraulic lines

On the green system both return lines of the landing gear system are fastened to the left wing spar in the wheel well. The lines are not shielded and both lines were damaged. There was a 10 mm long rupture on the lower line of the left landing gear (Fig 7). When the landing gear is being retracted, the line carries the full 3000 psi (206 bar) pressure. The green system leaked through the rupture in the hydraulic line. There was a dent on the upper line which carried a return pressure of below 1450 psi. This line did not leak during the flight. When the system was tested it sprang a spot leak at approximately 2200 psi (155 bar).
