Investigation report

D2/2009L

Ultralight accident at Lahti-Vesivehmaa aerodrome on 16 January 2009

OH-U502

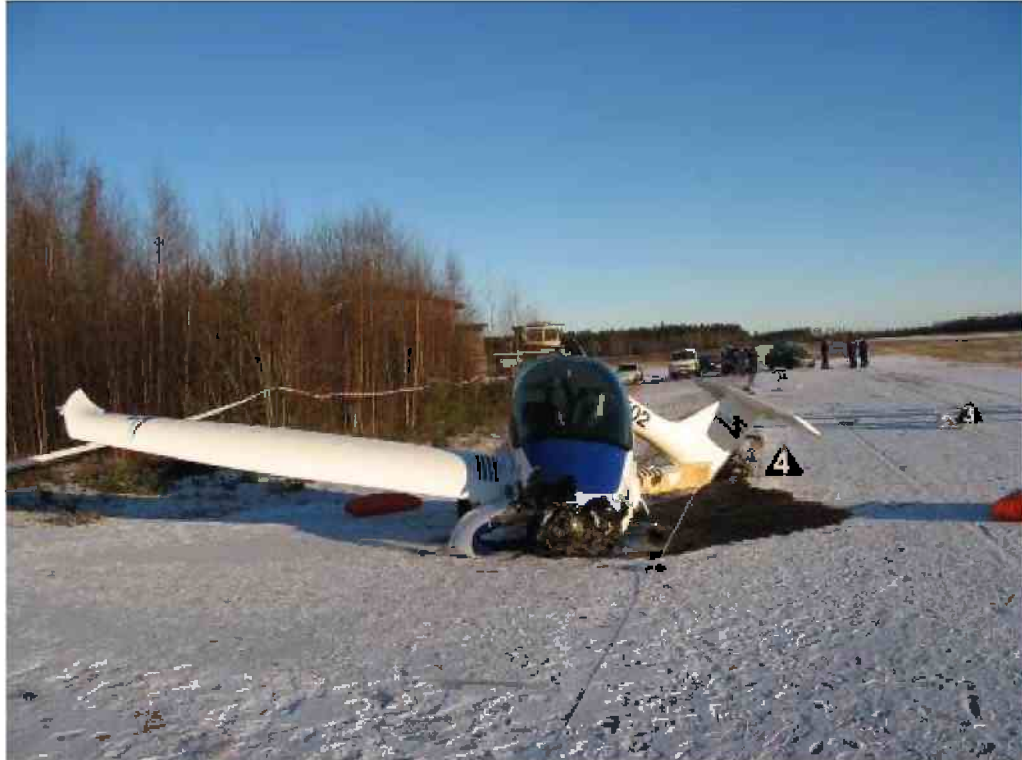
Figure 1. The aircraft after the accident.

Aircraft parts lay scattered between the point of collision with the ground and where the aircraft came to a stop, a distance of approximately 50 metres. The left wing made the first contact with the ground and was totally destroyed. The right wing shifted forward in such a manner that the wing flap lever loosened. The empennage broke into two and was bent downwards to the left. The left main landing gear wheel fell off and the nose gear folded under the fuselage. The propeller hit the ground and came off completely. The engine mount was damaged and the engine partially broke away from the mount. The firewall had partly come loose. The wing flap lever was in position 1, i.e. at 15 degrees. CSI investigators detected a very thin layer of hoarfrost on the surface of the wing prior to the arrival of AIB Finland's investigators.

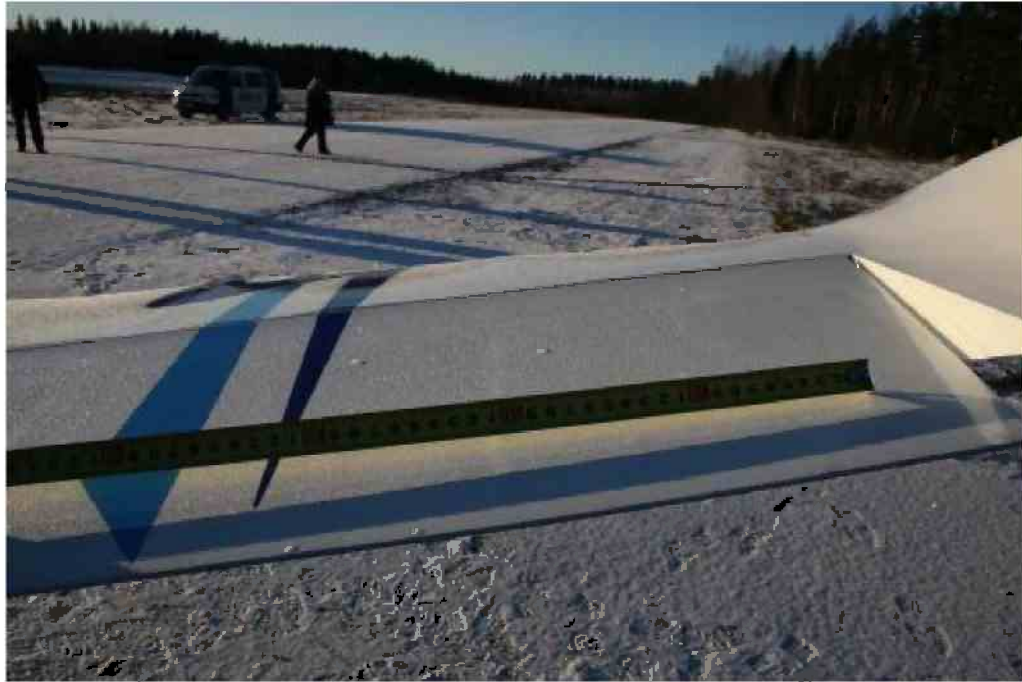
The aircraft's wing profile UA(2)-180 is a laminar profile, which was developed for ultralight aircraft in the 1980s. The performance of a laminar profile is based on the fact that the flow in a boundary layer stays laminar at as large a region of profile surface as possible. The surface of a laminar profile needs to be particularly smooth so that the flow stays laminar as long as possible and good aerodynamic characteristics are achieved. Even small amounts of contamination, such as water droplets, insects, hoarfrost or ice, accumulated on the wing surface may change the laminar boundary layer into turbulence and locally separate the flow from the wing surface. The change of the flow into turbulence, and especially the flow separation, degrade the wing's aerodynamic performance by increasing the drag and stalling speed and by reducing lift and the stall angle of attack. Asymmetric local flow separation can also result in roll control problems, for example during lift off.

A thin layer of hoarfrost and a few frozen water droplets are clearly distinguishable in photographs taken after the accident. The pilot said that he did not observe any frost on the wings when the aircraft was inside the hangar. It is possible that the temperature in the hangar was slightly higher than the outside temperature. In such conditions hoarfrost could have formed when the aircraft was taken outside. Hoarfrost formation could also have occurred during taxiing. According to meteorological information, no such large temperature fluctuations were present below 100 metres that could have caused sudden hoarfrost formation during takeoff or the initial climb.

Figure 2. Hoarfrost and frozen water droplets on top of the wing.

1. The investigators recommend that the aircraft manufacturer adds to the flight and operations manual a clear statement saying that before every flight the pilot must ensure that wings, stabilizers and control surfaces are clear of snow, ice, frost and other contamination.
