## **Safety study**

S1/2009L

# **Ultralight Aviation Safety and its Improvement through Accident Investigation**

Translation of the Finnish original safety study

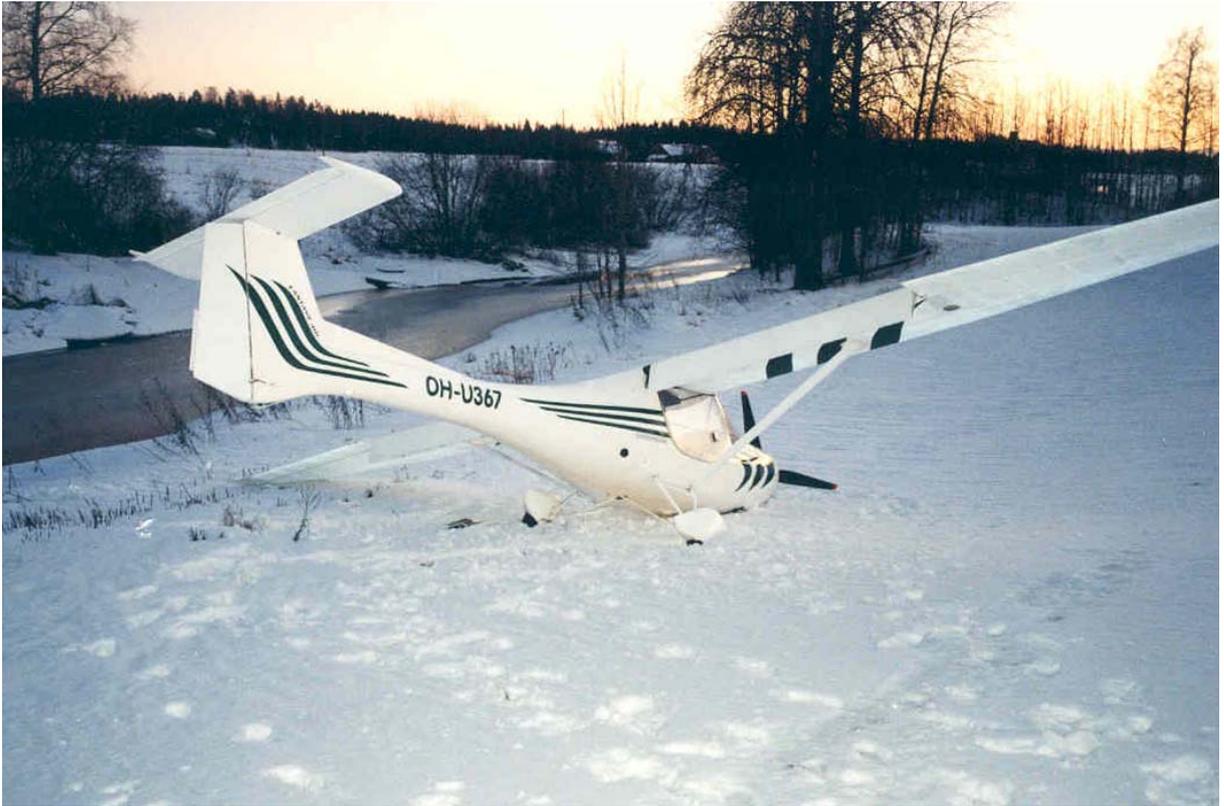
*Cora 200 Arius ultralight aircraft OH-U367 after an accident at Mäntsälä, occurrence 1 (investigation C1/2000L).*

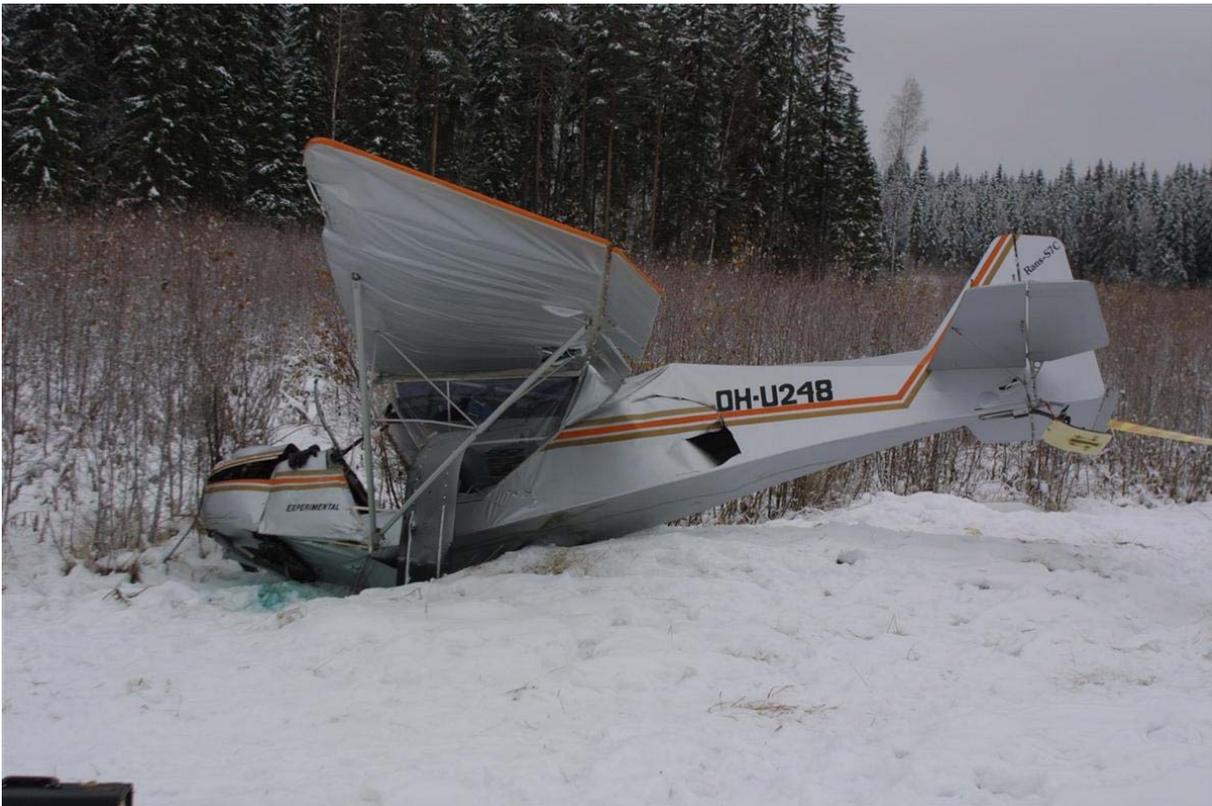
*Rans Courier S-7 L ultralight aircraft OH-U248 after an accident at Viitasaari, occurrence 3 (investigation C11/2002L).*

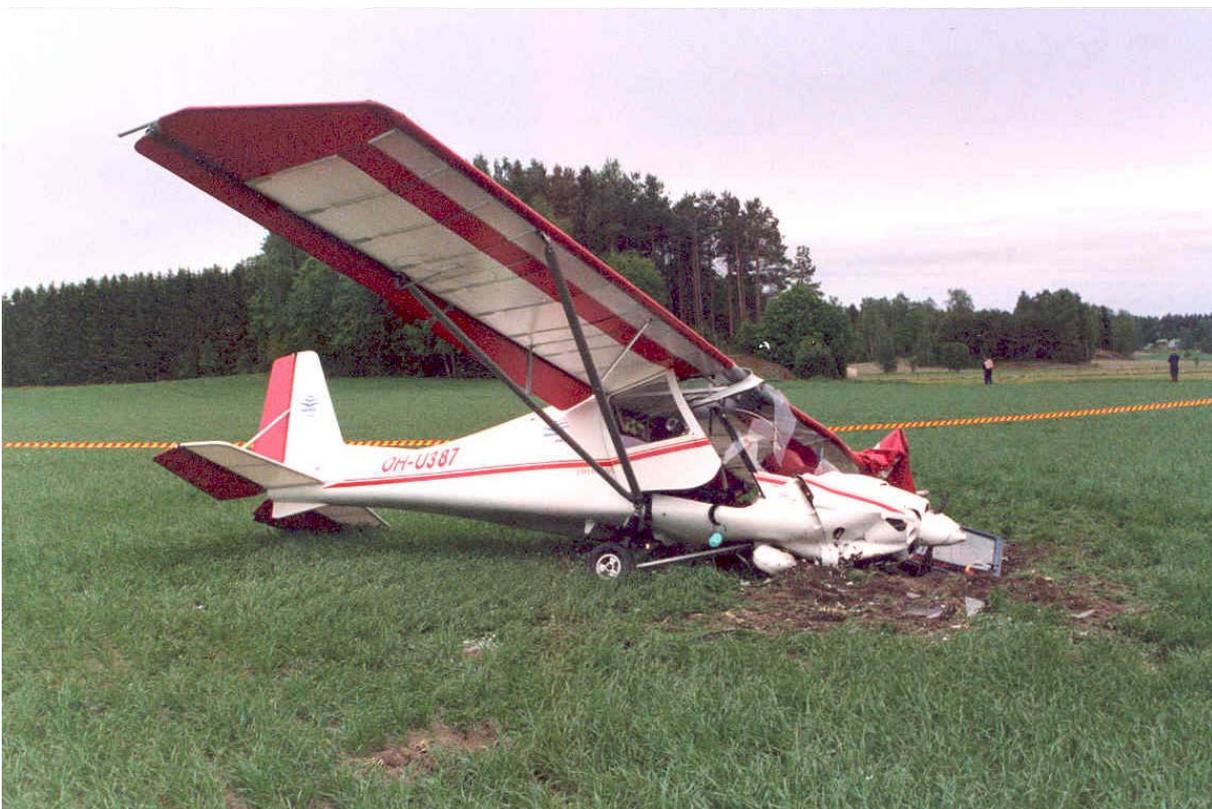
*Ikarus C42 ultralight aircraft OH-U387 after an accident at Kirkkonummi, occurrence 4 (investigation C7/2003L).*

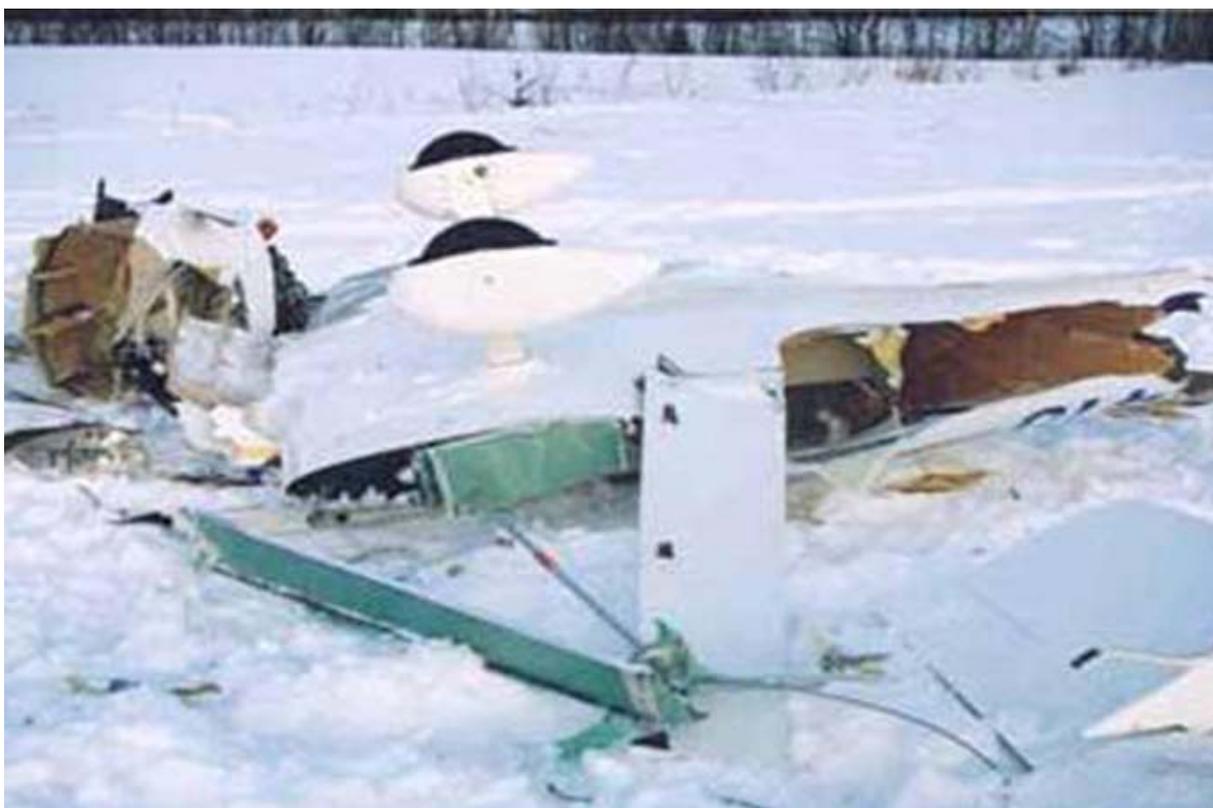
*Dynamic WT-9 ultralight aircraft OH-U415 after an accident at Hollola, occurrence 5 (investigation B1/2004L).*

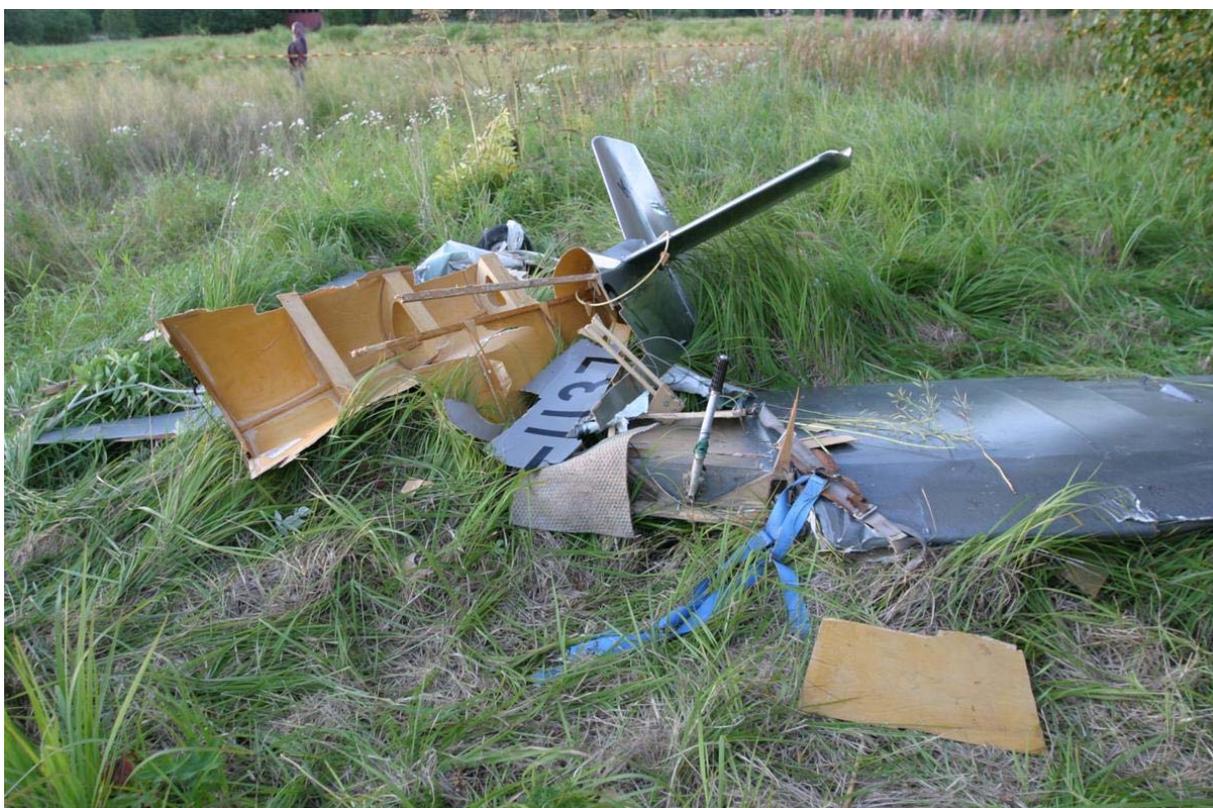
*Colibri MB 2 ultralight aircraft OH-U373 after an accident at Mäntsälä, occurrence 6 (investigation B3/2004L).*

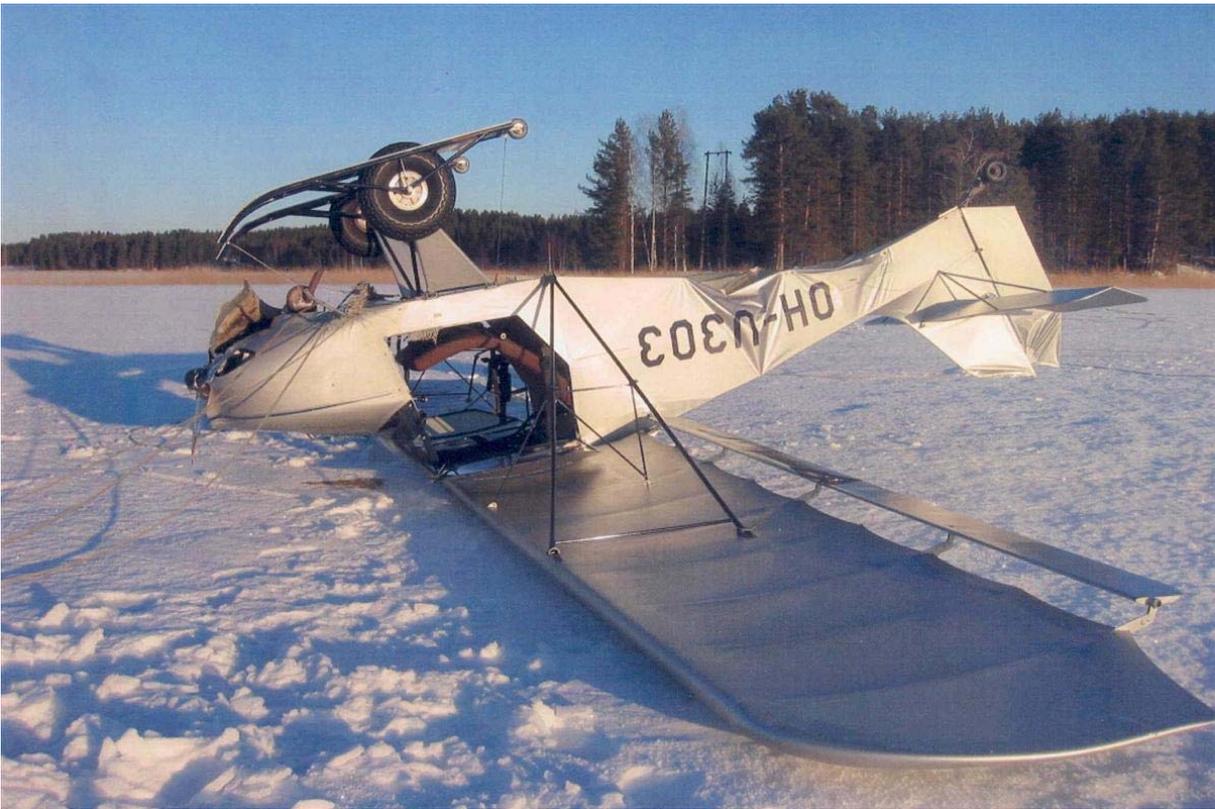
*Avid Flyer STOL ultralight aircraft OH-U303 after an accident at Viitasaari, occurrence 7 (investigation D1/2005L).*

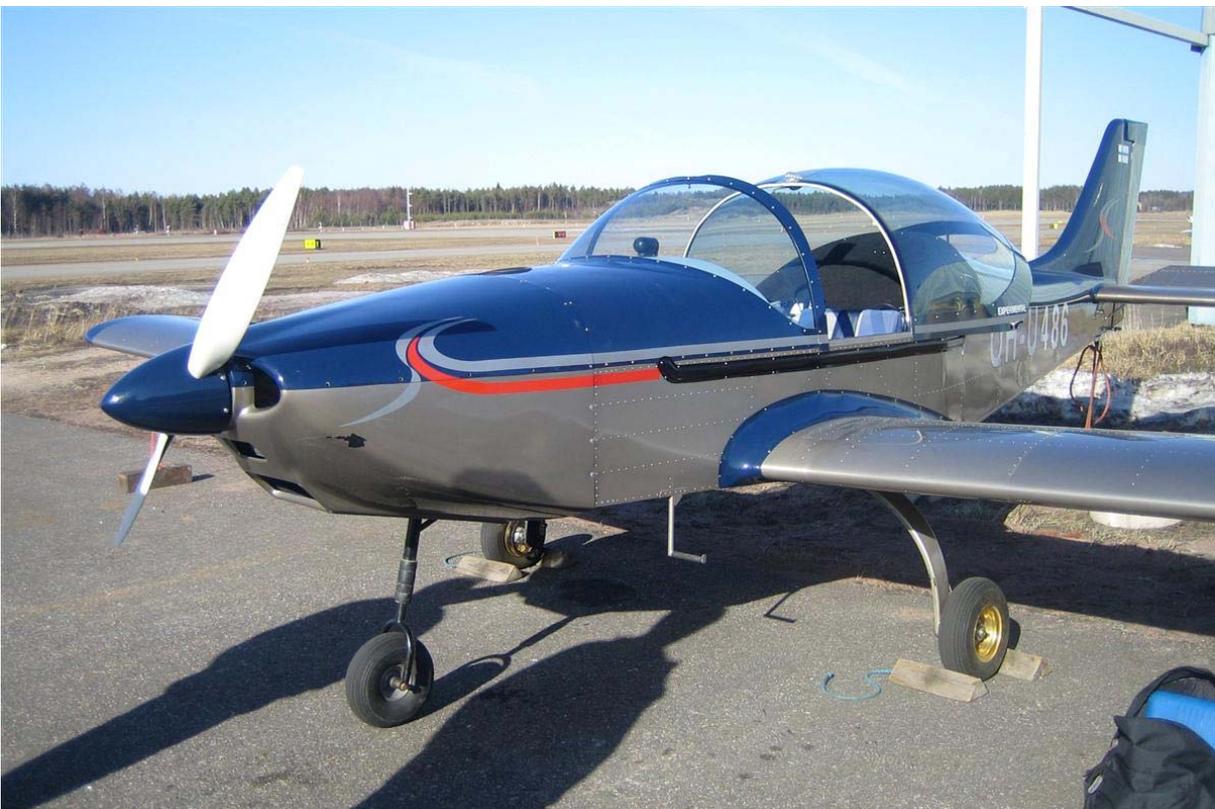
*Breezer ultralight aircraft OH-486 after a serious incident at Turku aerodrome, occurrence 8 (investigation D6/2006L).*

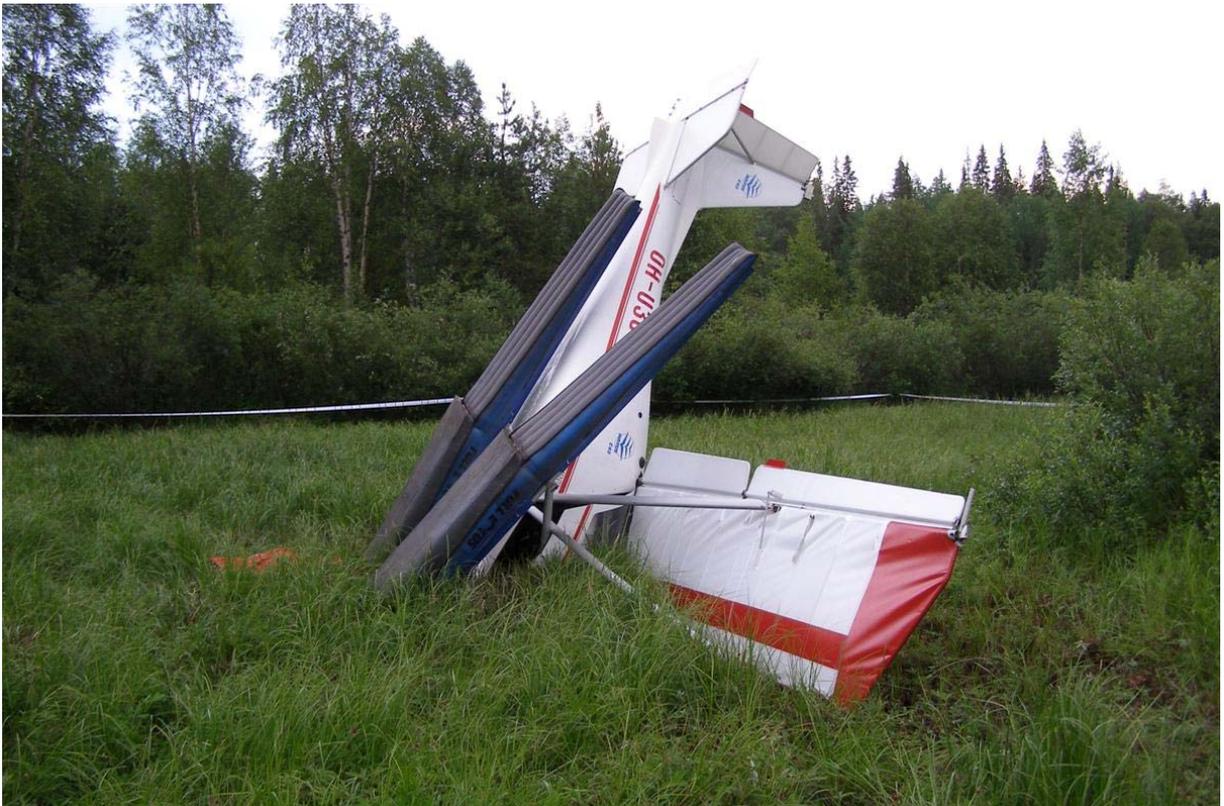
*Ikarus C42 ultralight aircraft OH-U369 after an accident at Sodankylä, occurrence 9 (investigation B2/2006L).*

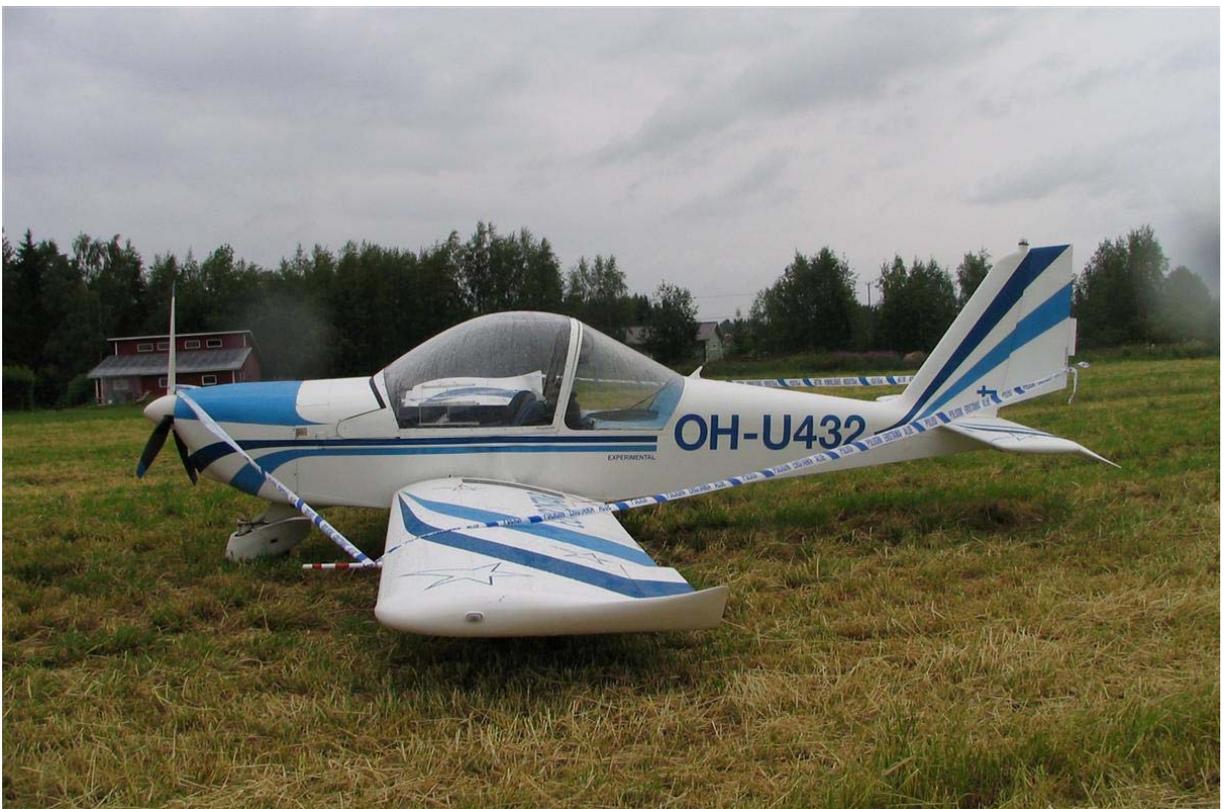
*Eurostar EV-97 ultralight aircraft OH-U432 after a minor accident at Haapavesi, occurrence 10 (investigation D9/2006L).*

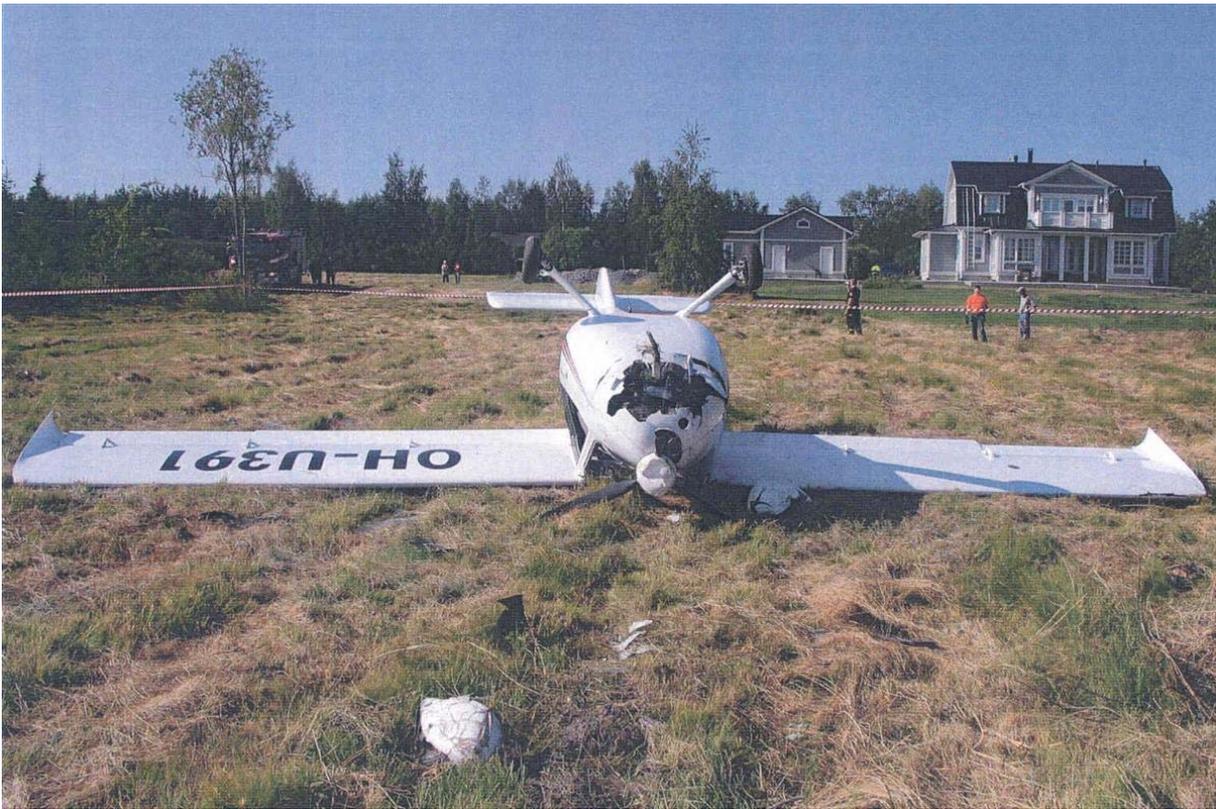
CT 2 K ultralight aircraft OH-U391 after a minor accident at Oulunsalo, occurrence 11 (investigation D11/2006L).

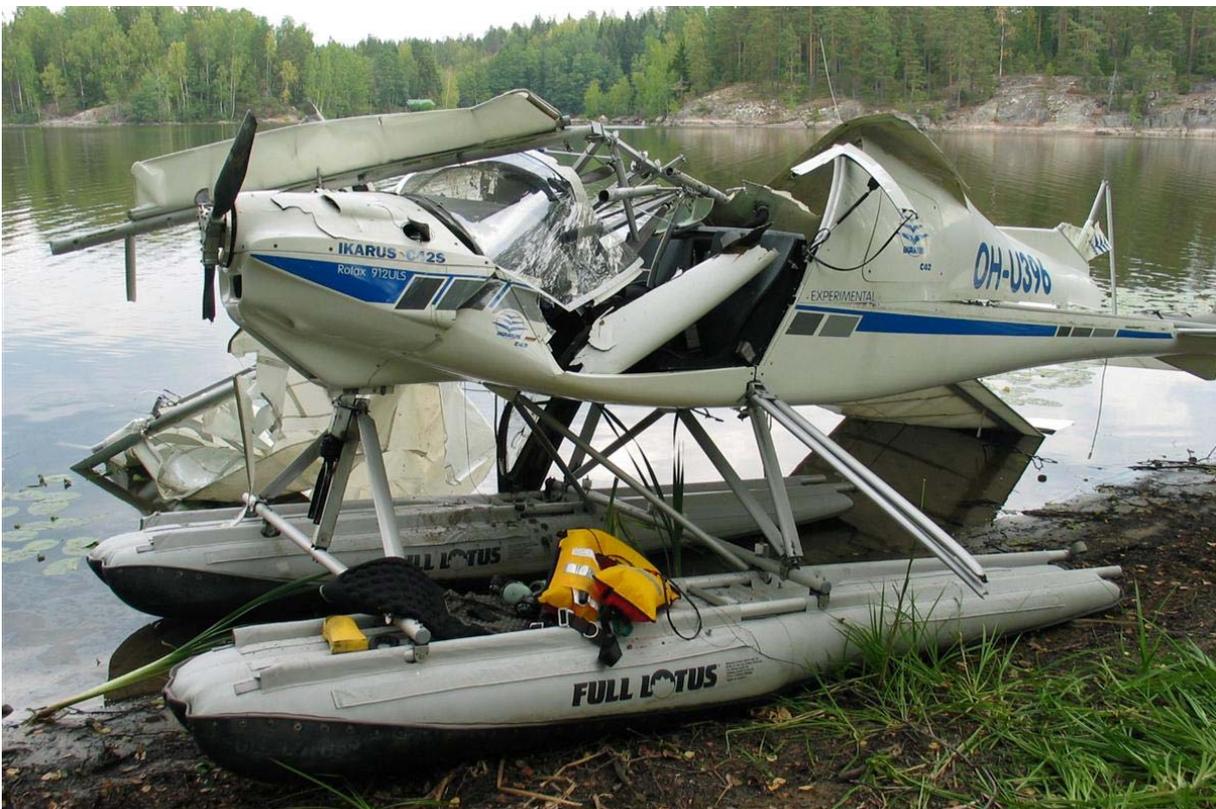
Ikarus C42S ultralight aircraft OH-U396 after an accident at Lake Hirsijärvi, occurrence 12 (investigation B3/2006L).

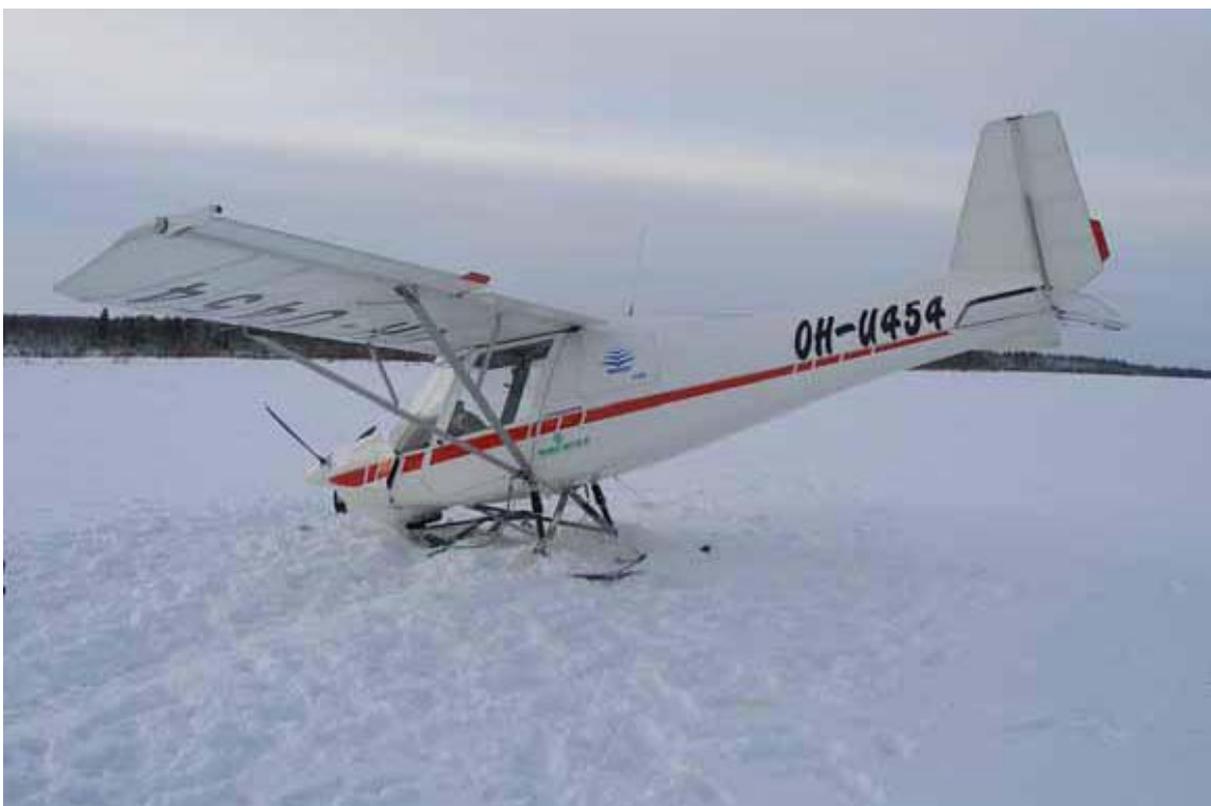
*Ikarus C42B ultralight aircraft OH-U454 after a minor accident at Pudasjärvi, occurrence 13 (investigation D4/2007L).*

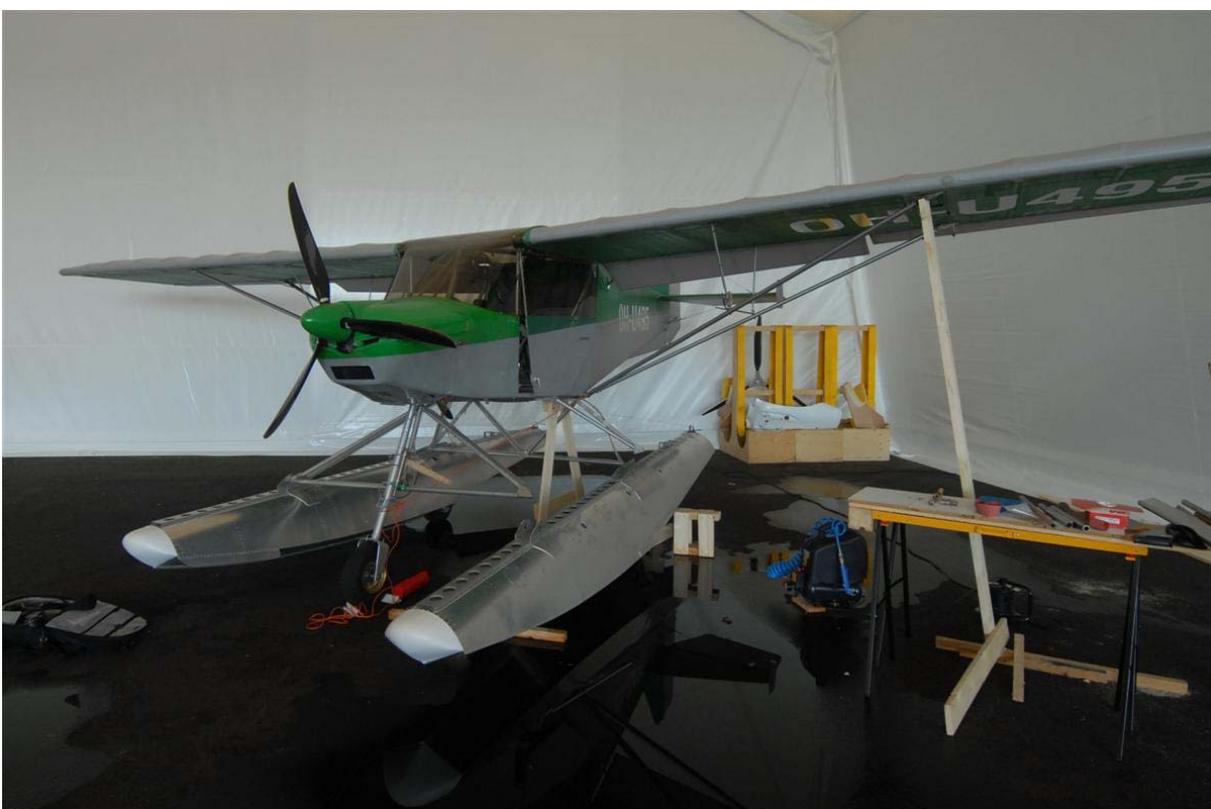
*Skyranger V.Max ultralight aircraft OH-U495 after a serious incident at Helsinki-Malmi, occurrence 14 (investigation C5/2007L).*

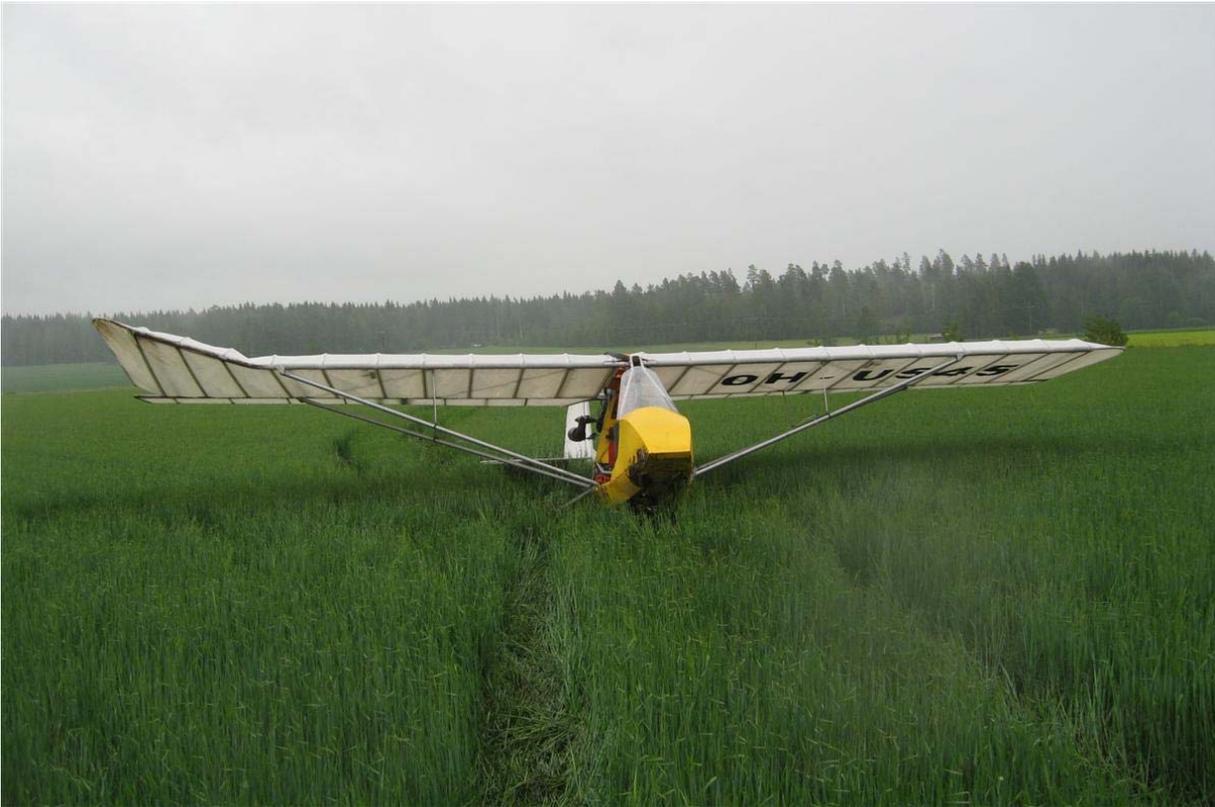
*Quad City Challenger ultralight aircraft OH-U545 after a minor accident at Vampula, occurrence 15 (investigation D2/2008L).*

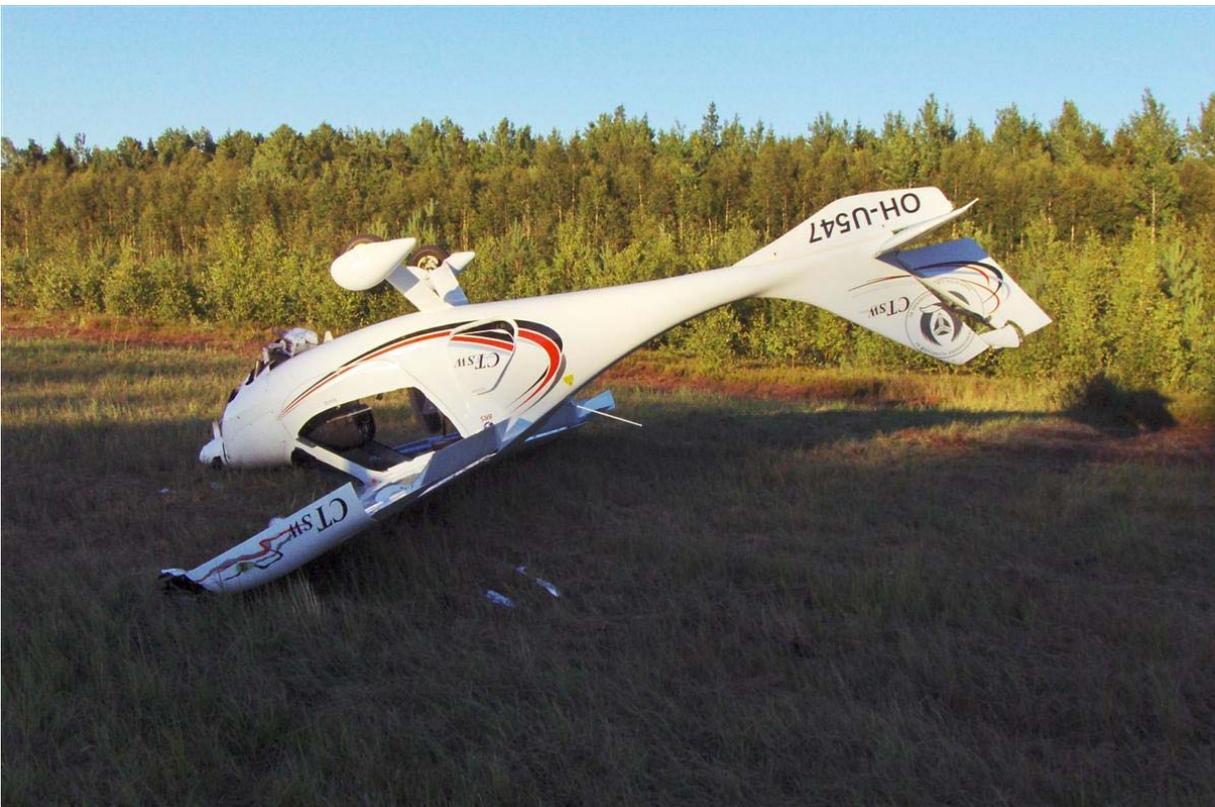
*CTSW ultralight aircraft OH-U547 after a minor accident at Hanko airfield, occurrence 16 (investigation D5/2008L).*

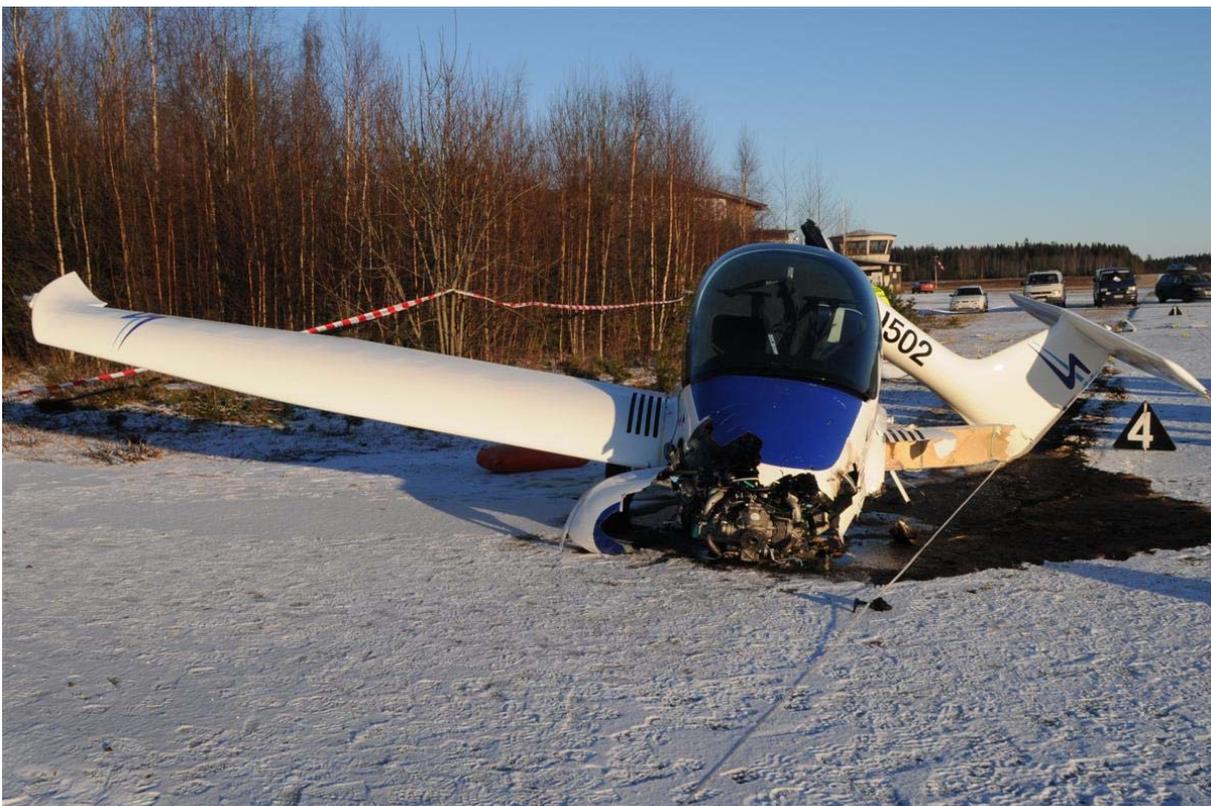
In 2009 more serious accidents occurred in Finnish ultralight aviation within a short period of time than had during previous years. In January 2009 at Lahti-Vesivehmaa airfield an accident occurred when a class B ultralight aircraft stalled after takeoff and collided with the ground. The pilot was seriously injured and the aircraft was badly damaged. In April 2009 three ultralight accidents occurred. The first accident happened to a class A weight-shift controlled ultralight at Hyvinkää airfield; the pilot died and the aircraft was destroyed. Approximately one week later an accident happened at Helsinki-Malmi aerodrome; a class B ultralight was badly damaged in a landing. One week after this an accident took place at Inkoo; a class B ultralight was destroyed in a forced landing. In early August 2009 an accident occurred at Kauhava aerodrome; a class B ultralight stalled at low altitude while trying to turn back to the runway following takeoff. Both pilots in the aircraft were killed and the aircraft was destroyed.

*ATEC Zephyr 2000 ultralight aircraft OH-U502 after an accident at Lahti-Vesivehmaa airfield, occurrence 17 (investigation D2/2009L).*

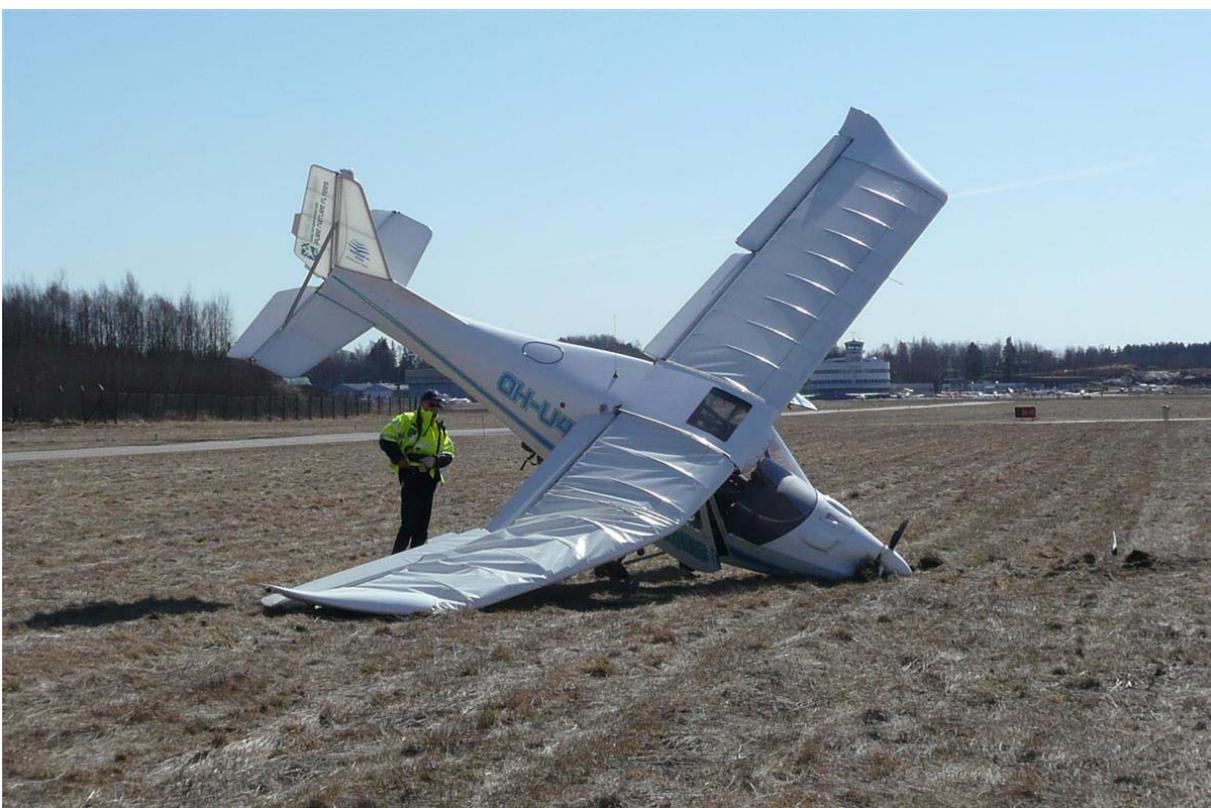
*Ikarus C42B ultralight aircraft OH-U478 after an accident at Helsinki-Malmi aerodrome, occurrence 18 (investigation D3/2009L).*

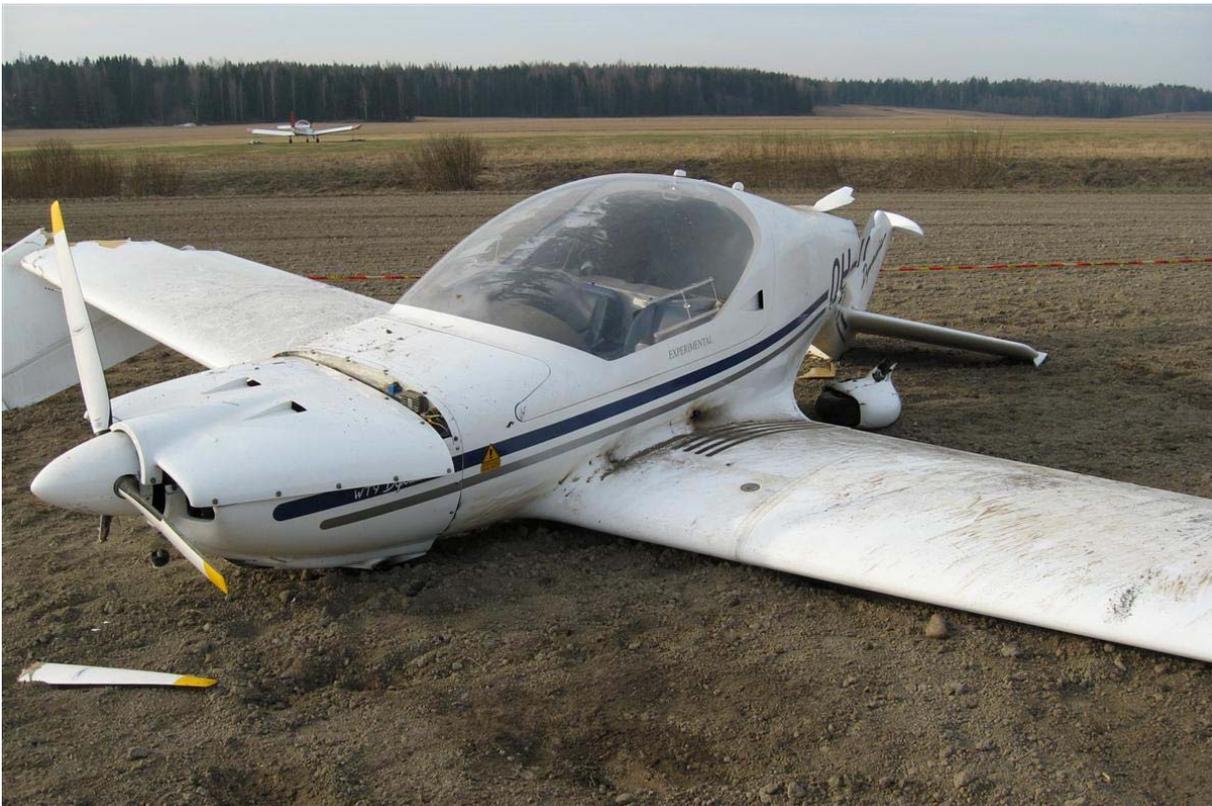
*Dynamic WT-9 ultralight aircraft OH-U474 after an accident at Inkoo, occurrence 19 (investigation D4/2009L).*

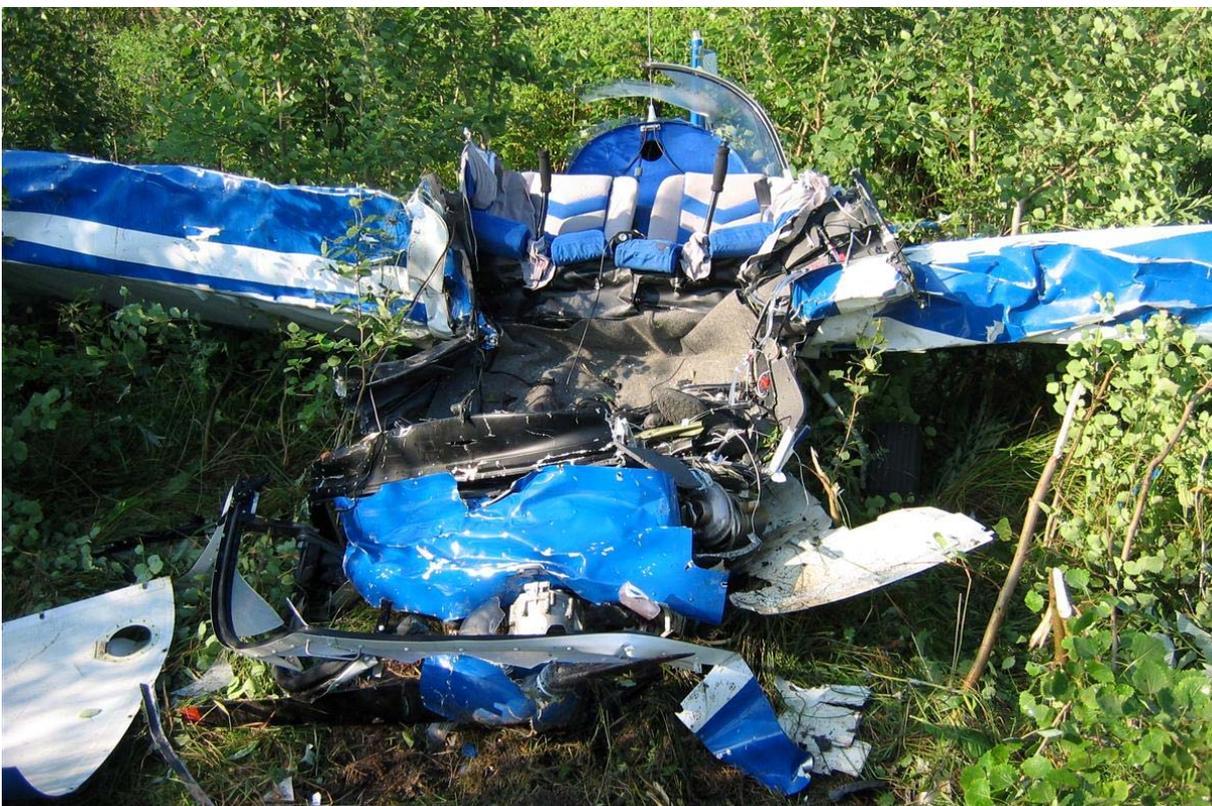
*EV-97 Eurostar ultralight aircraft OH-U507 after an accident at Kauhava aerodrome, occurrence 20 (investigation B6/2009L).*
