## Investigation report

B2/2010L

# Ultralight aircraft accident at Jämijärvi on 30 June 2010

OH-U430

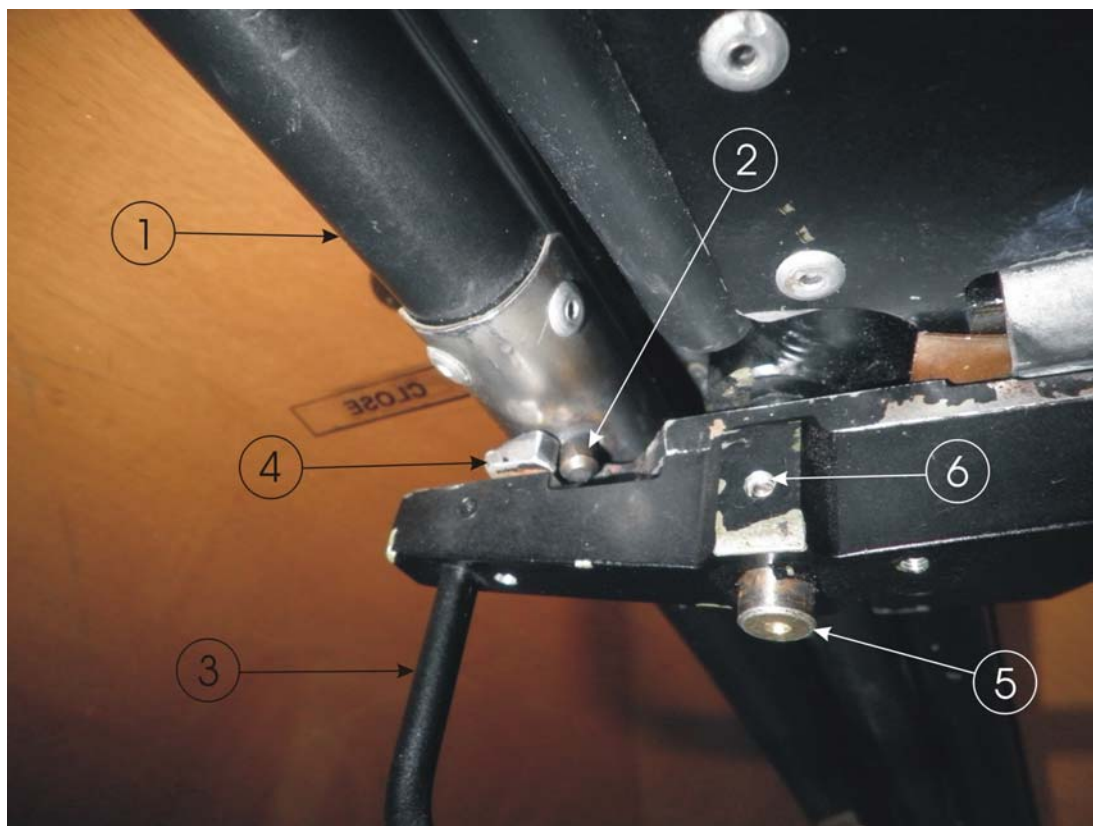
Picture 2. The locking of the accident aircraft in the closed position. 1. fixed support frame, 2. locking pin, 3. inner handle, 4. locking hook, 5. axel for outer handle, 6. metal pin functioning as locking pin.

The owners of the aircraft considered the canopy locking mechanism unreliable. During the 300 hour maintenance in May 2005 the play found in the locking handle was logged into the maintenance list. In spite of the play the locking was determined functional. The problem was the joint between the canopy's outer and inner handle which was loosened. The growth of the play was considered a risk because the axel of the outer handle might break at the joint. The joint was done with a 3 mm thick pipe locking pin. Because the outer handle had a 6 mm thick axel, a thicker locking pin could not be attached to eliminate the play.

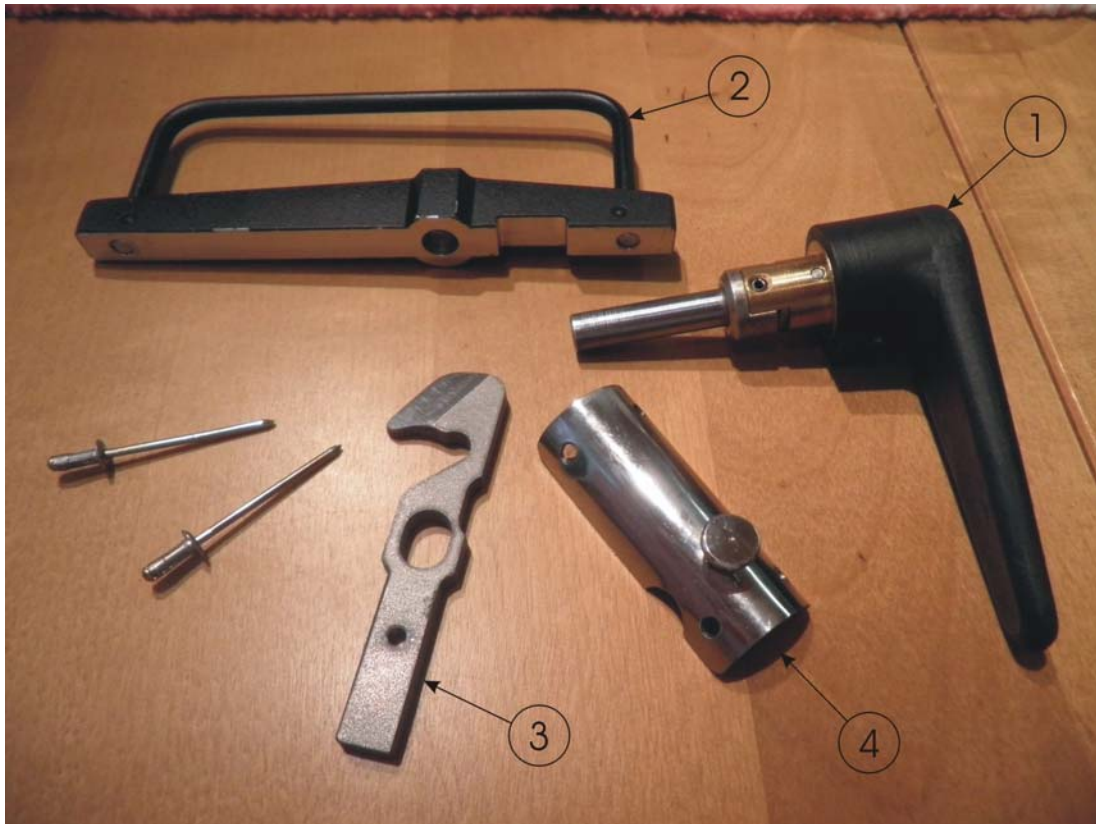
Picture 3. Canopy locking alteration parts delivered for another EV-97 Eurostar aircraft canopy alteration work. 1. outer handle, 2. inner handle, 3. locking hook to be attached to the inner handle, 4. flanged locking pin.

The locking mechanism was repaired by changing the outer and inner handle and attaching the old locking hook into the inner handle. In the new handle the axle was 8 mm thick which made it necessary to make the canopy axle hole bigger. The pipe locking pin was replaced by a machined metal pin which was widened at the other end and the other end was secured with a locking wire.

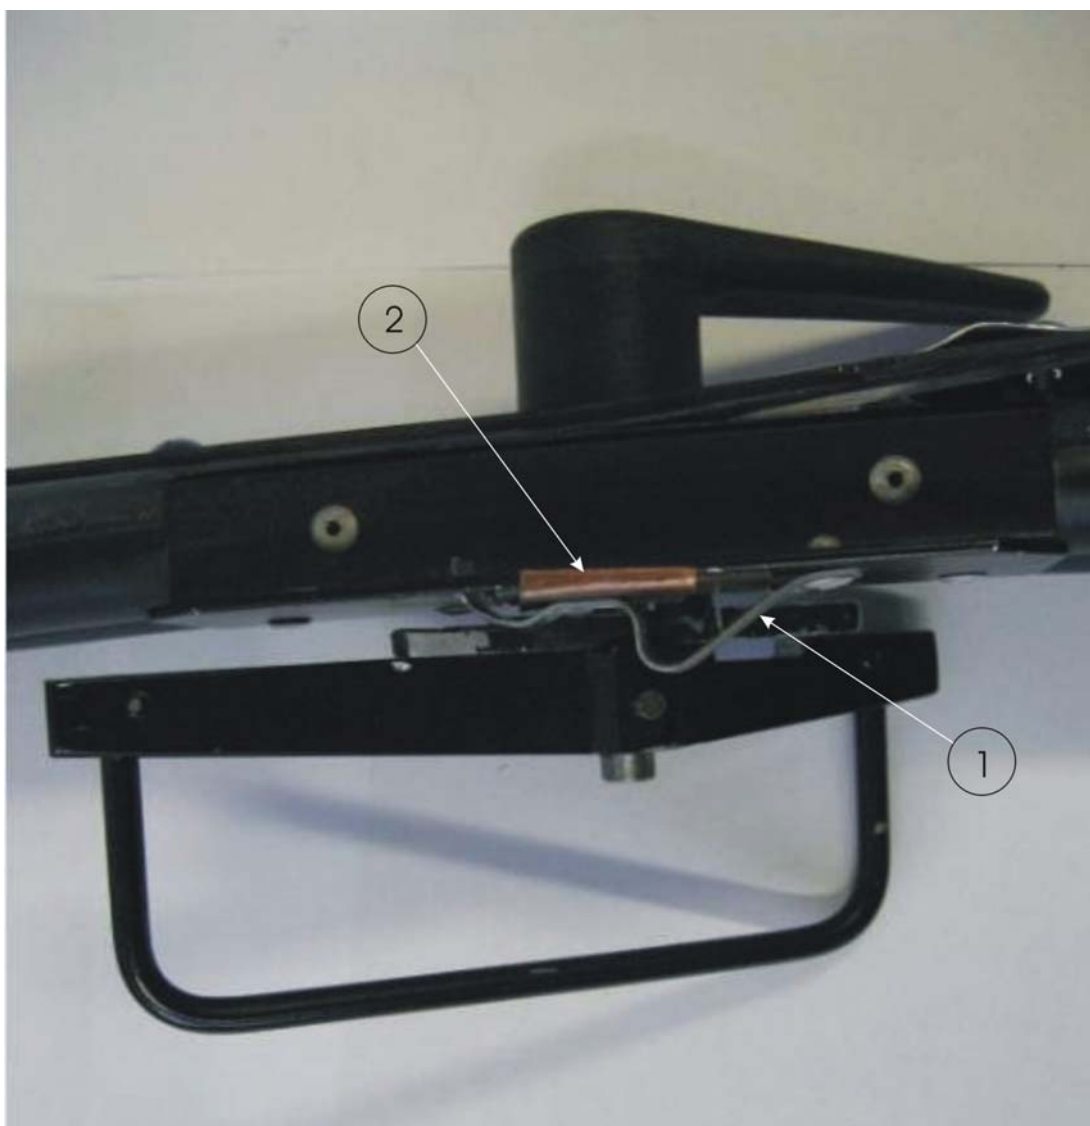
During the alteration work the owner performing the work strengthened the spring keeping the canopy locking handle in the closed position by assembling an additional plate under the actual spring. According to the owner the alteration made the locking feel better. In interviews the owners thought the feeling from the locking handle was good after the alteration (picture 4).

Picture 4. The canopy locking handle, the locking spring holding the handle in the closed position and the additional plate assembled under it. 1. Locking spring, 2. additional plate.

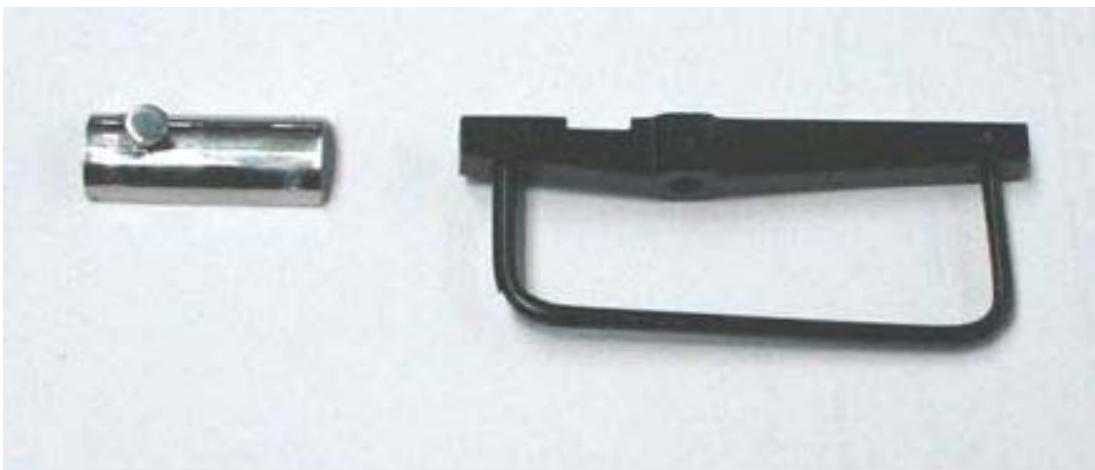
Picture 5. The parts to be changed to the locking mechanism according to bulletin number EV-97-009a.

During the investigation it was found that the manufacturer's bulletin does not cover all EV-97 Eurostar aircraft in Finland. According to the bulletin only the inner handle and the flanged locking pin are to be changed in the locking handle alteration work. It can be judged by the parts to be changed and the contents of the bulletin that the reliability of the locking mechanism is improved by changing the locking pin to a flanged one which prevents the locking hook from rising and slipping off the pin. The bulletin states: *"The stop of the pin installed on the rear fixed canopy frame prevents canopy unprompted opening"*. The inner handle with an indentation has to be changed to have the flange of the locking pin settle right into the locking hook.

The aircraft manufacturer Evektor-Aerotechnik a.s. has published a bulletin on 3 January 2006 (Mandatory bulletin number EV-97-009a) concerning aircraft with the wide canopy. The reason for publishing this bulletin was information of repeated unintentional openings of canopy during flight. The manufacturer considers the most likely reason for the opening the inadequate design of the locking mechanism. The locking is not considered adequate under all air loads that may affect the canopy during flight. The bulletin gives alteration work instructions for the locking mechanism and shows the parts needed for the work (picture 5). The parts to be changed were the inner handle and locking pin with flange. The manufacturer promises to deliver the parts without charge. The bulletin is mandatory. The schedule for the work is "as soon as the parts arrive". However, the bulletin does not limit flying before changing the parts as long as the pilot ensures careful locking of the canopy before flight. In uncertain cases the locking can be confirmed following the instructions in the bulletin.

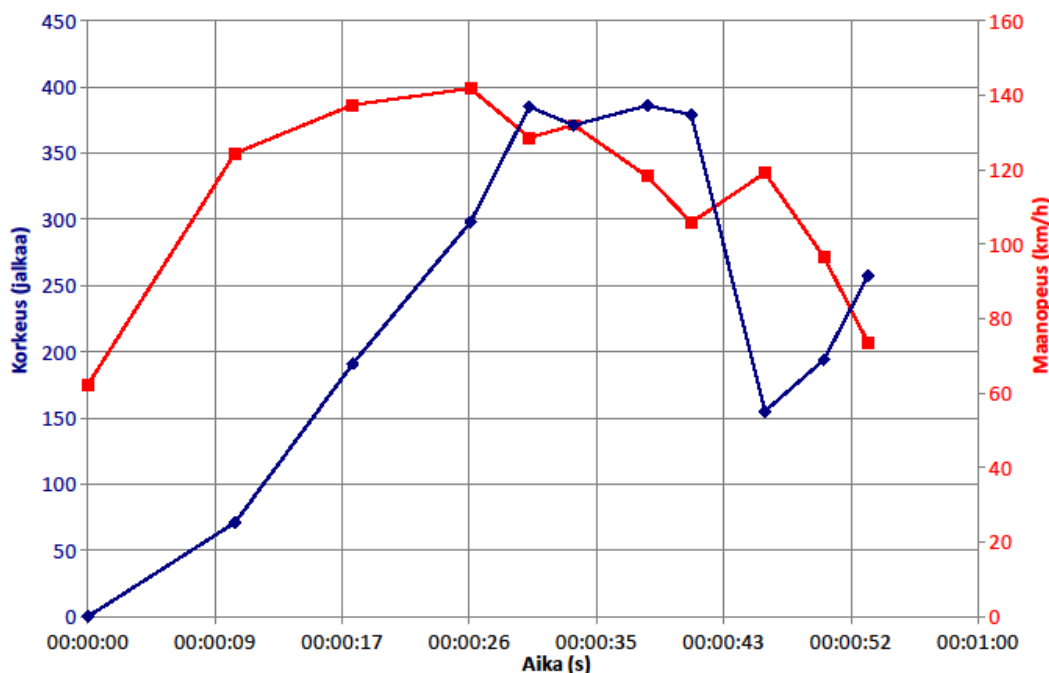
After the level flight phase the altitude of the aircraft diminished quickly over 200 feet (about 70 m). It is possible that the pilot tried to close the canopy with both hands, having to let go of the stick. Both the reduced airspeed and open canopy cause a nose down effect. Releasing the stick leads the nose to dive and loss of altitude. After noticing the rapid loss of altitude the pilot levelled the glide into climb by pulling the stick but not increasing engine power. As a consequence of the steering actions and the rapid loss of airspeed the aircraft started to bank heavily to the left, resulting in the pilot's loss of aircraft control.

Picture 6 shows the diagrams of ground speed and altitude extracted from the GPS recording. Based on the relative changes in the diagrams the changes in the flight can be assessed. Individual figures, especially altitude figures, in the diagrams may include inaccuracy due to satellite geometry.

Picture 6. The diagrams of ground speed and altitude extracted from the GPS recording. Ground speed is in red and altitude in blue.

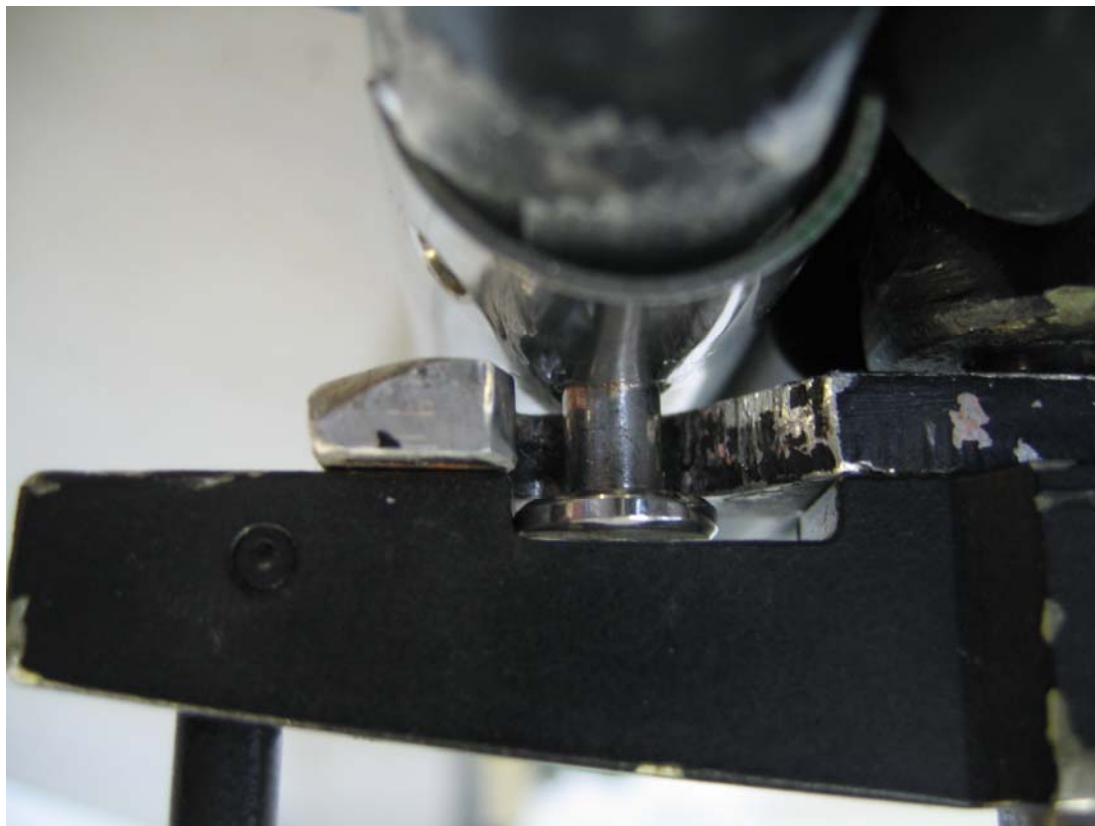
The understanding of the Investigation Commission is that strong shock-like quick changes in acceleration cause a momentary change in shape to the aircraft structure and, as a consequence, the locking hook may slip upwards over the 5 mm long locking pin. After this the inner locking handle may either slip from under the rear frame or turn into the open position making it possible for the canopy to open. Momentary changes in shape are apparent due e.g. to strong and gusty wind and the light structure of the canopy. The Investigation Commission considers this opening mechanism of the canopy locking system as most likely also on the accident flight.

The alteration work for the accident aircraft was partly done, but the flanged locking pin to the canopy fixed frame had not been assembled. According to the view of the owners, who had done the alteration work, the flanged locking pin was not compatible with the inner handle without machining. The purpose of the flange in the locking pin is to prevent the locking hook from slipping from the locking pin upward during momentary, non-permanent changes in the canopy shape caused by aerodynamic forces (picture 7). According to the Investigation Committee's perceived understanding, assembling the flanged locking pin would have considerably improved the reliability of the locking mechanism.

Picture 7. The settling of the flanged locking pin to the inner handle and the original locking hook.
