**SERIOUS INCIDENT REPORT 1/2011**

**ACCIDENT INVESTIGATION DIVISION**

Report on the Serious Incident of an Attempted Take-off on Taxiway  
Flight FIN070 Airbus A340-300 OH-LQD  
at the Hong Kong International Airport  
on 26 November 2010  
[27 November 2010 Local Time]

December 2011

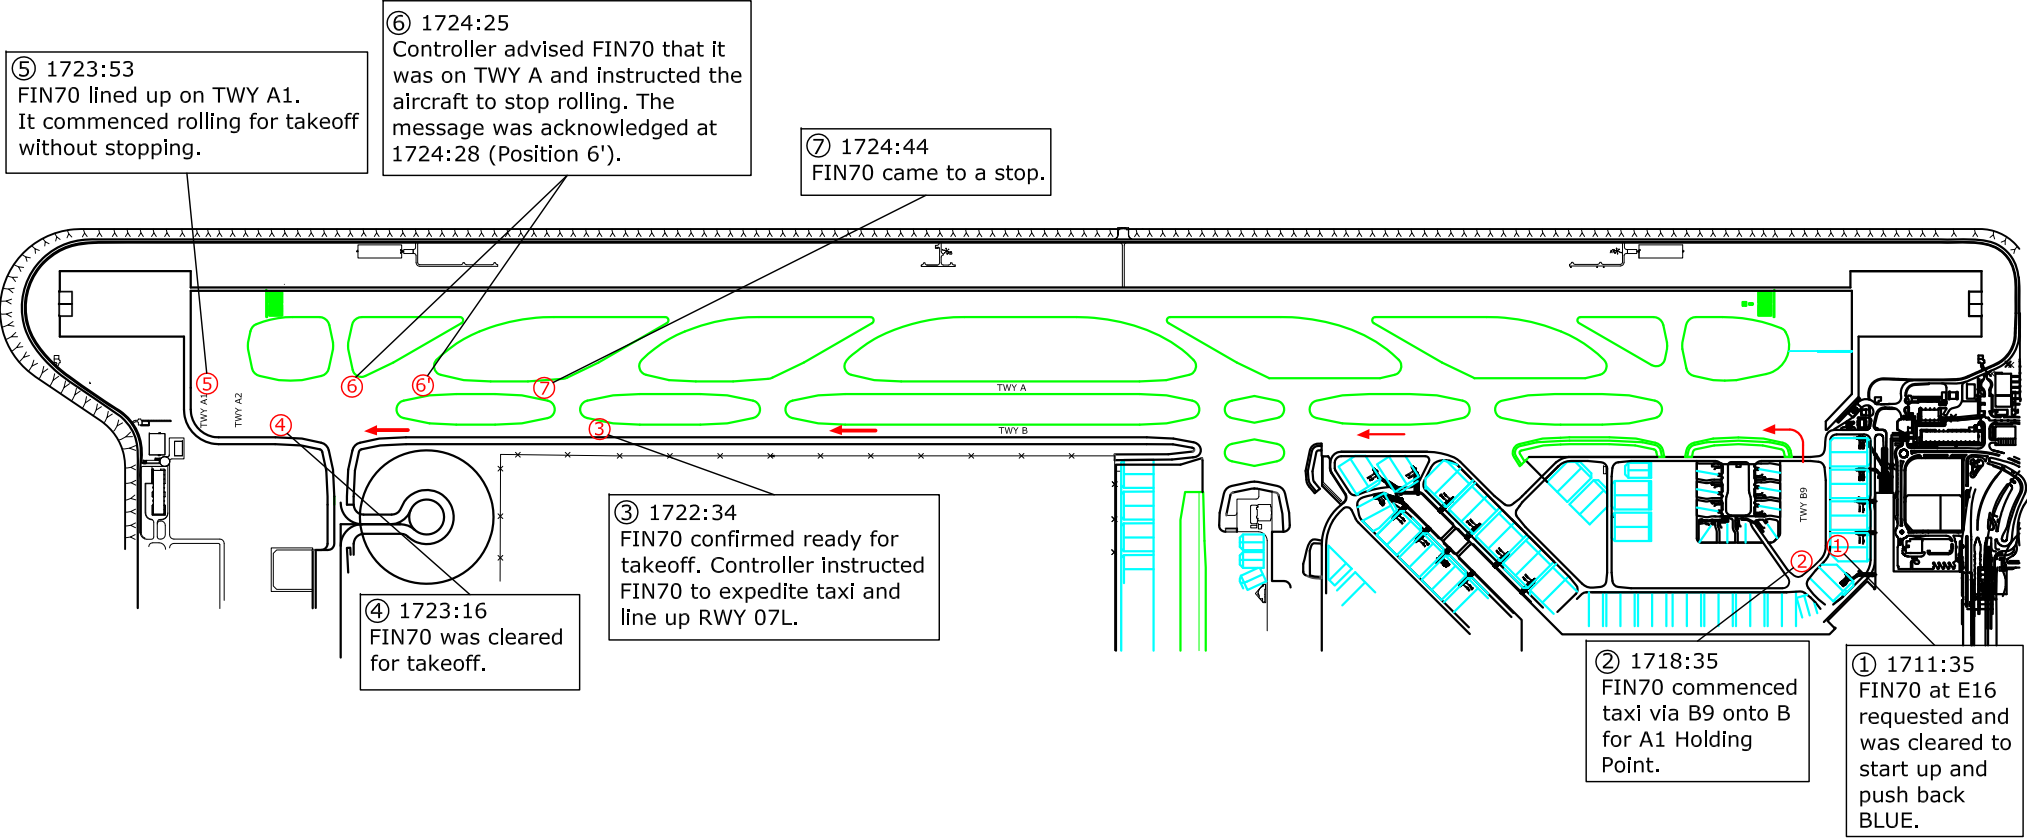
# Aircraft Track of FIN070 Based on A-SMGCS Recording

When FIN070 was approaching the RWY 07L Holding Point towards the western end of TWY B, the Air Movements Controller (AMC) cleared the aircraft for take-off. The aircraft took the normal right turn at the end of TWY B onto TWY A1 towards RWY 07L. However, before the aircraft reached the runway, it took a premature right turn onto TWY A, a taxiway parallel to and situated in between RWY 07L and TWY B. Upon entering TWY A and being aligned with the 07L orientation, it commenced a rolling take-off. This abnormal manoeuvre was detected by the Ground Movements Controller (GMC) on the Advanced Surface Movement Guidance and Control System (A-SMGCS), who promptly alerted the AMC. The AMC immediately instructed FIN070 to stop rolling. The aircraft came to a halt abeam TWY A5, approximately 1400 metres (m) from the western end of TWY A. (The aircraft track of FIN070 based on A-SMGCS recording is shown in Appendix A)

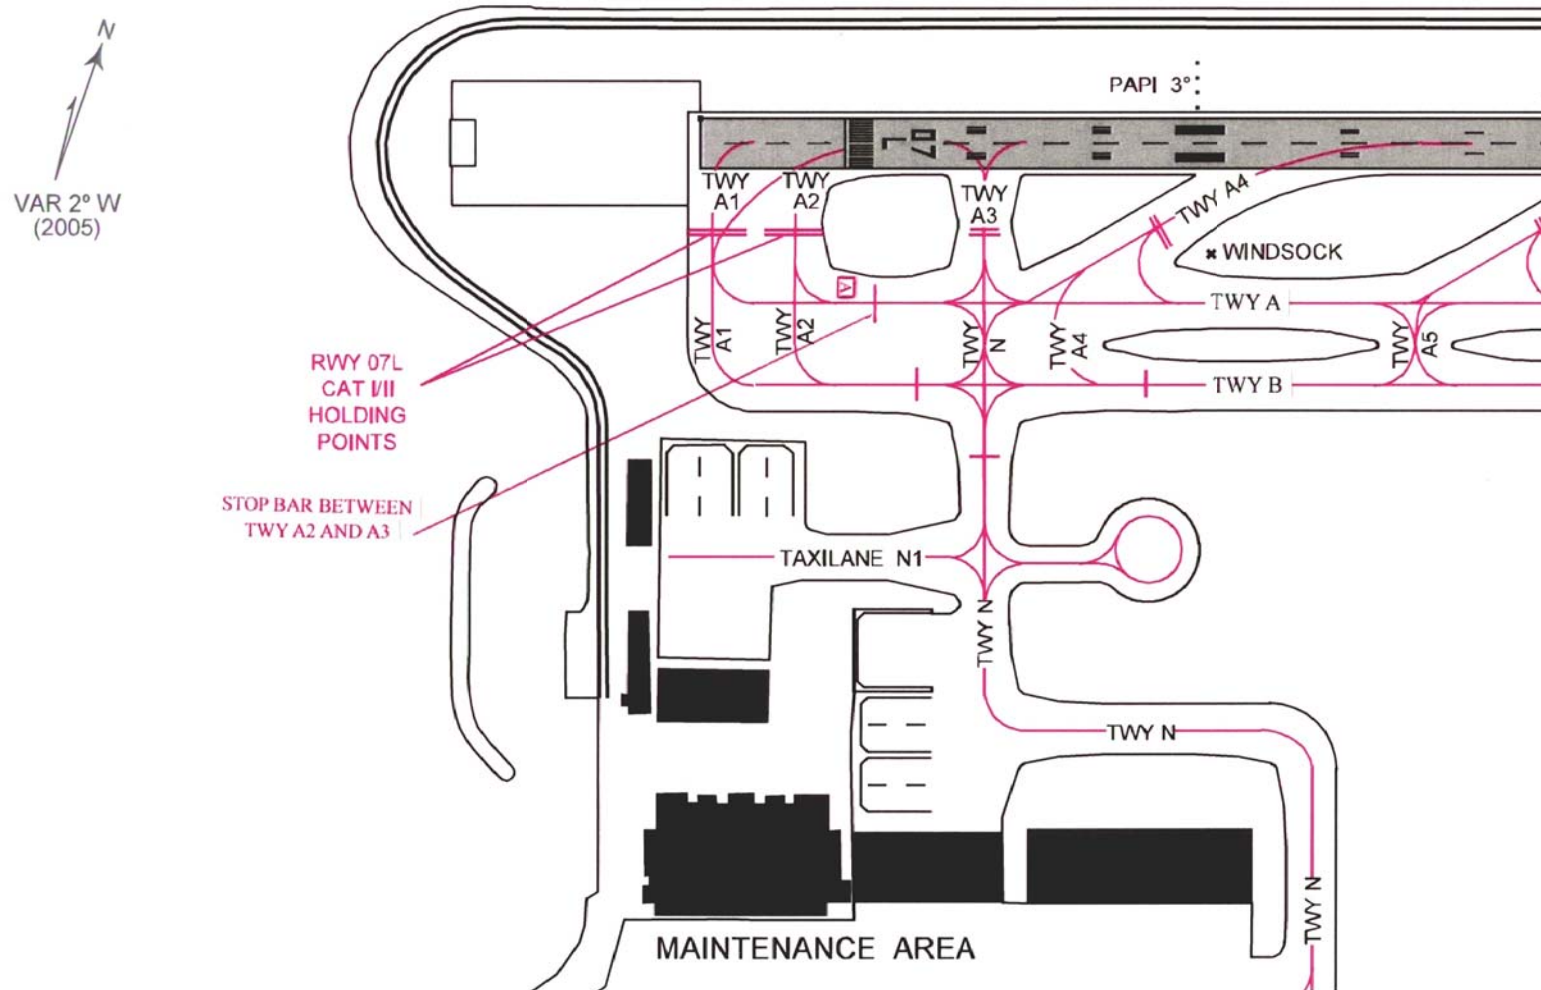
## Aerodrome Visual Marking in the Vicinity of TWY A1, TWY A2 and RWY 07L

down zone marking, runway side stripe marking and with white inset centre line lights and white elevated edge lights. (See Appendix C for aerodrome marking layout and Appendix D for aerodrome lighting layout). It should be noted that the taxiway marking and the associated taxiway lights leading from TWY A1 northbound turning onto TWY A have been removed so as to provide additional safeguard against pilots inadvertently making a pre-mature turn onto TWY A instead of RWY 07L. (Table under paragraph 1.20.3 refers)

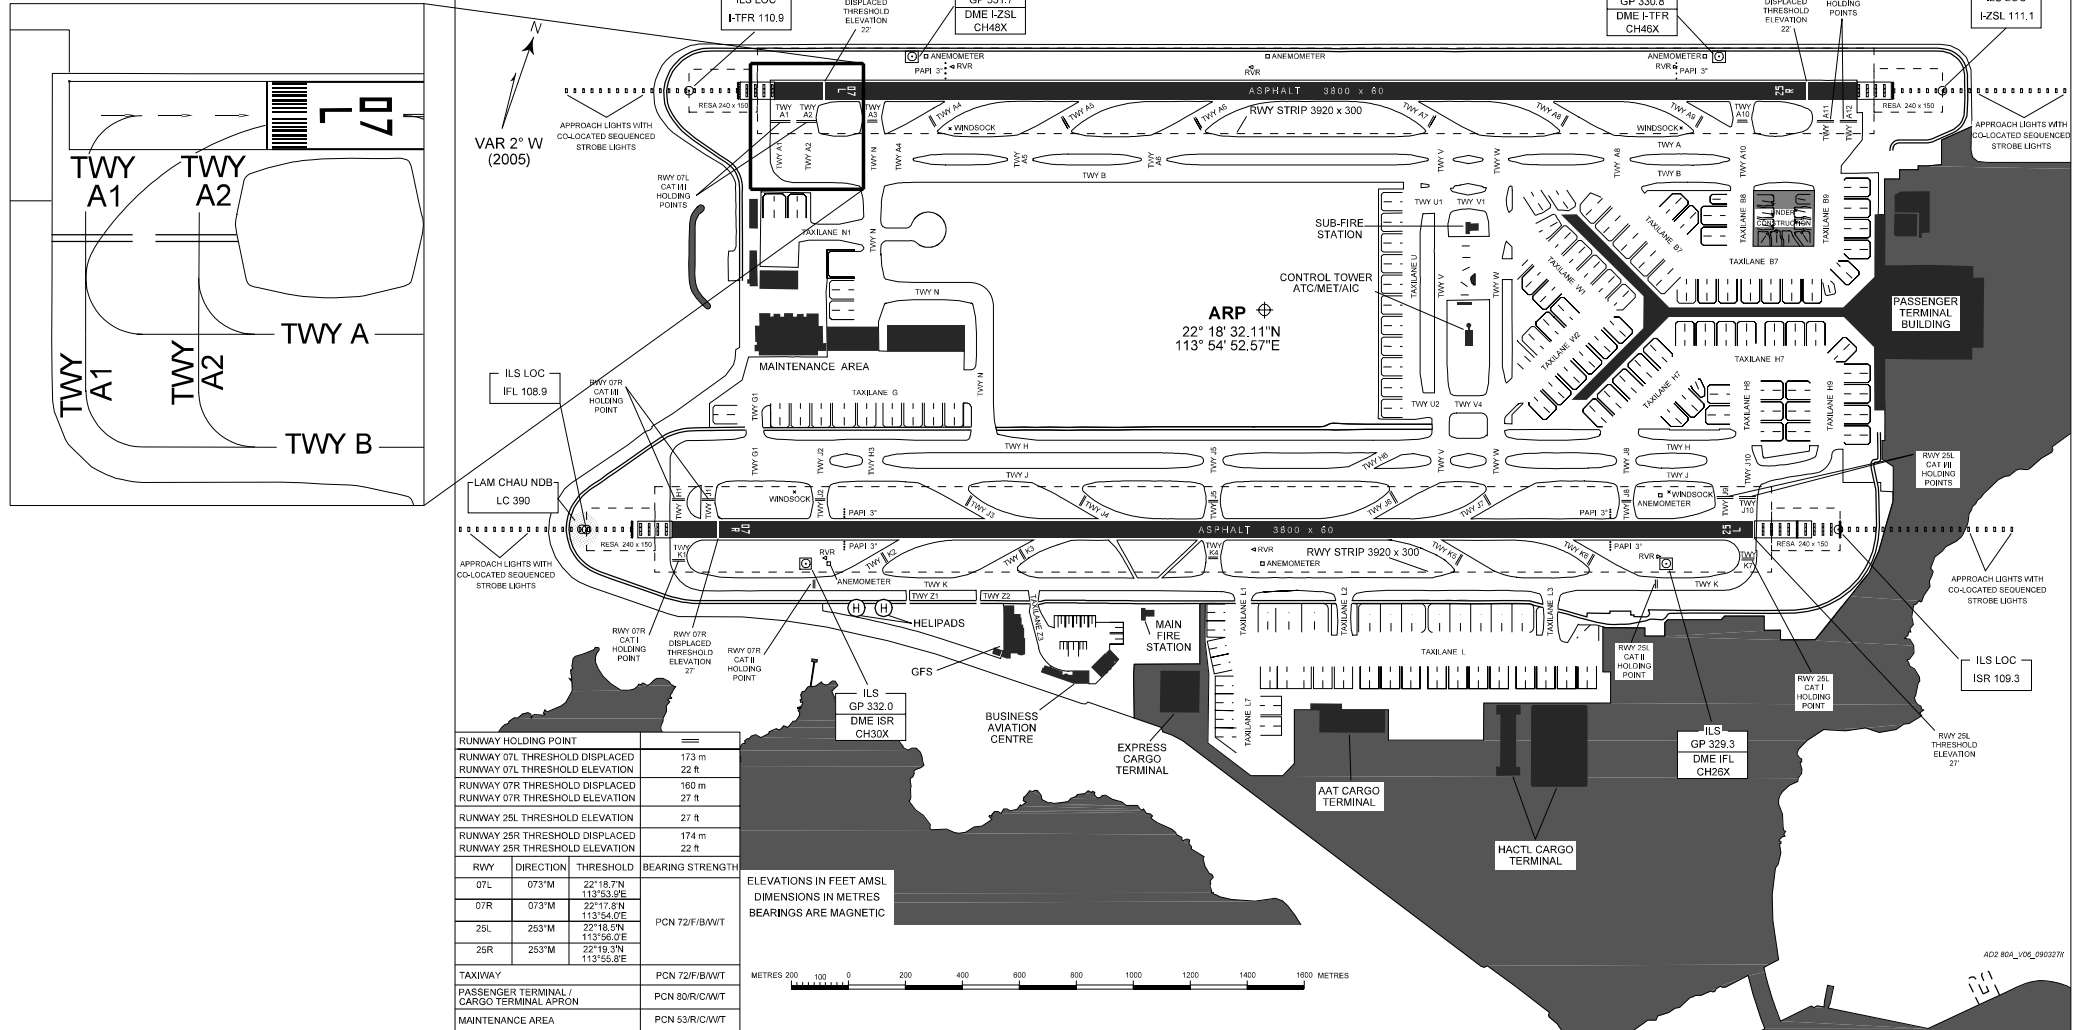
## TWY A1 and TWY A HOTSPOT

2.5.3 In view of previous incidents in which departure aircraft mistook TWY A as RWY 07L and attempted to line up and take off on the taxiway, the Hong Kong CAD published an AIP Supplement on 9 April 2009 to highlight the designation of hot spot around the area of TWY A, TWY A1 and RWY 07L Holding Point. The AIP Supplement stated that in the past six years there had been three occasions at night when pilots had mistaken TWY A for RWY 07L and attempted to take off from the taxiway. The AIP Supplement also highlighted the improvement in the taxiway centre line marking and lightings. It was noted that such important information for avoidance of confusion between the runway and taxiway was not included in the company Airport Briefing, which was meant to enhance the awareness of pilots. Following the incident, the company Airport Briefing was subsequently revised on 21 December 2010 incorporating information on the hot spot at the HKIA. It is therefore considered that there is a need for the operator to strengthen document control to ensure that up-to-date safety significant information, such as aerodrome hot spot, is incorporated in the Airport Briefing on a timely basis.

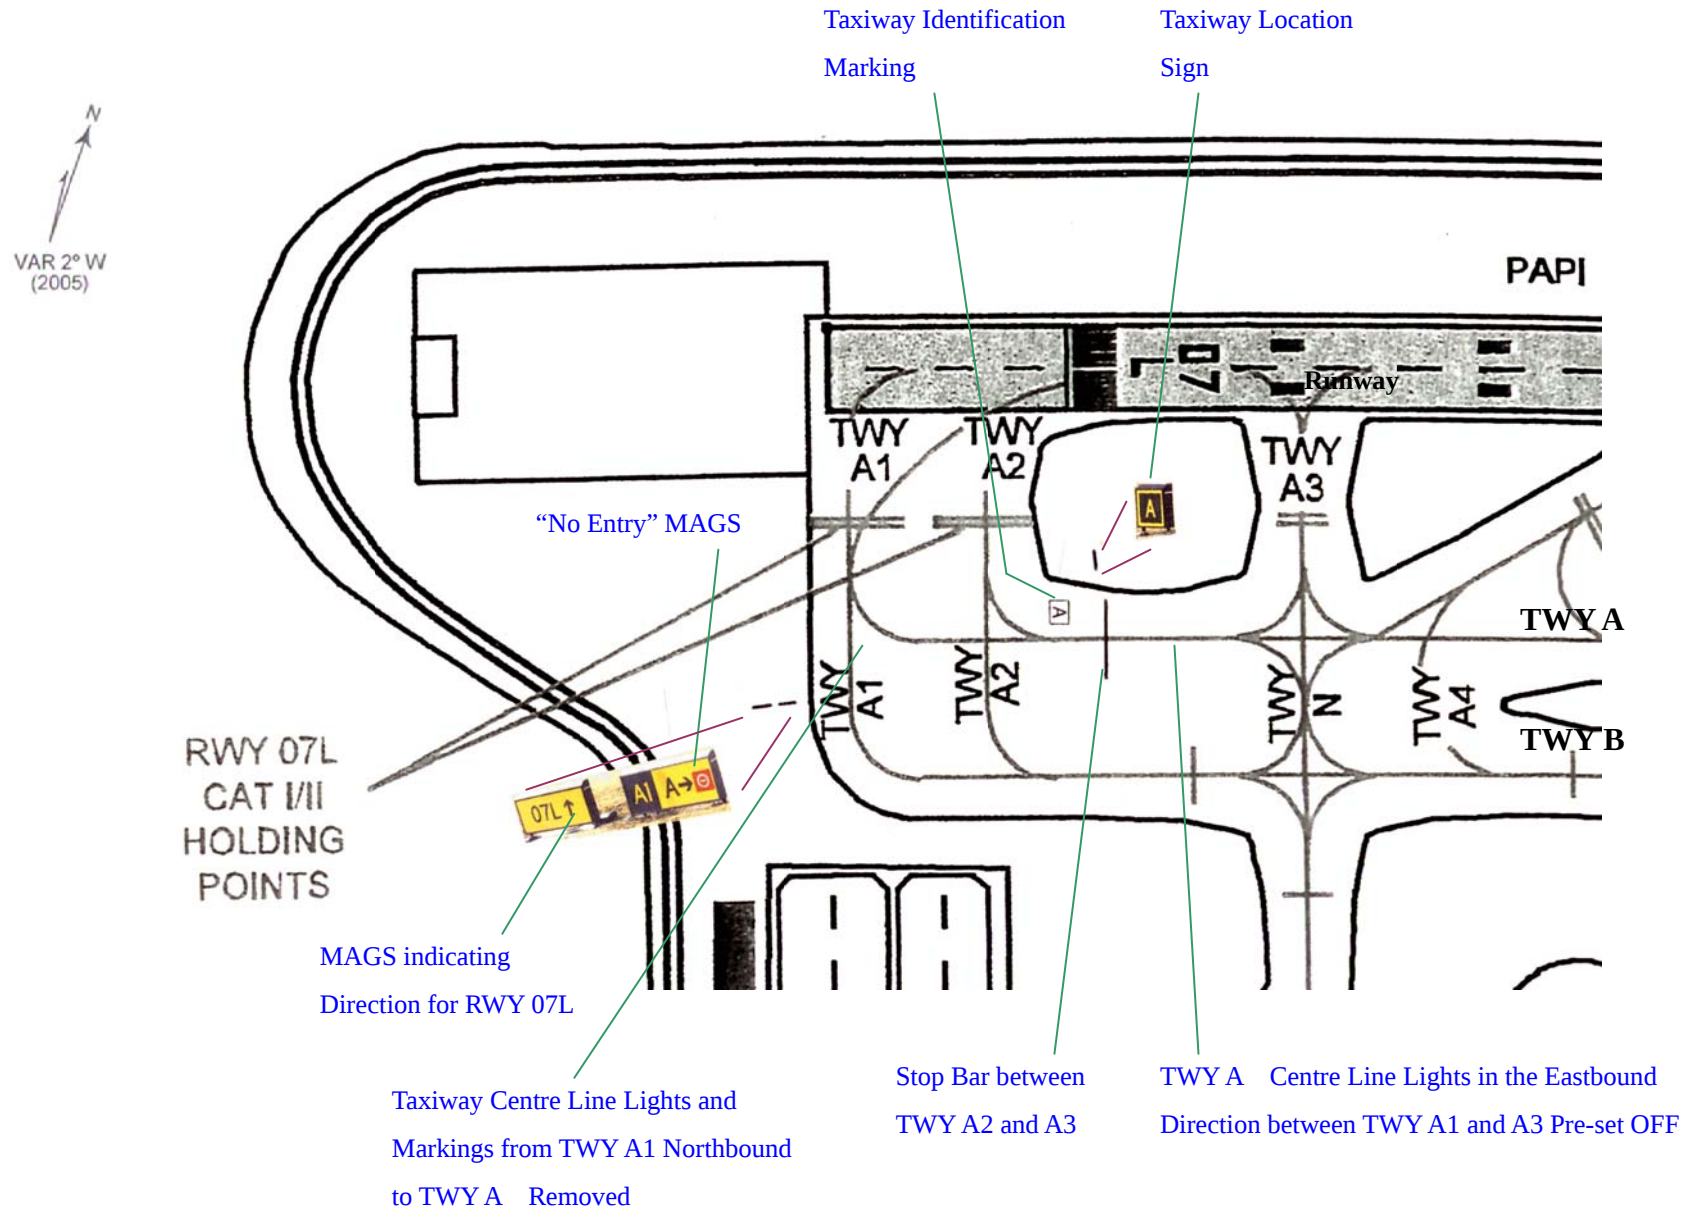
# Improvement to Guidance for Aircraft in the Vicinity of TWY A1, TWY A2 and RWY 07L

- 2.1.4 It was further noted that with a taxiway identification mark on the pavement and a taxiway location sign on the left hand side grass area of the eastbound TWY A between TWY A2 and TWY A3 (See Appendix G), TWY A was well identified. The investigation team had critically reviewed the visual aids on the airfield around TWY A and TWY A1 and were satisfied that they provided adequate visual guidance to pilots and to safeguard against inadvertent entry into TWY A, unless important warning signals were not heeded. Specifically, the right turn from TWY A1 onto TWY A involved manoeuvring onto an initially unlit concrete pavement area, leading to an obvious taxiway with green centreline lights, blue edge lights and a red stop bar across TWY A, instead of a green threshold bar had it been on the runway.

2.12.6 Upon completion of modification works on the AGL, including the installation of stop bar lights on TWY A, and improvement to airfield ground marking and signage in accordance with the recommendations in the investigation report of the 2008 incident, OI62/08 was cancelled on 15 October 2010, just slightly more than a month before this incident. As a prudent measure to prevent recurrence of similar incidents, the Investigation Team recommended soon after the FIN070 incident that the above interim ATC procedure be re-instated. OI 46/10 was accordingly issued on 29 November 2010, requiring the AMC to withhold the take-off clearance for RWY 07L until ascertaining that the departure aircraft has completely crossed TWY A by referring to the A-SMGCS or the SMR.

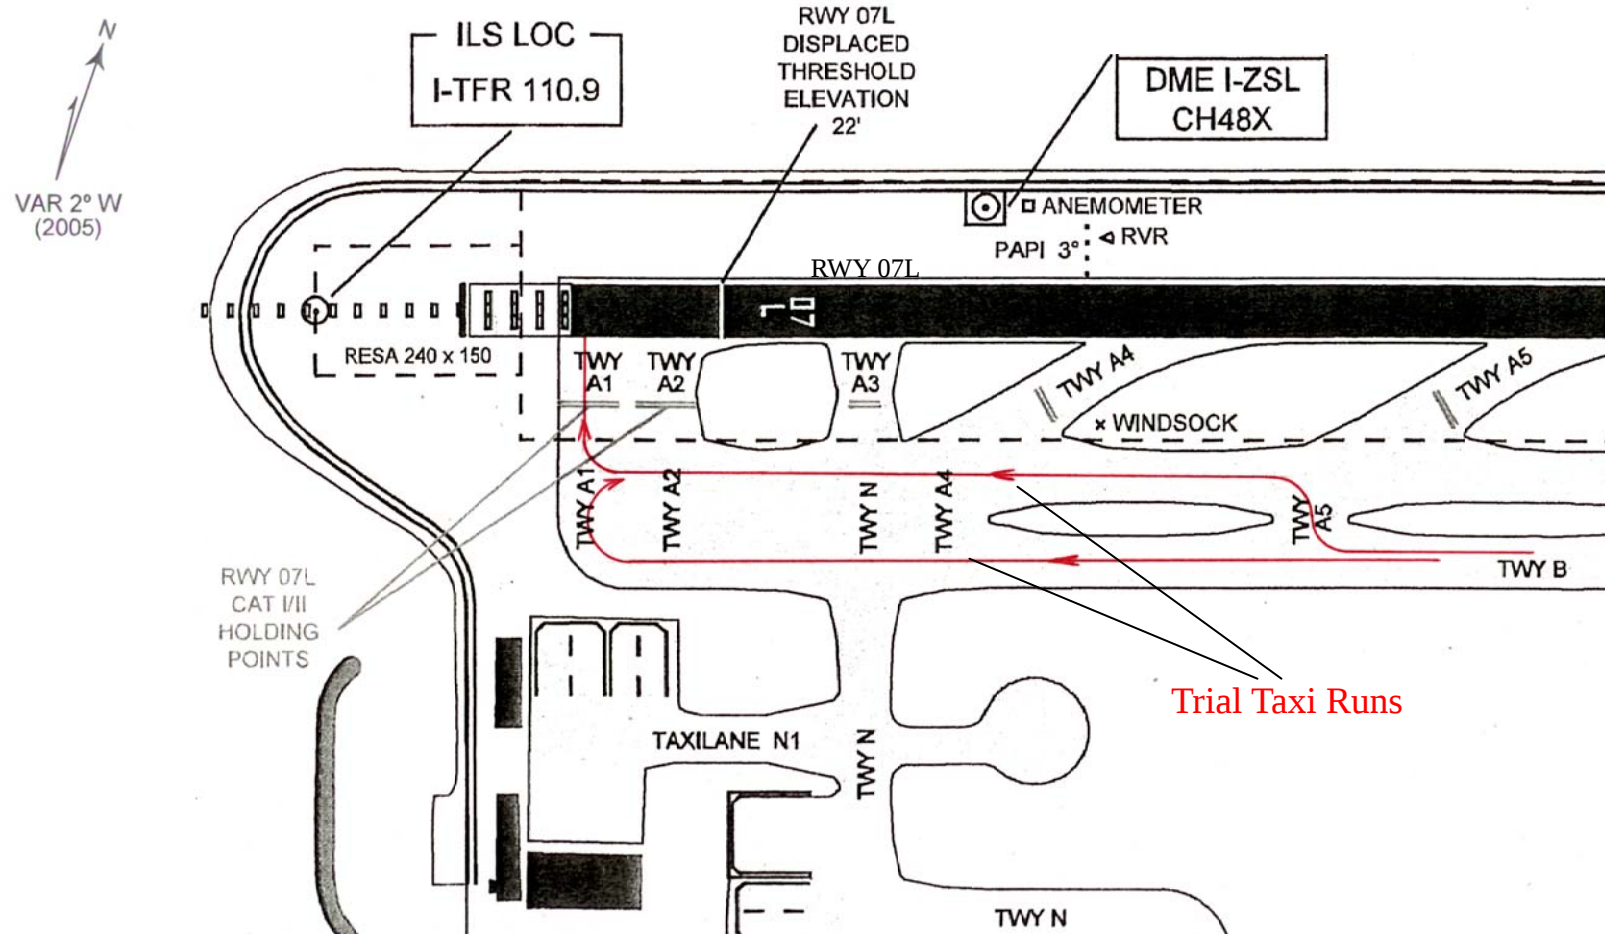
# Trial Taxi Run

- 1.21.1 To better appreciate the runway and lighting conditions as seen from the cockpit on the day of the incident, a series of trial taxi runs were carried out at the HKIA on the evening of 21 December 2010. The weather conditions on the day of the taxi runs were similar to those on the day of the incident. An Airbus A330, which has the same dimension and wheel height as an Airbus A340, was used to assess the visual conditions from the cockpit of FIN070. Also, the cockpit instrument displays on the Airbus A330, including the PFD and ND, are similar to those of an A340.

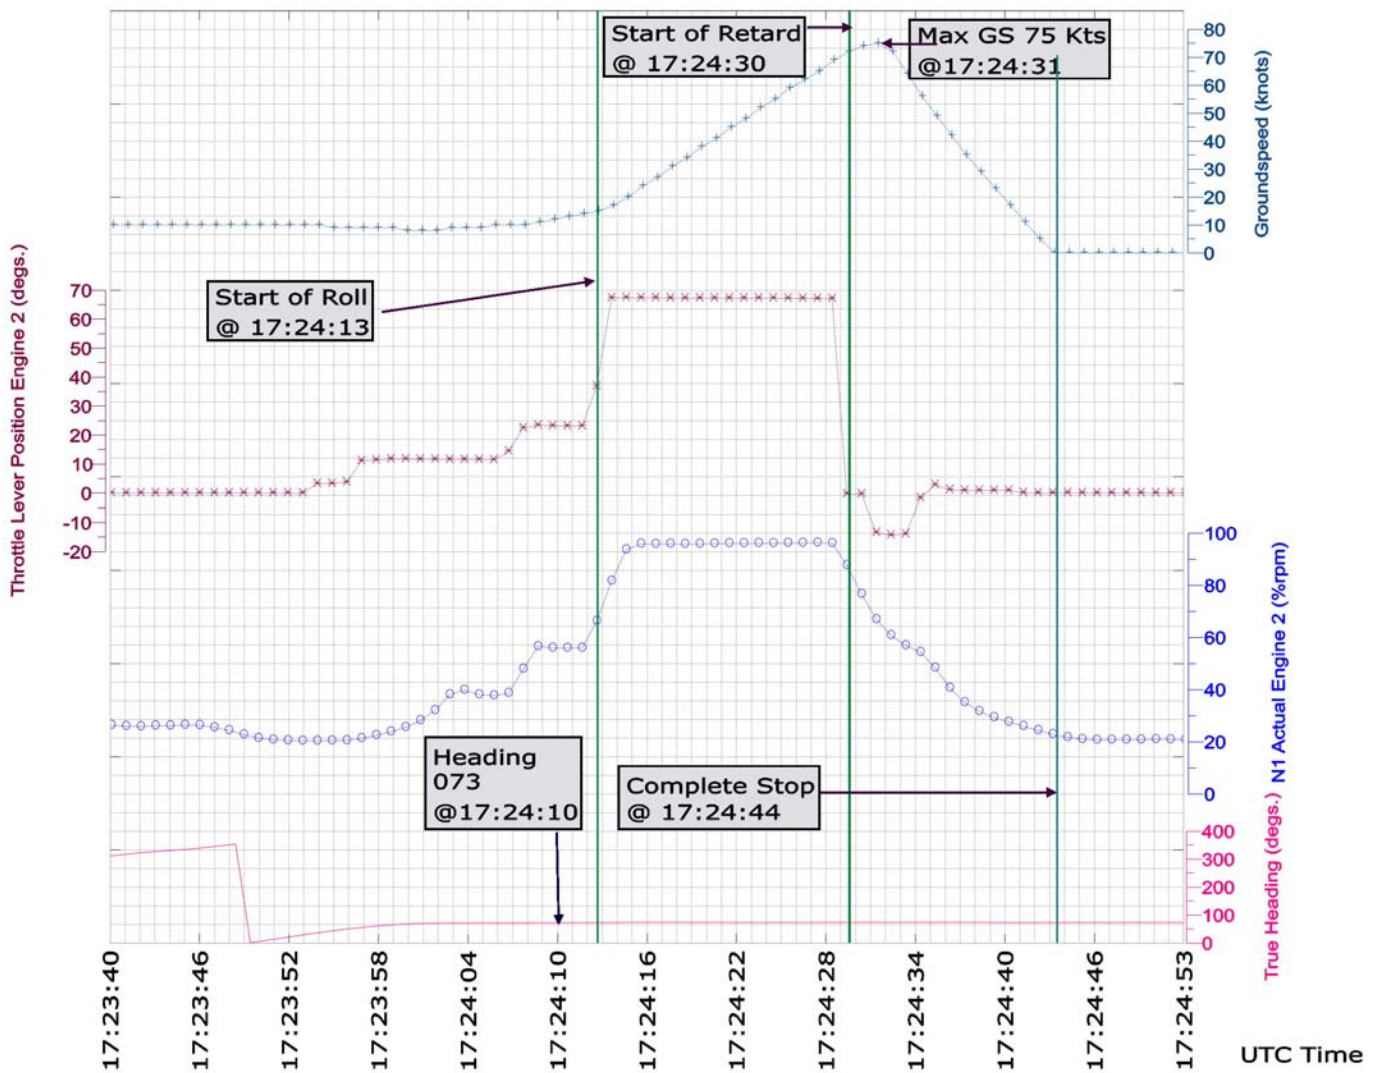
### Engine Control and Aircraft Performance Status During Take-off Phase

2.3.1 According to the DFDR data retrieved, together with the ATC radio transcript, the flight crew obtained the take-off clearance at 1723:14 and started the take-off roll at 1724:13. ATC instructed the flight crew to stop rolling at 1724:24 after the aircraft was found rolling on the taxiway. The crew stopped the take-off roll by moving the engine throttle levers to idle position at 1724:30.
