Investigation report

C11/2010L

A330 Jetliners' Engine Bleed Air System Failures: Serious Incidents on 11 and 22 December 2010

AIRBUS A330-302

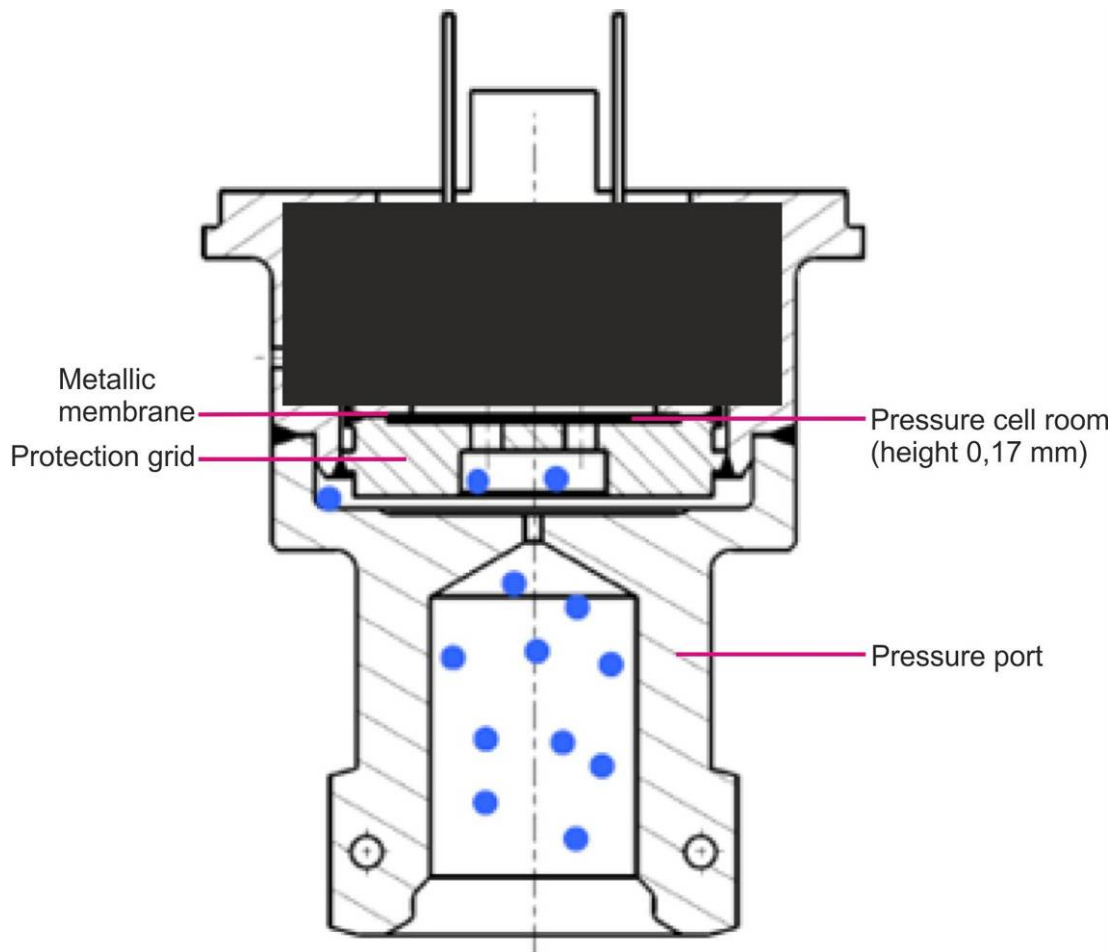
Figure 15. A cross-sectional view of the pressure port and pressure cell room of pressure transducer p/n ZRA380-00. The blue dots represent water droplets. Part of the pressure cell's design is masked on the request of the manufacturer. Source: Esterline-Auxitrol³.

No pressure transducer version prevents the accumulation of moisture inside the pressure cell room. Temperature changes and changes in humidity may cause moisture condensation in bleed air system's sense lines and pressure transducer's pressure ports. Condensed water droplets may travel to the pressure cell room and condensation may also directly occur in that space.

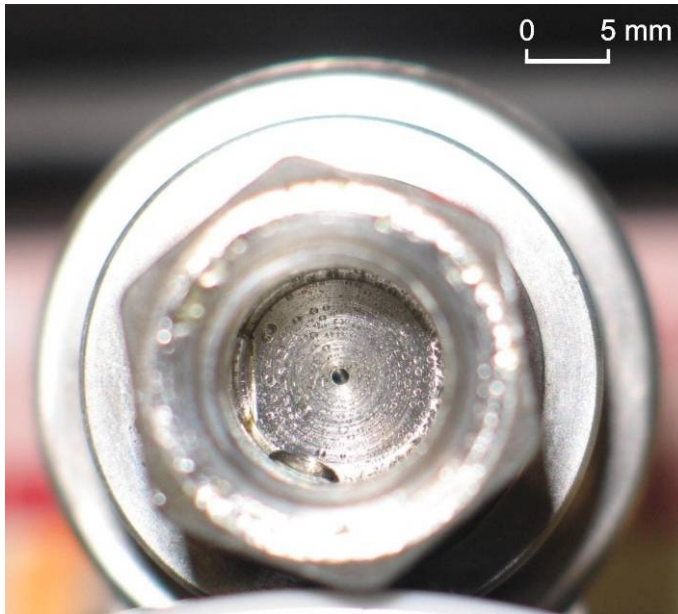
On the next flight, 12 Dec 2010, the flight crew received a transient AIR ENG 1 BLEED FAULT ECAM warning. Upon arrival at Helsinki-Vantaa airport on 13 Dec 2010 both of the left engine's pressure transducers were replaced. Figure 16 shows that the pressure transducer Pr which had been removed contained several water droplets. Pressure transducer Pt was dry. After the transducers had been replaced the engines' bleed air system worked flawlessly during an engine test run.

Figure 16. Pressure transducer Pr that was removed from the left engine's bleed air system on 13 Dec 2010. A large drop of water is visible at seven o'clock inside the pressure port. Source: Finnair Technical Services Ltd.

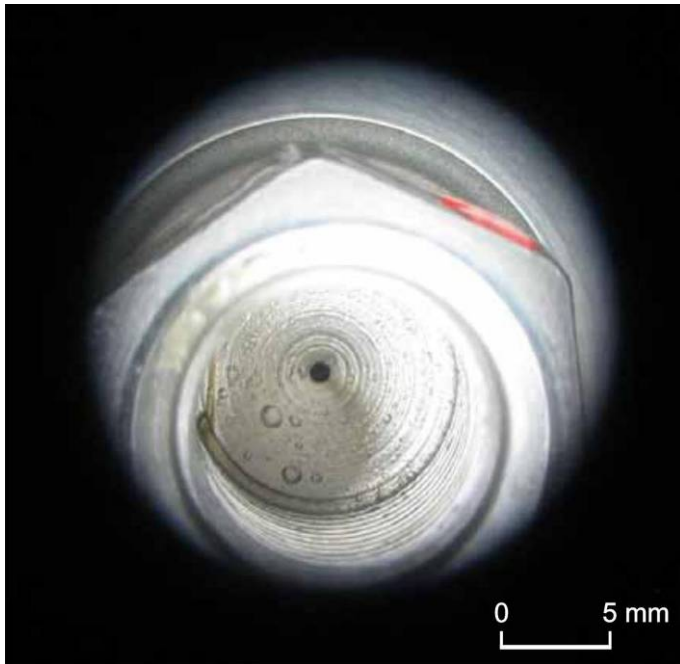
First the pressure transducers were visually inspected. Inspection revealed that the pressure transducers were properly packaged for transportation and that the appropriate cover plugs were installed. All pressure transducers were clean, with no signs of corrosion. Pressure transducer s/n ASA14074 had 'scrap' written in red on it. During the visual inspection a significant amount of water was detected in one of the OH-LTO's transducers, s/n ASA12735 (Fig. 17). This was the very same transducer in which water was discovered at Helsinki-Vantaa airport on 13 Dec 2010 (Fig. 16). Esterline-Auxitrol's visual inspections did not detect any water in the other pressure transducers. Appendix 9 contains photographs of each of the five pressure transducers.

Figure 17. Pressure transducer s/n ASA12735 of OH-LTO. Source: Esterline-Auxitrol⁴.

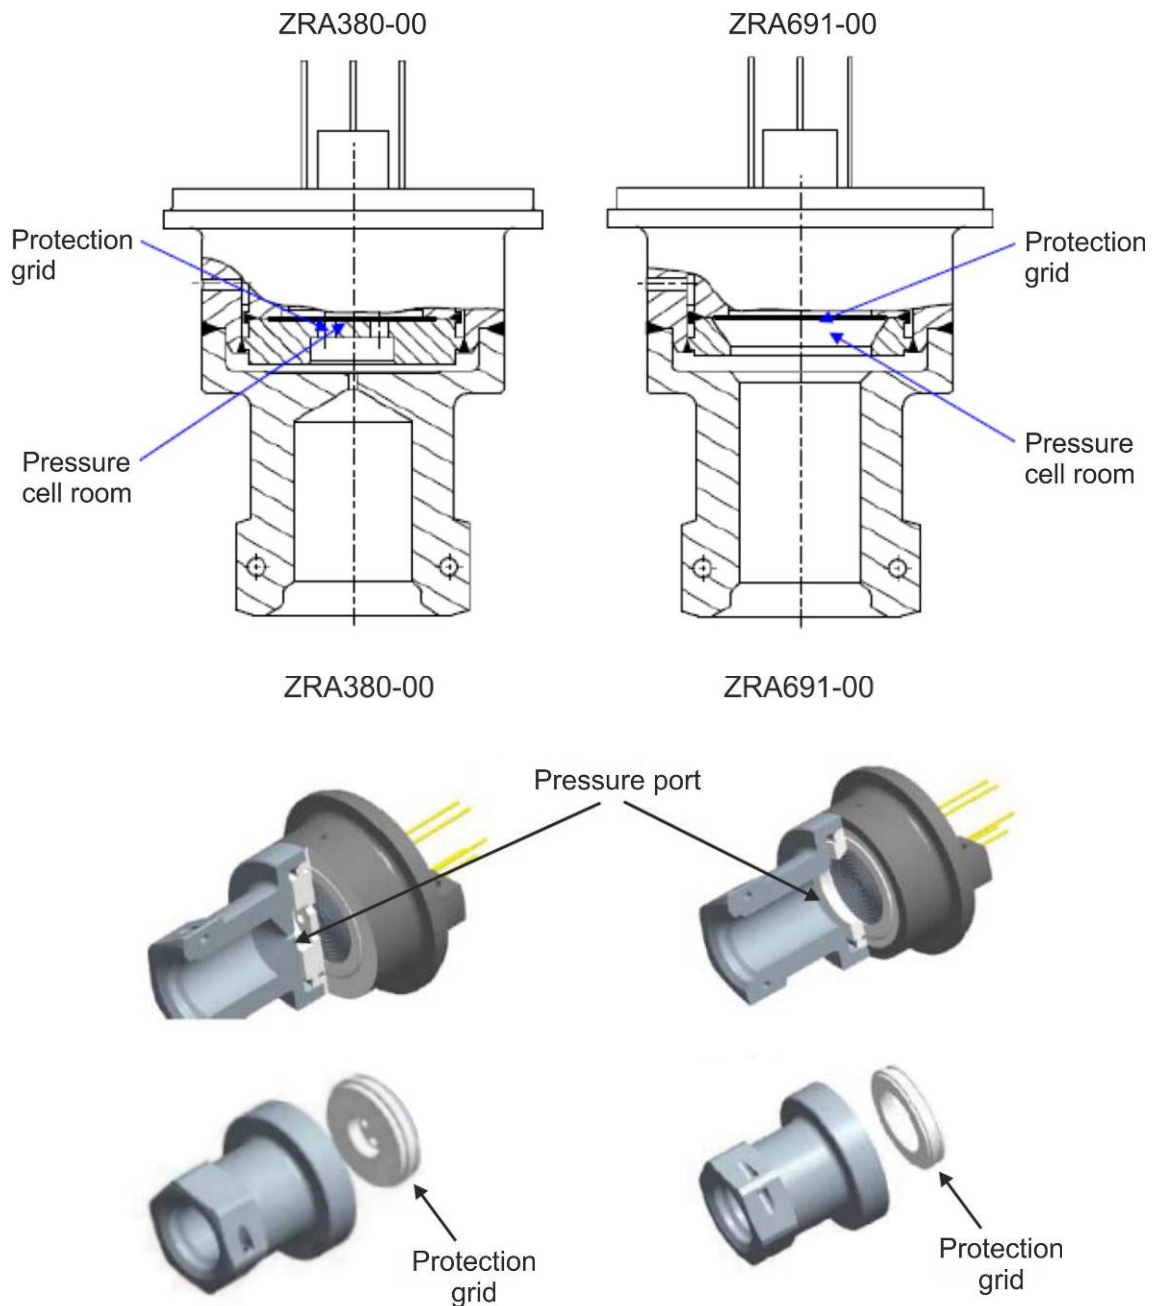
STRUCTURAL DIFFERENCES BETWEEN PRESSURE TRANSDUCERS P/N ZRA380-00 AND ZRA691-00

The third pressure transducer version, p/n ZRA691-00, was designed and manufactured by modifying p/n ZRA380-00, the second version. Their essential differences lie in the protection grid as well as the pressure cell room between the grid and the metallic membrane. In order to avert blockage caused by ice build-up, the four small holes in version no. 2 are no longer present in the third version. They are replaced by one large hole. Whereas the height of the second version's pressure cell room is 0.17 mm, it is 5.2 mm in the third version.

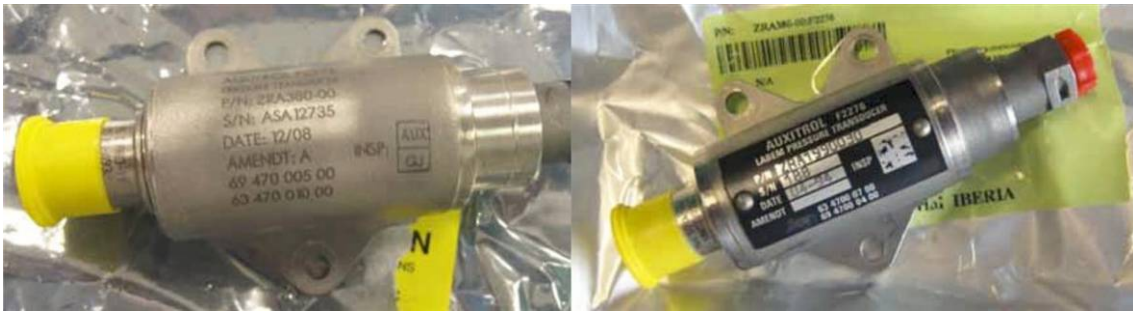
Pressure transducers removed from OH-LTO's left engine; s/n ASA12735 on the left and s/n 188 on the right.

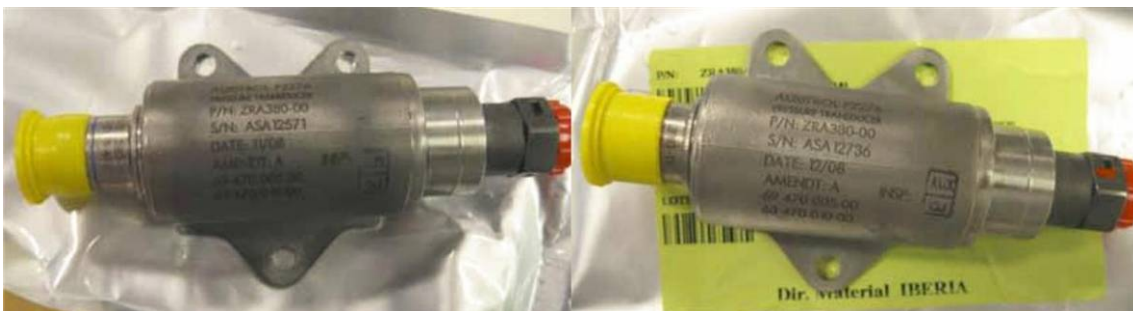
Pressure transducers removed from OH-LTO's right engine; s/n ASA12571 on the left and s/n ASA12736 on the right.

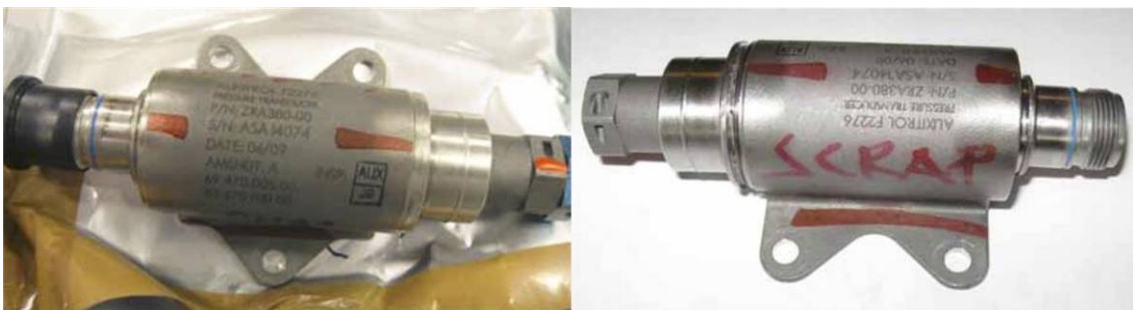
When the aircraft arrived at Helsinki-Vantaa airport on 22 Dec 2010 each of the four pressure transducers were replaced. Moisture condensation was detected in the transducers of the left engine. No moisture was discovered in the sense lines leading to the pressure transducers. The right engine's transducers were dry. No water was discovered in the sense line leading to the Pr. On the other hand, there was water in the sense line leading to the Pt.

Pressure transducer s/n ASA14074 removed from OH-LTS's left engine.
