## Investigation report

C12/2010L

# In-flight Upset of a Business Jet in the Moscow Terminal Control Area on 23 December 2010

Bombardier BD-100-1A10 Challenger 300

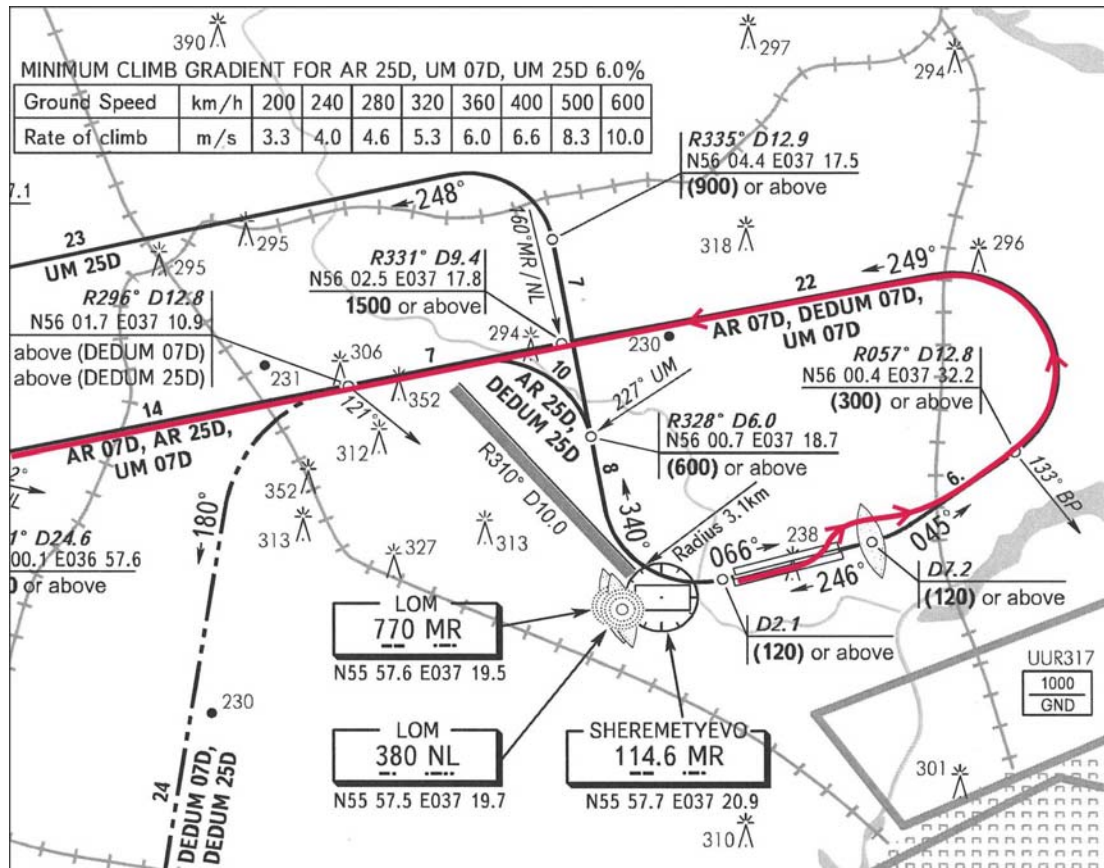
Figure 2. Moscow Sheremetyevo Standard Instrument Departure BUZHAROVO 07 DELTA (AR 07D) and the estimated track of the aircraft (red line). Source: (AIP of the Russian Federation).

As the flight crew were rolling out from the turn they engaged the autopilot (AP). At that moment, the aircraft's vertical climb rate was still approximately 2800 ft/min (ca. 14 m/s) and the altitude was approximately 2600 ft (ca. 800 m) above ground level. The FD was already in the altitude capture mode for level-off guidance to the preselect altitude of 2960 ft (900 m) above ground level. Immediately after the AP was engaged, the Master Caution (MC) annunciated a caution. This was caused by the EICAS system indicating that the horizontal stabilizer trim system was unable to trim the stabilizer as commanded by the AP (AP STAB TRIM FAIL). The flight crew reset the MC by pressing its switch/light.

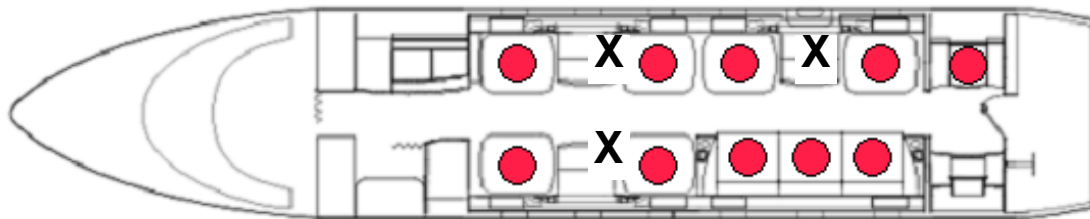
Two of the passengers were seated in the second row, facing forward. They were lifted up out of their seats during the accident. The passenger on the left seat broke the right hand armrest of the seat as a result of falling down back into the seat. These two passengers suffered only minor injuries. The passenger, who was seated in the right hand (RH) seat of the last row, also facing forward, was thrown higher up out of their seat and, deduced from the stains and scratches on the cabin ceiling, possibly hit the ceiling during the accident. Upon falling back down into their seat, the passenger hit their upper torso on the seat and consequently sustained several fractured ribs. None of the passengers had their seat belt fastened during the accident.

Figure 3. Seating arrangement in the cabin. The seats marked with an X denote seated passengers.
