## Investigation report

C5/2010L

### **Serious incident at Helsinki-Vantaa Airport on 12 June 2010**

AVRO 146-RJ85

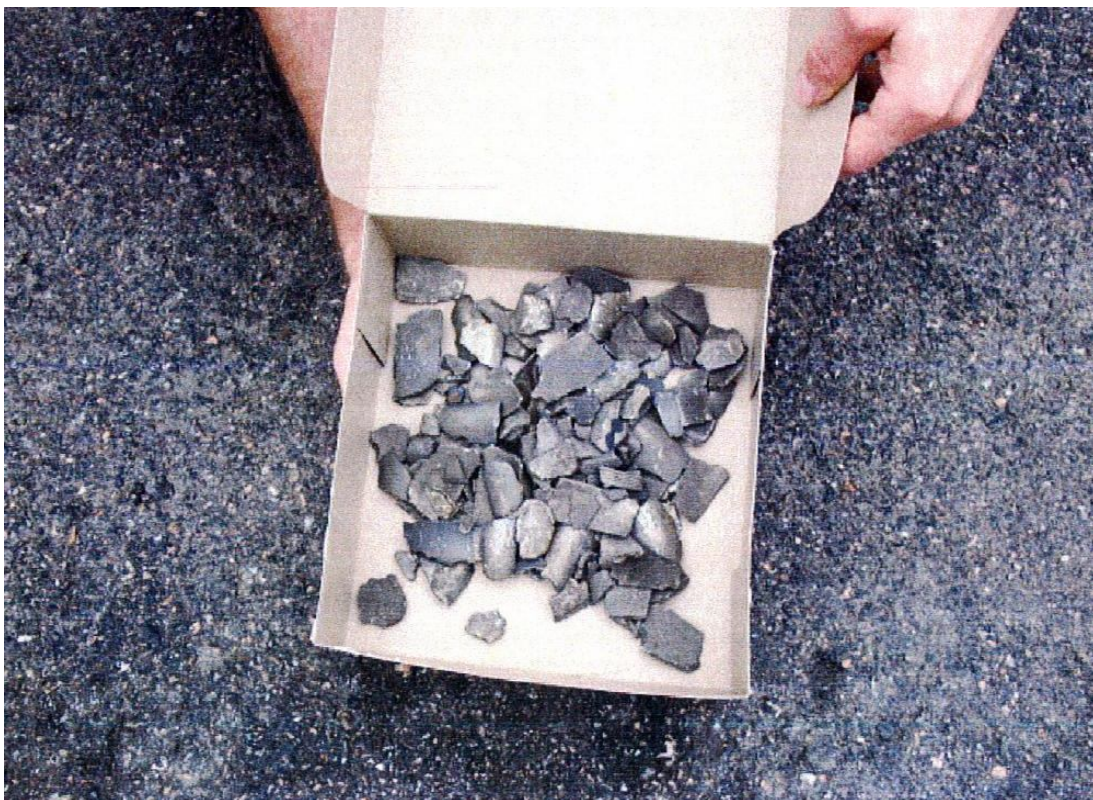
At 04:07, the pilot-in-command of BLF639 informed the aerodrome control tower that pieces were missing from the damaged engine. The tower controller requested a new runway inspection at 04:12. The same vehicle (Haukka1) as earlier was sent for the inspection task, but the airport maintenance shift supervisor joined in the inspection on his own initiative, using another vehicle (Kunto2). Some 50 pieces of the damaged engine, sized 2–40 mm, were found on the runway. First pieces were found about 5 metres left of the runway centerline, while most parts were located about 15 metres left of centerline and some were outside the runway. Longitudinally, the pieces were scattered over a distance of 400 metres. Some pieces had burnt into the runway surface, but could be removed by hand. Since the pieces were very small and of the same colour as the pavement, they could be best detected in a walking inspection. Runway 22R was closed to make sure that it was obstacle-free. The area between intersections WD and WS was thoroughly swept and inspected. In addition, intersection WP, taxiway S and the crossing point of runway 04R were cleaned by sweeping. The sweeping was delayed because of LVP inspections. From the point of view of airport maintenance, the runway was available for traffic again at 07:35.

Figure 4. Pieces of engine found by the airport maintenance unit on runway 22R. The runway surface is shown in the background.

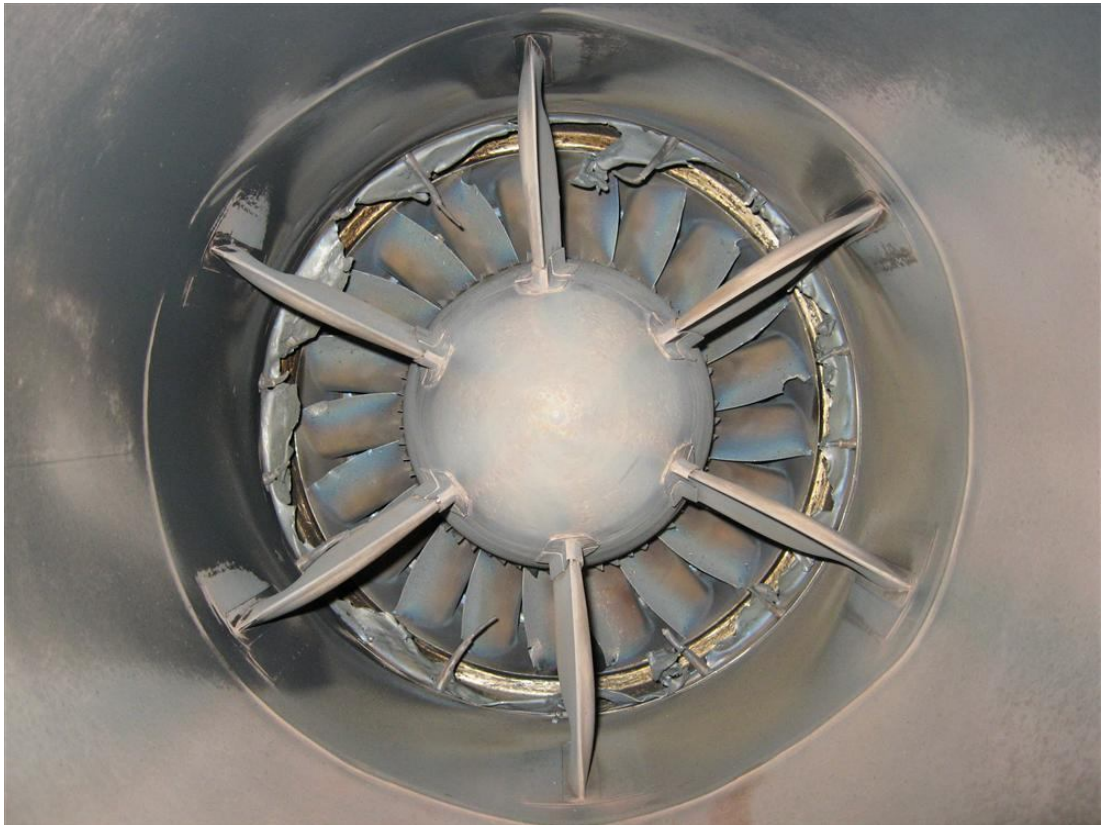
The examination of the damaged engine started at Blue1 Technical Operations with a visual inspection on the day of the incident. The first observation was that there were no signs of a bird strike or other foreign object damage. The compressor area was intact, but the turbine was jammed and could not be moved at all. Chips were found in the bearings. Damage to the engine hot section was extensive.

Figure 5. The damaged engine no. 1 pictured from behind after the incident.

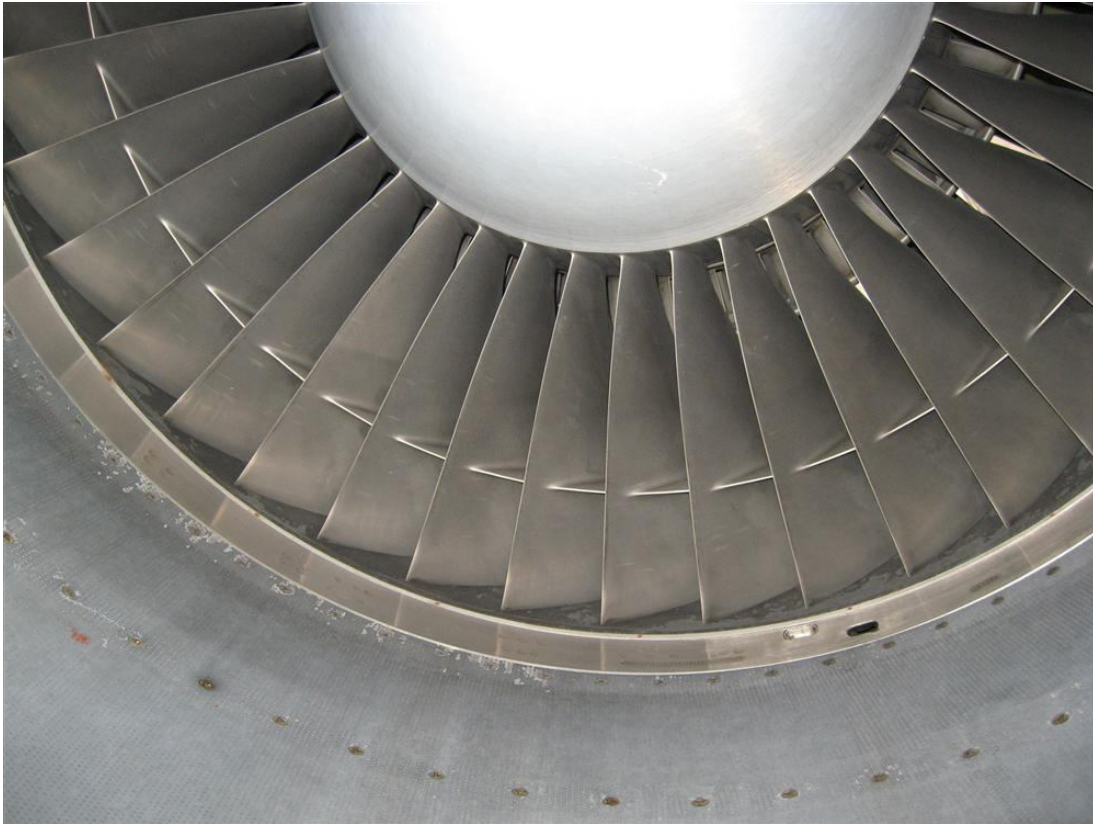
Figure 6. The damaged engine no. 1 pictured from the front after the incident.

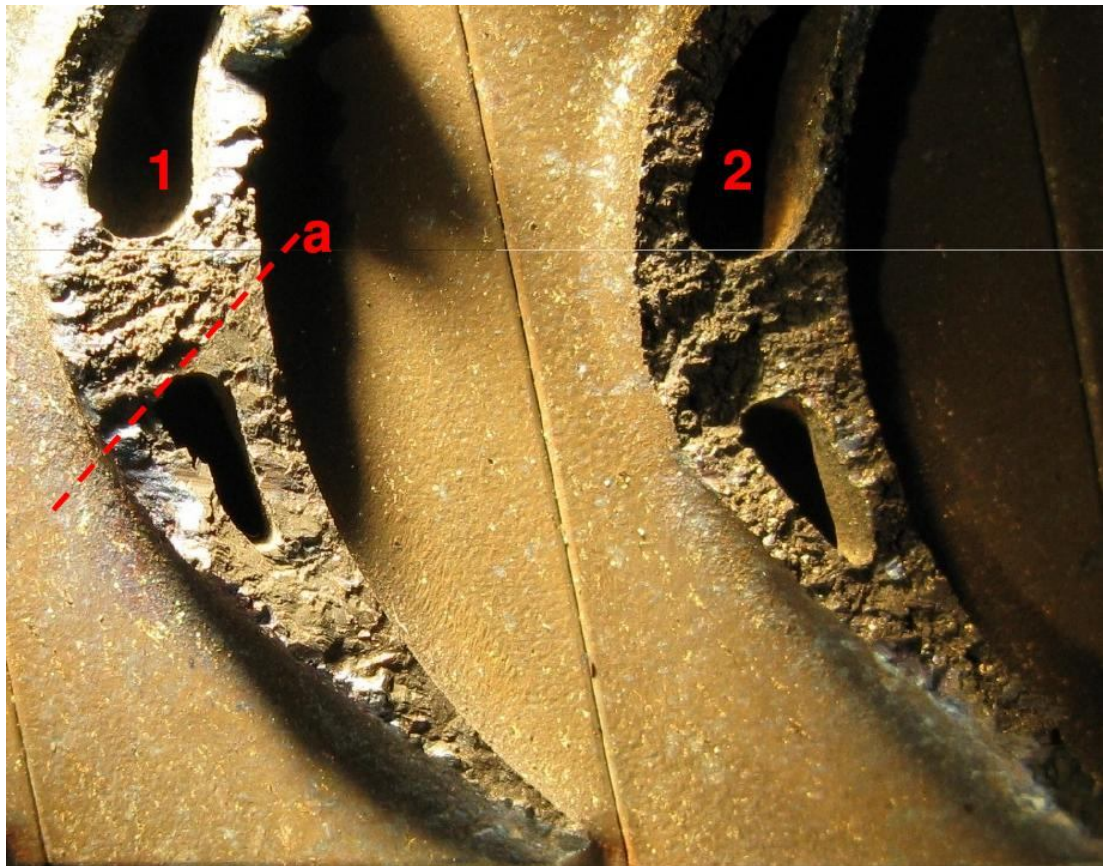
The second-stage turbine blade, which had suffered a fatigue fracture, caused massive overload damage in the third and fourth stage and also damaged bearing no. 4. In the hot section of the engine, a large carbon stain was noted on the combustion chamber liner suggesting the engine had operated with an abnormal fuel manifold spray pattern. The abnormal spray pattern was probably caused by carbon residue in the nozzle.

Figure 7. On the left, a turbine blade (1) where the fatigue fracture can be seen as a smoother area up to line (a). Compare with the other blade (2) on the right with an overload fracture surface across the entire root.

14. In a later inspection, it was concluded that the engine damage had resulted from a fracture in the root of a second-stage turbine rotor blade.
15. The rotor blade fracture was probably caused by overheat in the engine although other causes could not be excluded. The fracture could not be predicted on the basis of current engine condition monitoring procedures, which showed no difference between the damaged engine and the other engines.

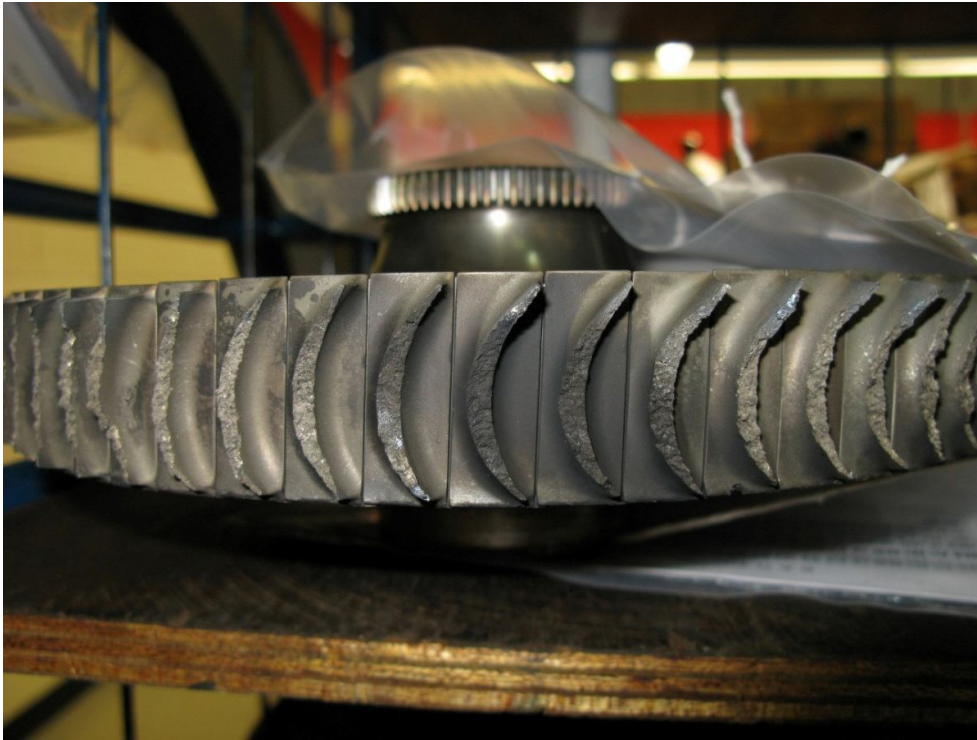
Figure 8. Fracture of all blades caused by overload in the third stage of the turbine.

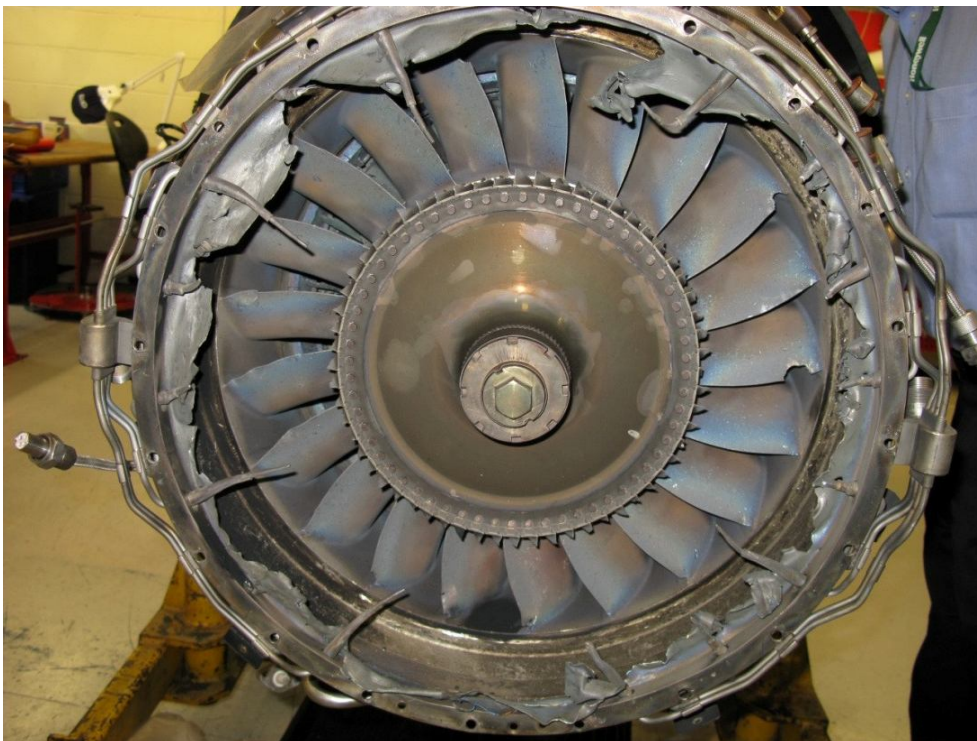
Figure 9. Damage in the fourth stage of the LP turbine was caused by the detachment of the turbine blades. The LPT4 turbine blade shroud was damaged, and the containment flange was melted but complete. The EGT probes were severely distorted.
