Investigation report

C7/2010L

Airliner fuel system malfunction: incident during an approach to Helsinki-Vantaa aerodrome on 5 July 2010

OH-ATK (FCM256K)

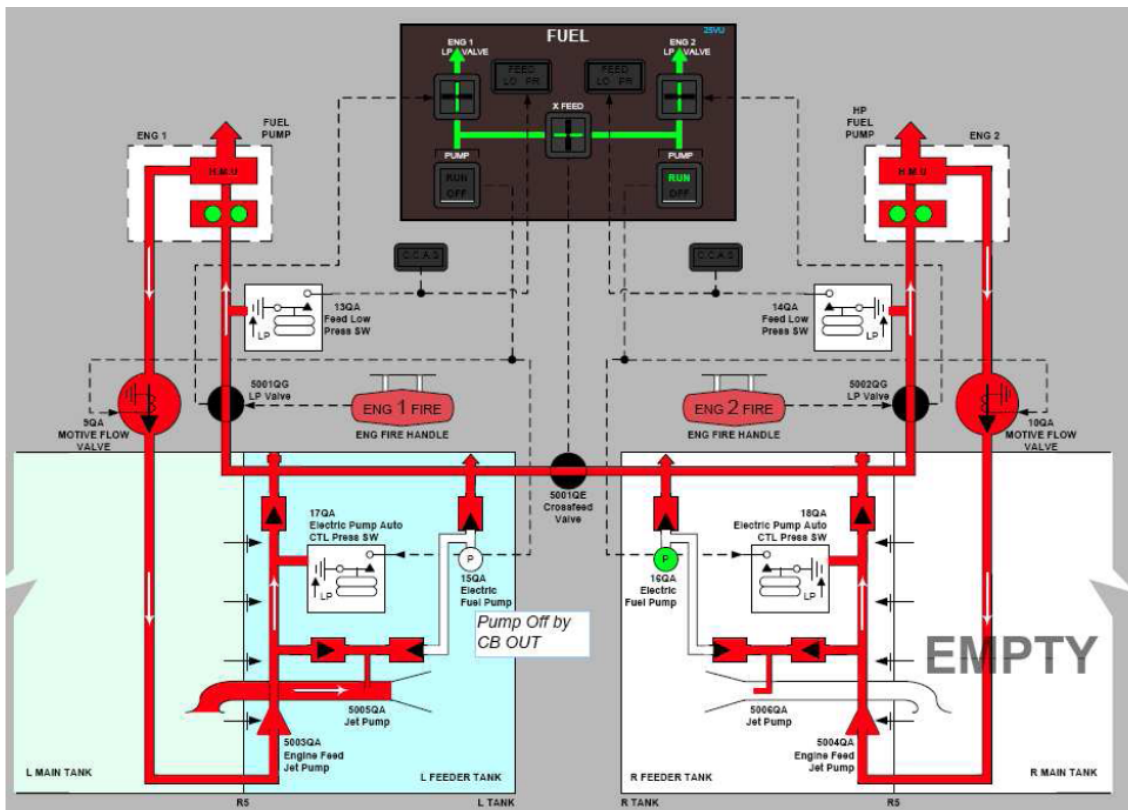
Annex 2. Fuel system diagram if tank 2 is empty

The investigation also established whether both engines would have flamed out if the right main tank had emptied. According to the aircraft manufacturer's (ATR) comments, in such a case the left main tank would have continued to supply fuel to both engines and they would not have flamed out.
