## Investigation report

D1/2010L

# Business Jet Dual Engine Flameout During Taxiing at Helsinki-Vantaa Airport on 6 March, 2010

BOMBARDIER LEARJET 60

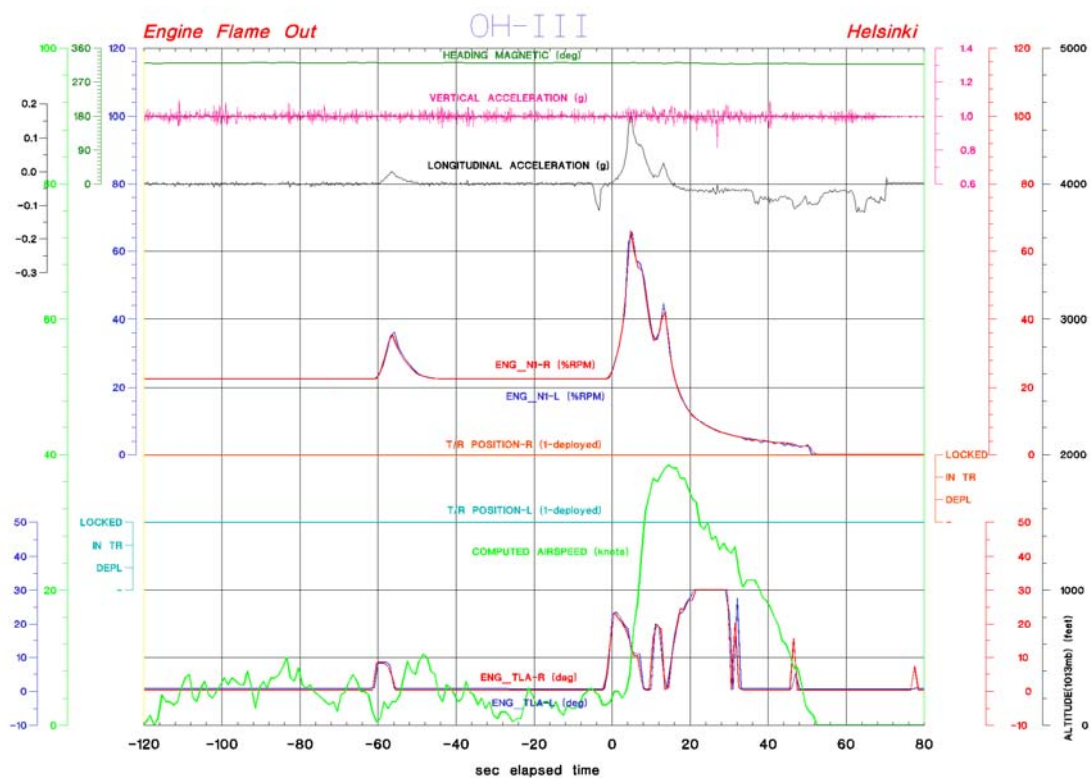
Since the FDR parameters precisely indicated the throttle lever movements including their timing prior to the flameout event, an accurate re-enactment was arranged at the behest of an SIAF investigator. On the second attempt the left engine flamed out, generating the same 'QF' fault code as it did during the actual occurrence. After a few additional attempts they also achieved a right engine flameout.

Figure 1. An FDR printout of the occurrence, produced by the German Federal Bureau of Aircraft Accident Investigation (Bundesstelle für Flugunfalluntersuchung BFU).
