## Investigation report

D7/2010L

# Accident during landing practice at Helsinki-Malmi aerodrome on 12 August 2010

OH-NTL

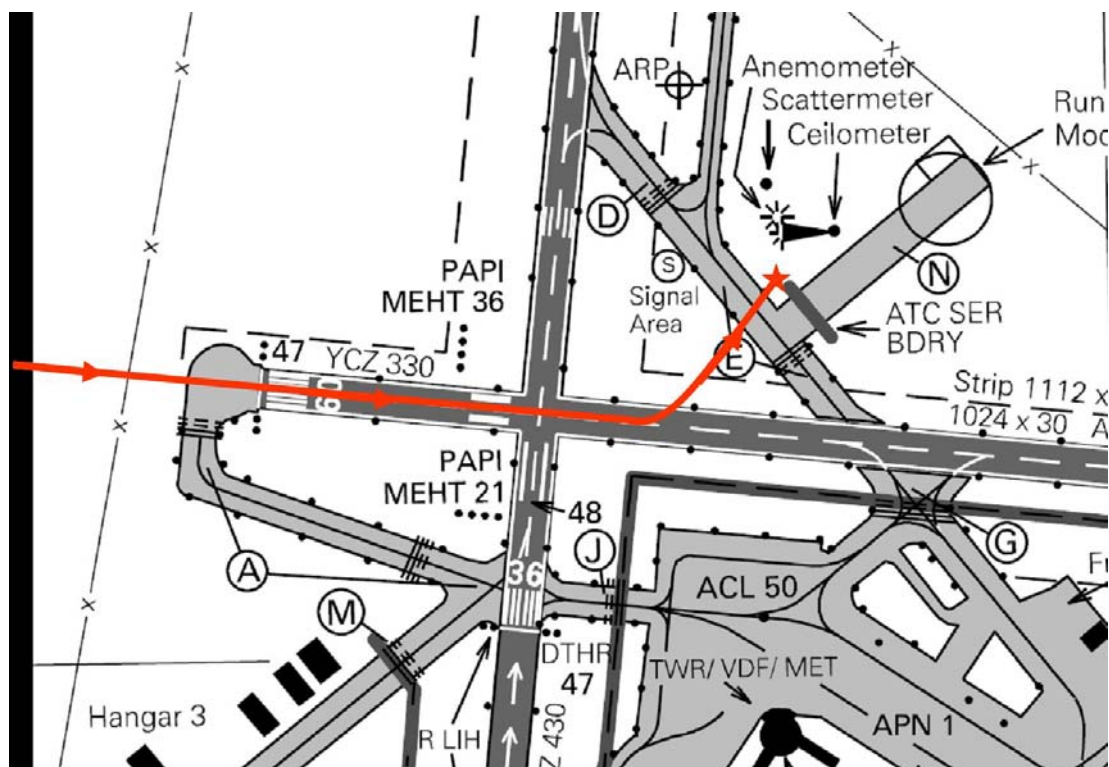
Figure 1. The site of the accident and the aircraft's estimated track during the final phase of the flight. © Finavia Corporation, permission L7027/07

10. The student pilot had inadvertently selected zero flaps instead of middle flaps (15°). This resulted in a higher stalling airspeed.
11. Once the aircraft cleared the ground effect at the approximate height of 10 metres it stalled and collided with the ground approximately 120 metres left of the runway.

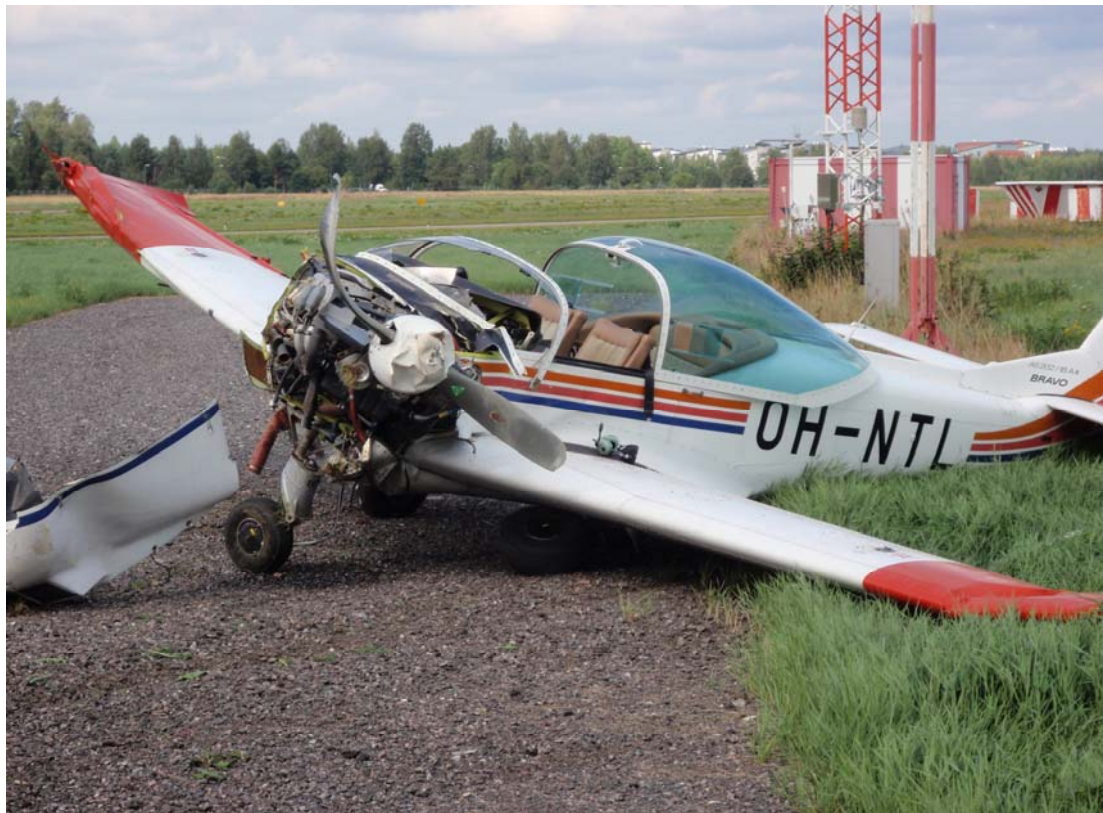
Figure 2. The aircraft after the accident.

12. The aircraft skidded on the ground, tail first, for 20–30 metres. However, it stayed upright.
13. The aircraft was damaged beyond repair.
14. There were no injuries to persons.
