Investigation report

D8/2010L

Risk of collision in Pori Terminal Control Area on 23 August 2010

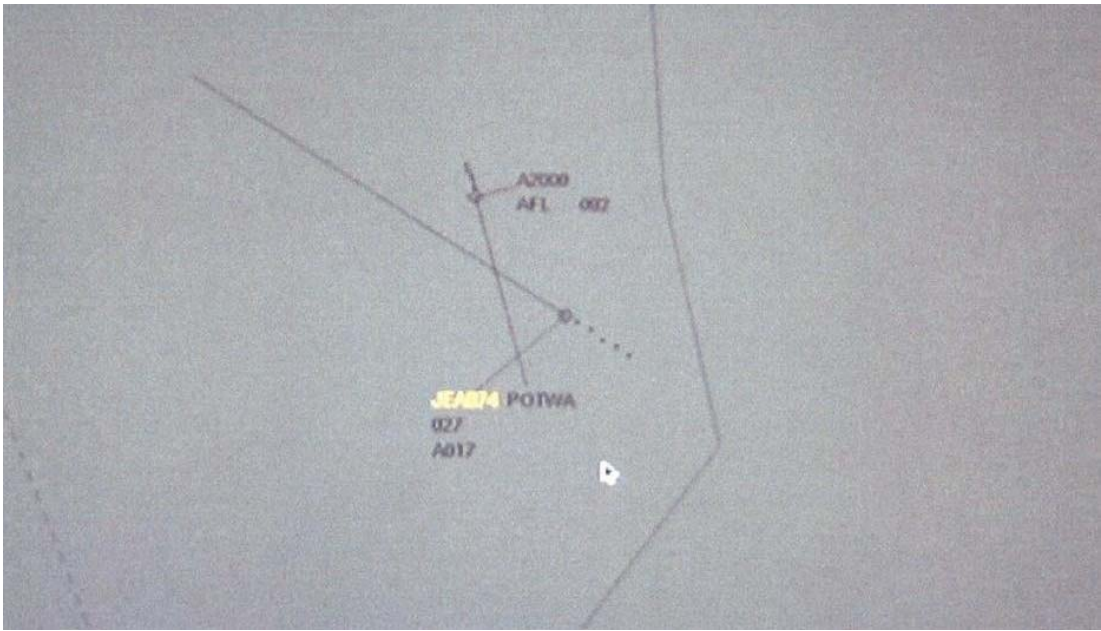
Figure 1. Positions of the aircraft before passing according to the radar recording. (JEA874's altitude 2700 feet).

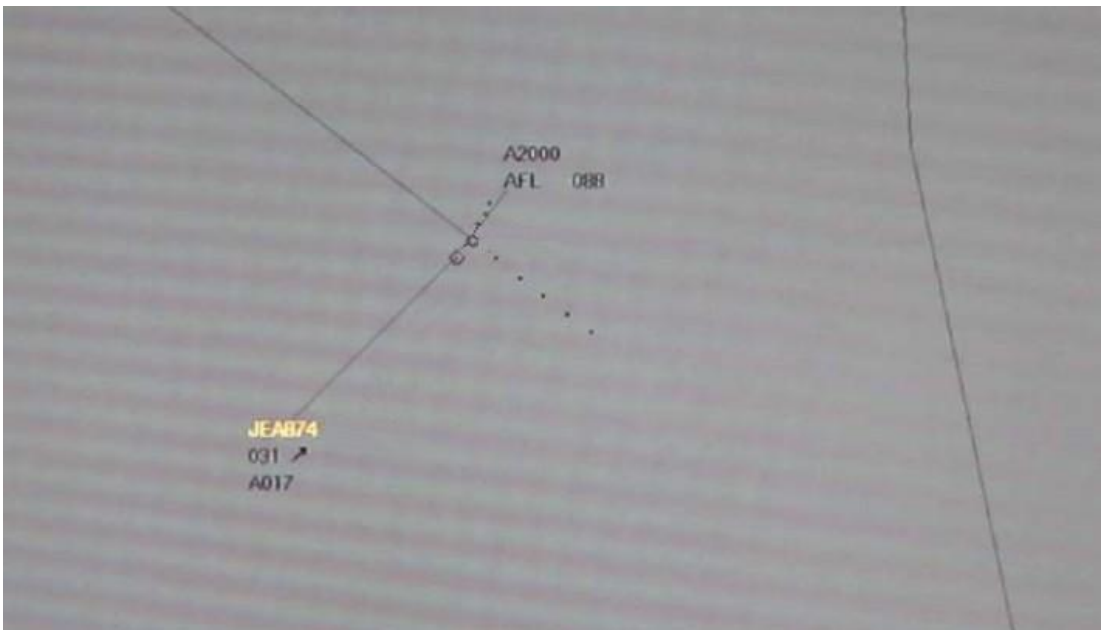
Based on radar and radiotelephony recordings, the vertical distance between the aircraft at the time of passing was about 400 feet (120 m) and the shortest horizontal distance about 0.2 NM (370 m).

Figure 2. Closest distance between the aircraft according to the radar recording. (JEA874's altitude 3100 feet).

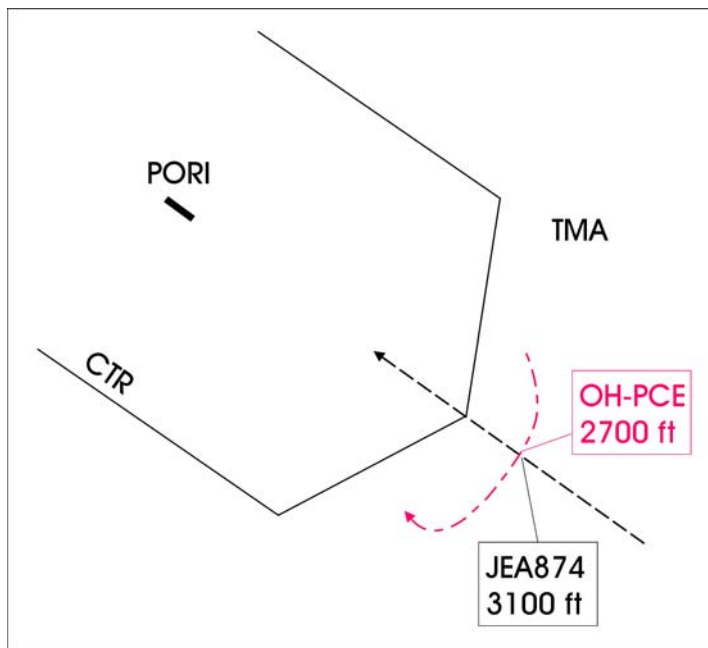
The incident occurred in Pori TMA, at a distance of about 17 NM from runway 30 threshold at an altitude of about 2800 feet. The lower limit of the Control Zone (CTR) is ground surface and the upper limit is 1100 feet MSL. The lower limit of the TMA is 1100 feet MSL and the upper limit FL95. Both the CTR and the TMA are controlled airspace in class D. In class D airspace, an air traffic control clearance and continuous two-way radio communication with the appropriate ATS unit are required. In class D airspace, IFR and VFR flights are not separated from each other, but traffic information is provided and traffic avoidance advice given on request. IFR flights are separated from other IFR flights.

Figure 5. Tracks and altitudes of the aircraft at the time of passing.
