Investigation report

B1/2011L

Collision between two sailplanes in Hattula on 12 June 2011

OH-920 (competition sign YX)
OH-983 (competition sign BO)

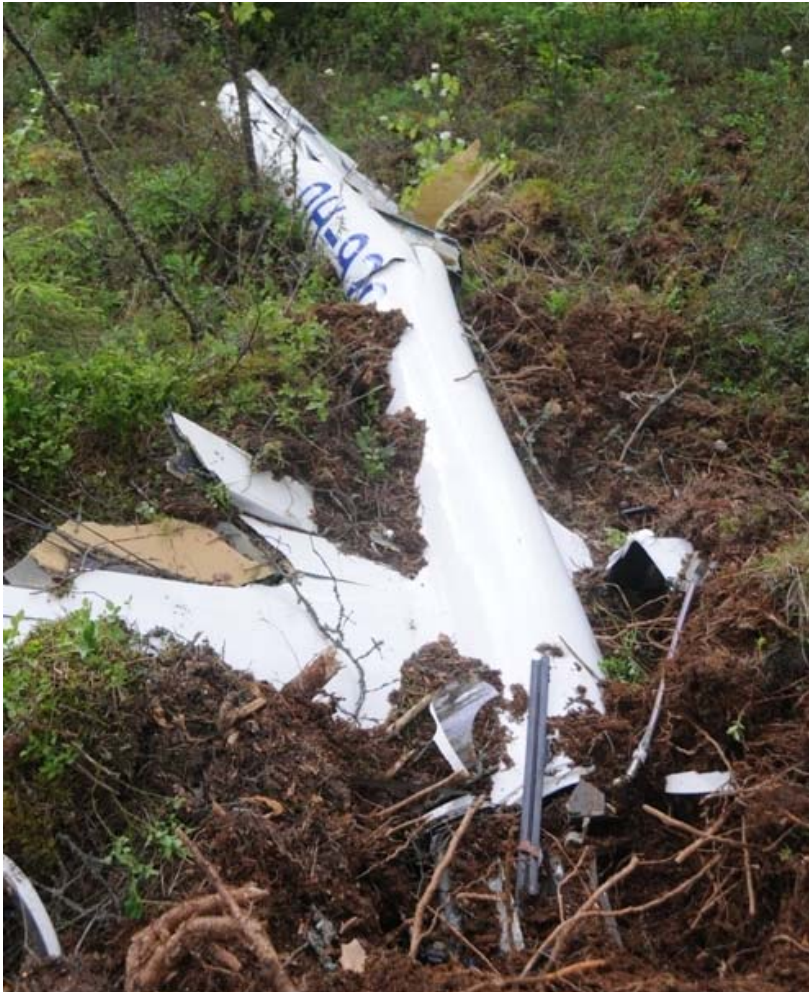
Both wings and fuselage of YX had broken off in the air as a result of the collision. The canopy was also shattered. On ground impact, the front part of the fuselage had cracked and bent to the right. The seat belts were unfastened and intact. The canopy frame was in place. Small pieces of canopy plexiglass and a ventilation hatch were found beside the fuselage. The rear fuselage remained attached to the front fuselage only by cables and push rods. Wing roots were still attached to the fuselage.

The wings were found at about 150–200 m from the fuselage. Some wing skin plates were found at a distance of about 800 m. Pieces of horizontal stabiliser were found in two different places about 200–300 m from the fuselage. Large pieces of canopy plexiglass were found near the pieces of BO's canopy, at about 500 m from the fuselage of YX.

Figure 1. YX in boggy terrain.

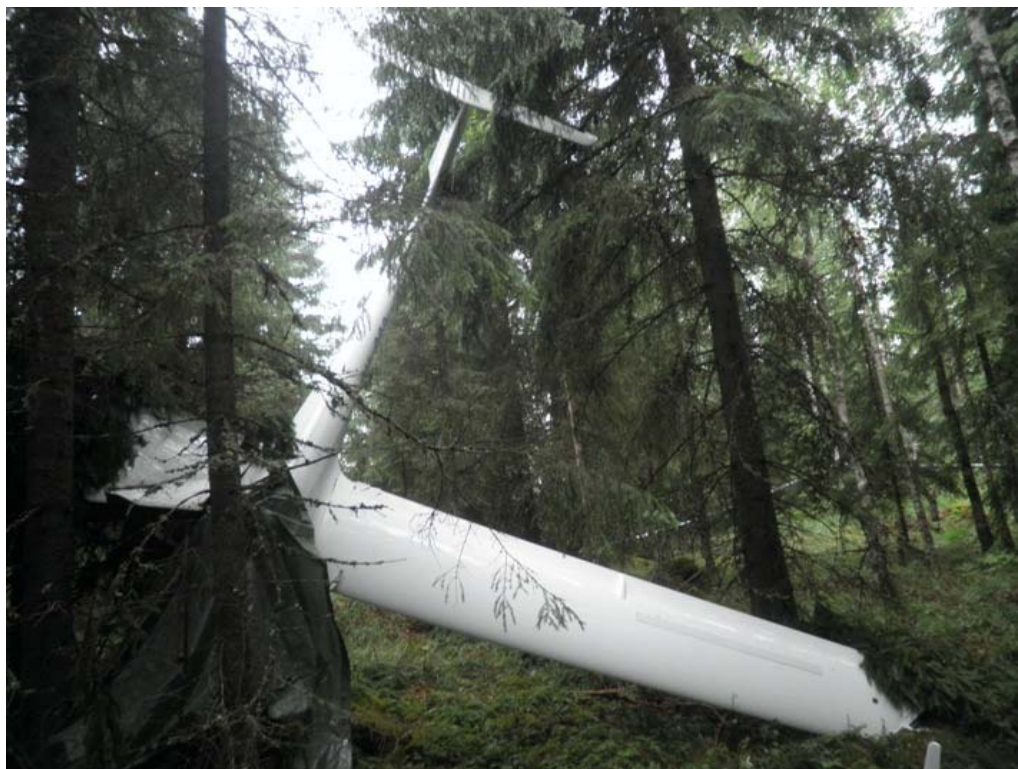
BO had crashed into a forest where the terrain was hard. The right wing had been wedged between two trees, so that the plane was in an almost vertical position with the nose and left wing towards the ground. The left wing had broken off on ground impact at a distance of about 2 m from the wing tip. All parts were left in the wreckage, except for the plexiglass of the canopy. The plane was disassembled at the accident site and transported to Konekorhonen Ltd's repair shop hangar at Hyvinkää for further investigation.

Figure 2. BO on the crash site in a forest.

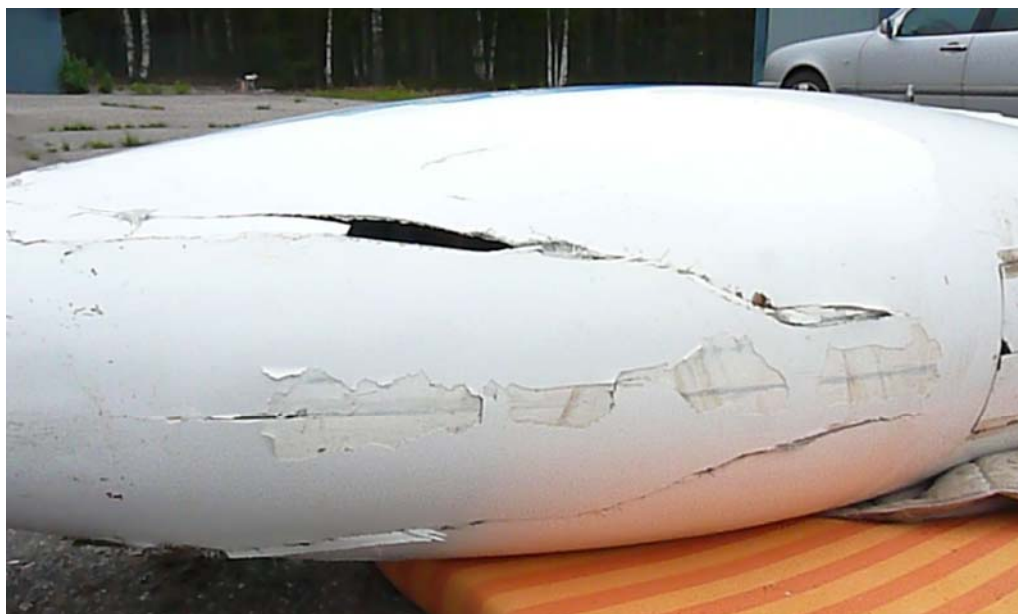
The lower side of the fuselage nose section had cracked in a large area. The plexiglass of the canopy had shattered on impact, but the canopy frame was in place. The rear part of the fuselage was intact. The engine was in its place inside the fuselage and undamaged. When testing the elevator control, the investigators found that the rearward movement of the control stick was limited. With the stick in the full aft position, the elevator remained slightly below the neutral position.

The flight control system of BO was checked. The control stick was found attached to a metal tube located between two arches, which were made of 10 mm plywood and covered with glass fibre material. The frontmost of the arches had broken. This had allowed

the front part of the metal tube to be pushed up, which restricted the control stick movement. The crack was partly caused by the battery which was located under the arch. The effect of the forceful impact at the bottom of the fuselage, right where the battery was located, was conveyed by the battery further to the plywood arch, thus breaking it.

Figure 3. The bottom of BO's front fuselage, damaged in the collision.

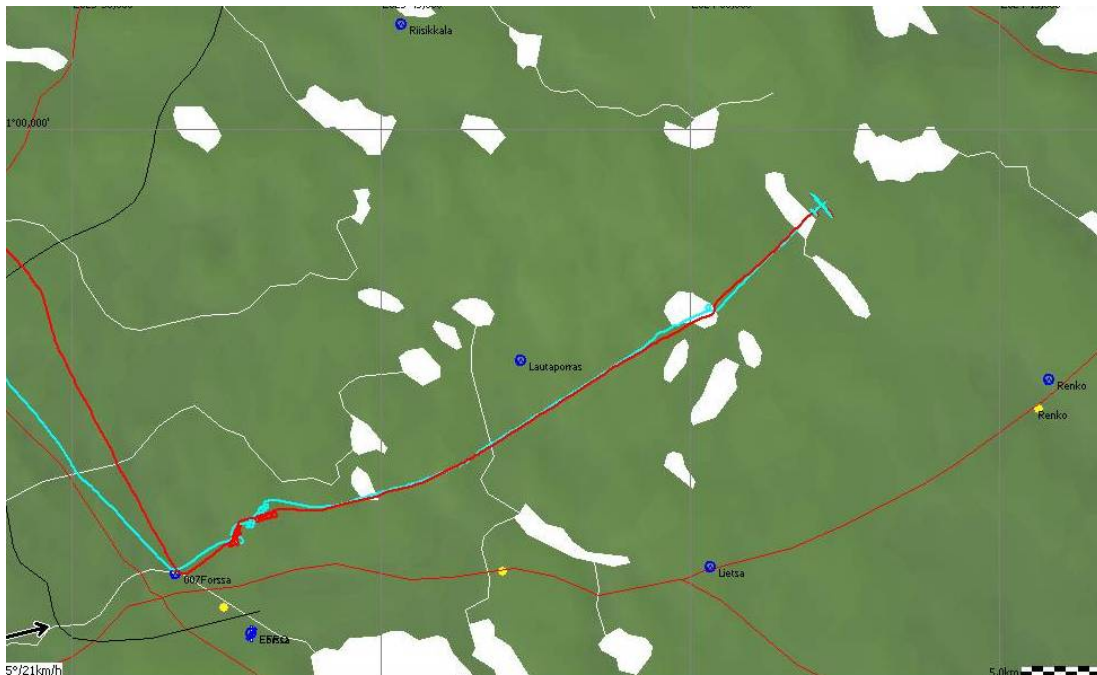
Five minutes before the collision BO flew past YX from the left side at the same altitude. The planes were gliding at a speed of about 220 km/h. In this situation, BO's pilot told having seen YX for the last time. The planes continued gliding almost along the same route, BO in front and YX behind it slightly to the right.

Three minutes before the collision BO came to an area of lift at 1450 m reducing speed and started turning to the left. YX was about 600 m behind BO at the same altitude, gliding at a speed of almost 200 km/h. When YX reached the same lift, it started a left turn. It reduced speed and climbed to 1540 m. At this stage, BO had turned about 180° and was on YX's front left side at a distance of about 450 m, slightly higher. YX did not continue circling, but continued to the right towards the course. BO continued to the same direction slightly higher, 400 m behind YX and 250 m to the right.

Figure 4. Flight tracks of the sailplanes during the last 20 minutes. BO's flight track and symbol are depicted in blue colour and YX's in red. Picture taken from SeeYou analysis software.

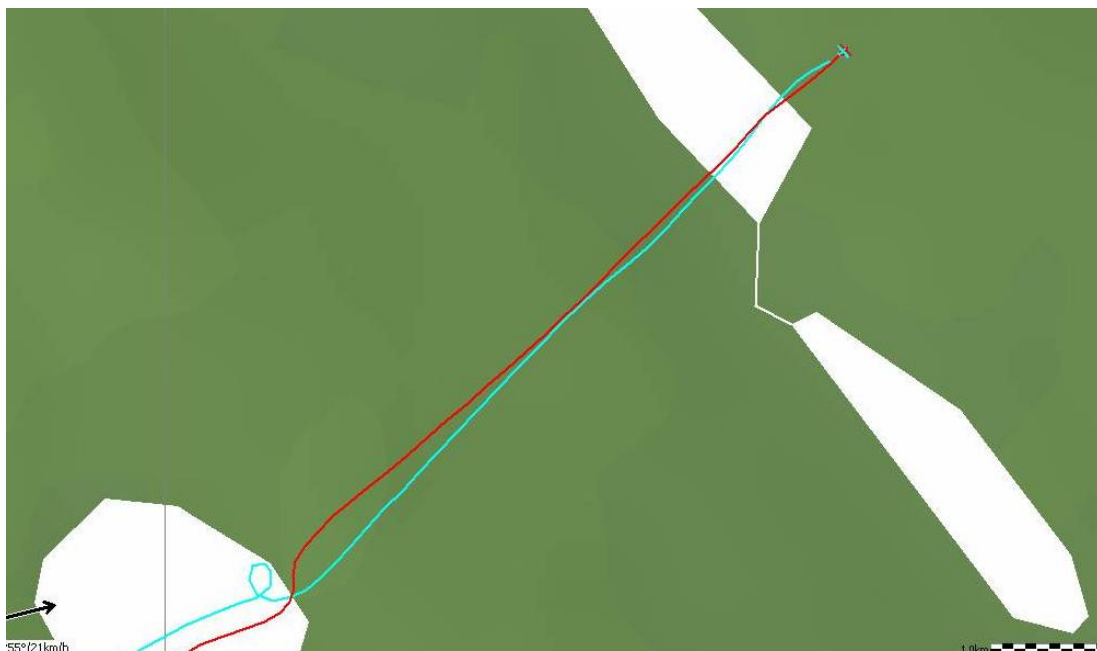
Figure 5. Flight tracks of the sailplanes during the last 2.5 minutes. BO is depicted in blue and YX in red. Picture taken from SeeYou analysis software.

About one minute before the collision BO flew past YX from the right side. About half a minute before the collision YX was almost at the same line, 60 m behind BO and about 70 m lower. BO came to an area of lift reducing speed. YX was flying about 20 km/h faster than BO. After this, YX's flight path intersected BO's flight path from left to right,

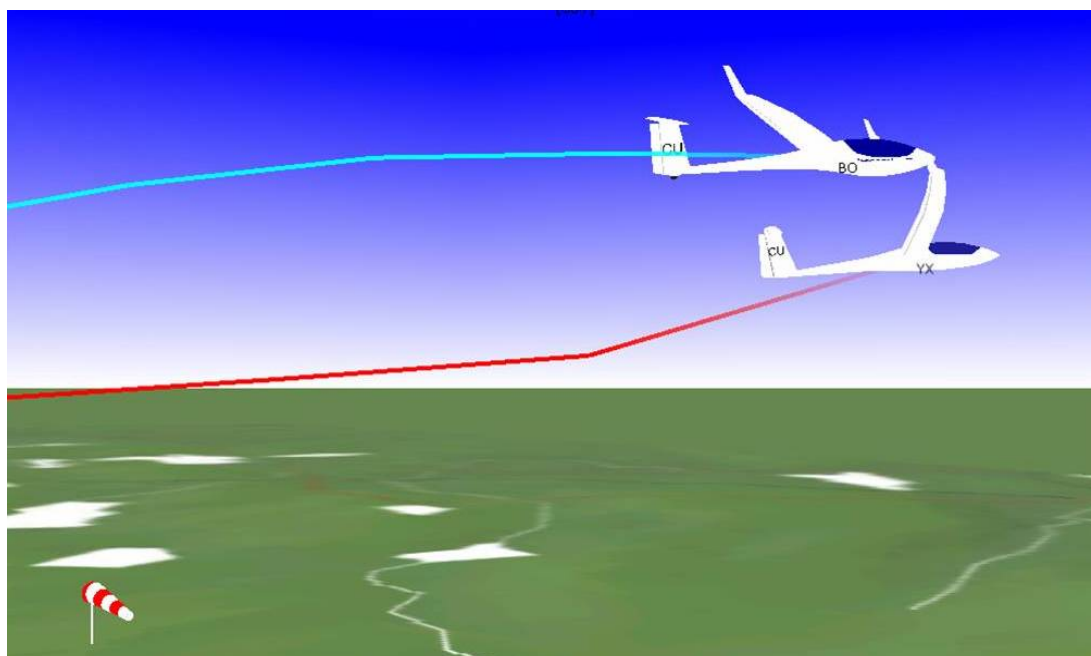
About five seconds before the collision YX was on BO's front right side at a distance of 44 m and about 40 m lower. Just before the collision YX was 25 m ahead of BO and still about 40 m lower. At impact, YX's flight speed was 160 km/h and rate of climb about 7 m/s. BO was flying almost level at 168 km/h.

Figure 6. The collision situation. Picture from SeeYou analysis software.

The accident was caused by pilots' insufficient situational awareness leading to the situation, where the planes got above each other and their flight paths intersected in the vertical direction. At the same time the pilots could not see each other.

To increase and maintain safety awareness, the Safety Investigation Authority, Finland recommends the Finnish Aeronautical Association to organise a safety information session before every gliding contest and to address safety issues in the briefing session for each day of competition.
